April 23, 2012

On January 1, 2012, Cities' Inspection Service, Inc. completed a home inspection of the property located at 123 Oak Road, Somewhere, Minnesota for you. Doug Hastings did all the fieldwork related to this project. Doug used the national home inspection protocol; the American Society of Home Inspectors (ASHI) Standards of Practice.

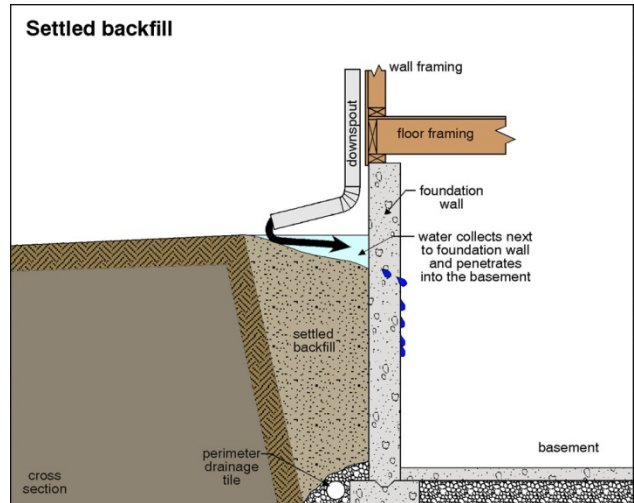
A1. Flat or settled grade

- A. Grounds
 - Earth grade and sidewalks do not slope away from the foundation (basement moisture). The grading requires a french drain pipe on the north side. This pipe should daylight out the hill in the front yard.
- B. Building Exterior
 - Loose, buckled, painted, and storm damaged wall siding, window, door, and overhang trim. Cracked window, door, and trim caulking.
 - Cracked garage floor.
- C. Structure
 - Water stained basement walls and floor.
 - Water bucket in attic (water stained bedroom ceiling).
- D. Electrical
 - Low overhead exterior service wires.
 - Ungrounded main panel.
 - Unsecured basement junction panel and unprotected wiring.
 - No bath outlet with GFCI protection.
- E. Plumbing
 - Corroded iron water pipes; low kitchen and bath water pressure.
 - Leaking kitchen and laundry faucets.
- F. Mechanical
 - None.
- G. Interior Room
 - Unsafe living room gas heater.

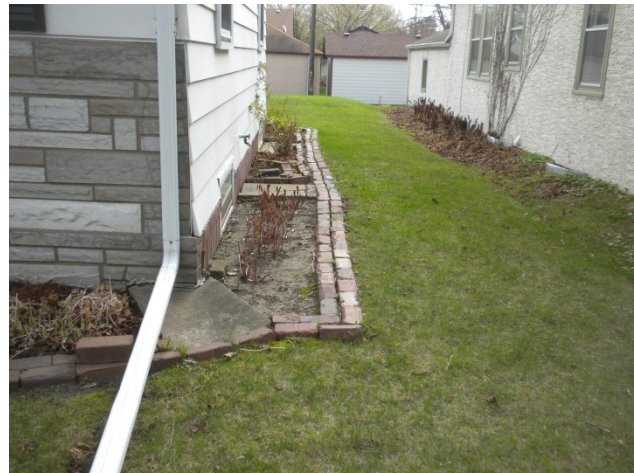
A1. Flat grade

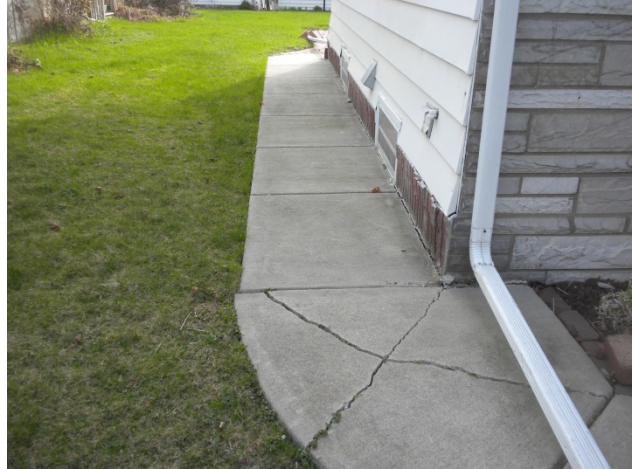
A2. Flat & cracked sidewalk

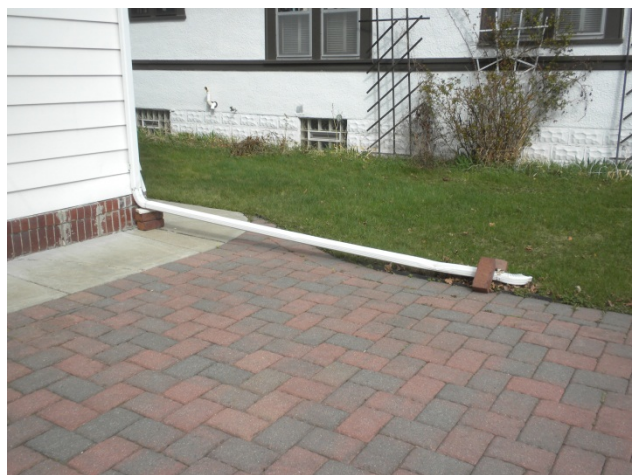
A2. Over extended downspout extension

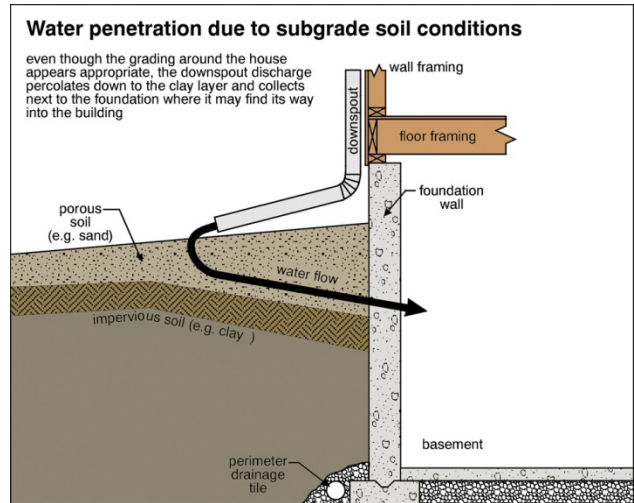
A2. Downspout issues

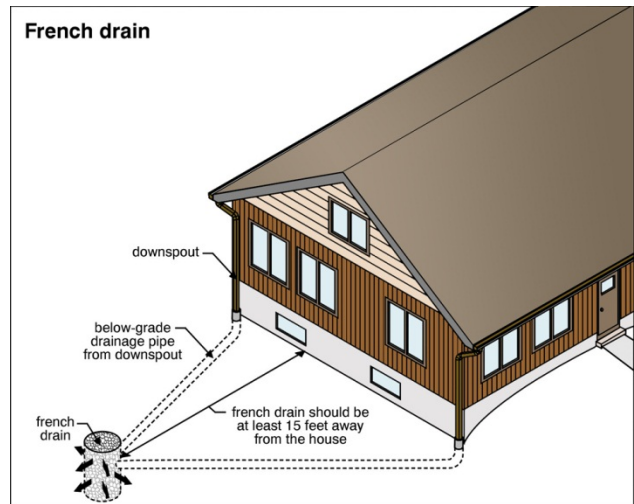
A2. Drainage pipe

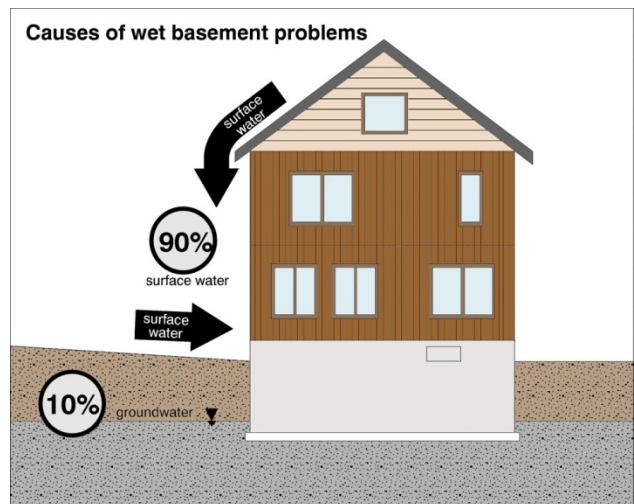
A1. Basement moisture

1. If grading does not completely resolve the basement moisture problem, you may need to install gutters to control roof drainage.
2. Mold and asbestos remediation work has been done, extent and completeness of work not visible. You should have the air quality tested.
3. Licensed contractor to certify no underground oil storage tank on property.
4. Not visible or limited view:
 - Underground sewer pipe (inaccessible)
5. Not viewed operating:
 - Outside water faucets (water off)
 - Garage overhead door opener (disconnected).

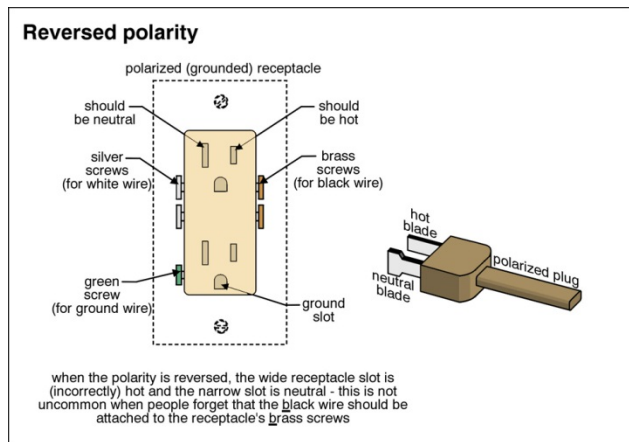
A3. Garage outlet

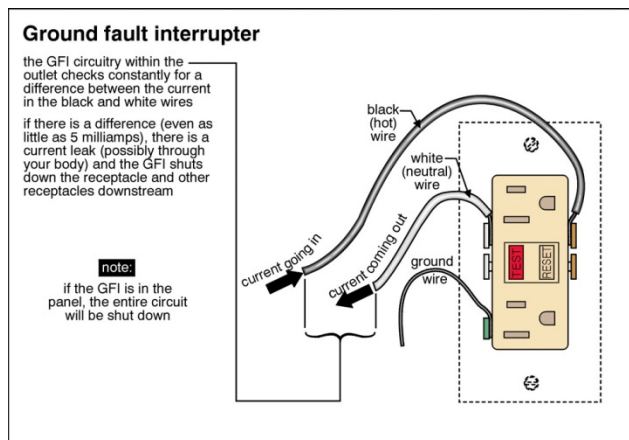
A3. Garage outlet

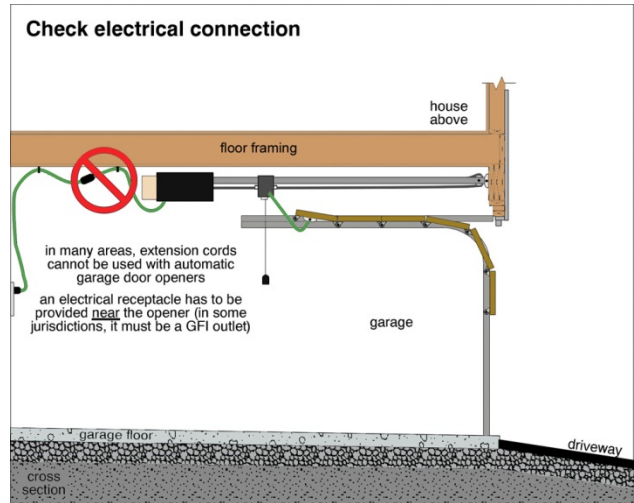
A3. Garage opener wiring

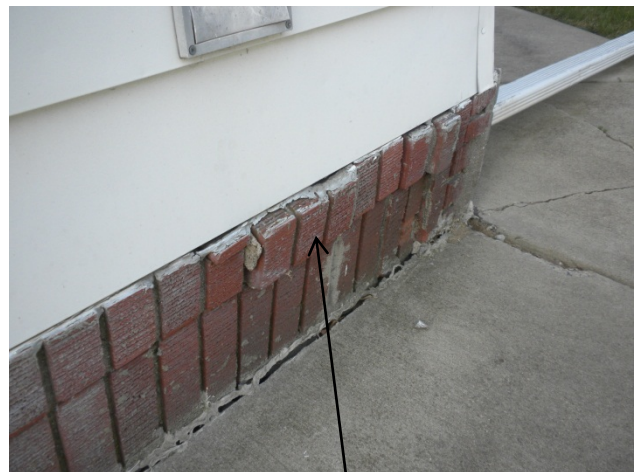
B1. Loose & tipped bricks

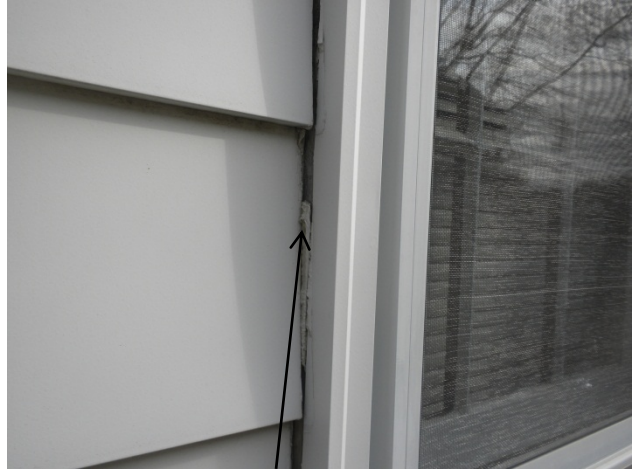
B1. Cracked & missing caulking

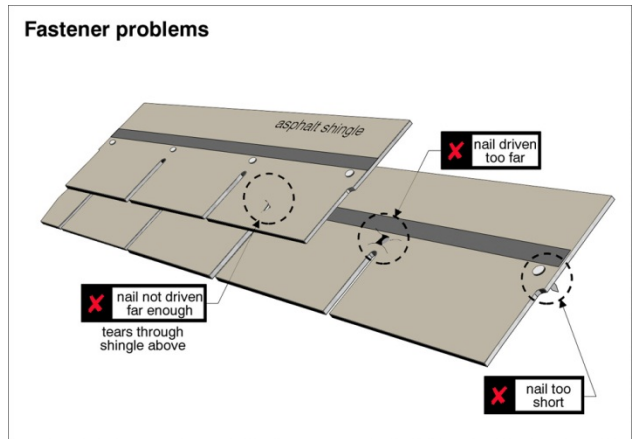
B2. Loose roof shingles

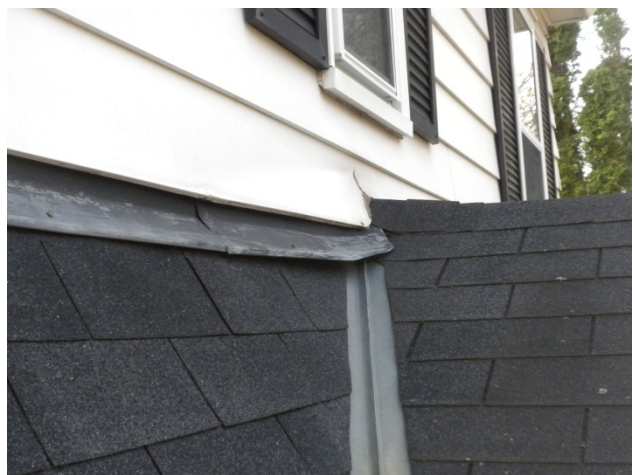
B2. Loose wall flashing

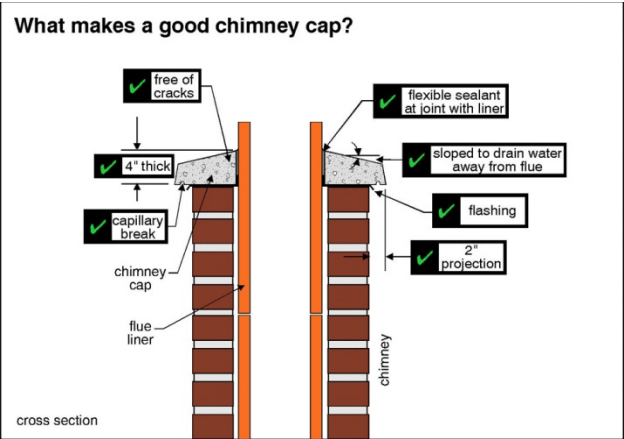
B2. No chimney cap

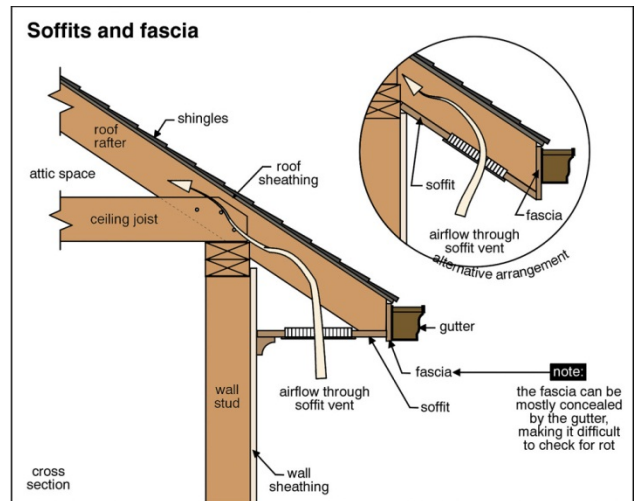
B2. No overhang ventilation

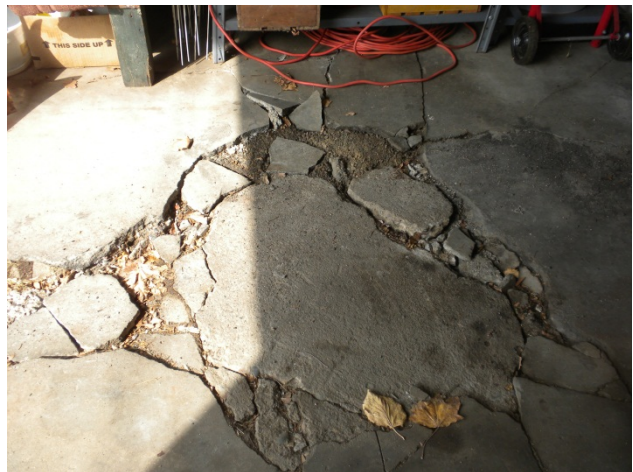
B3. Cracked garage floor

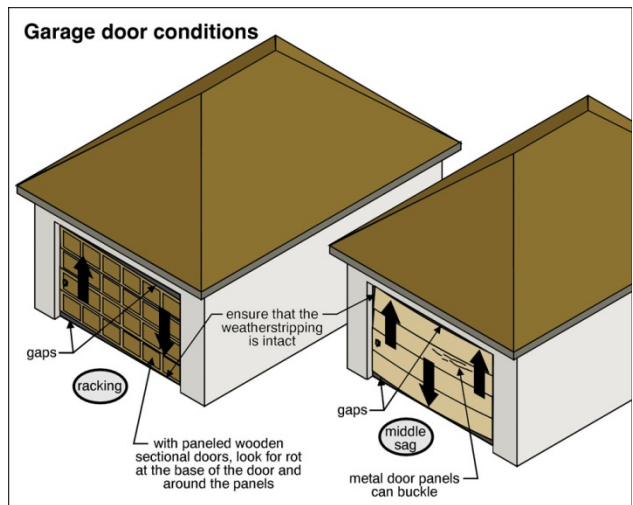
B3. Bent overhead door

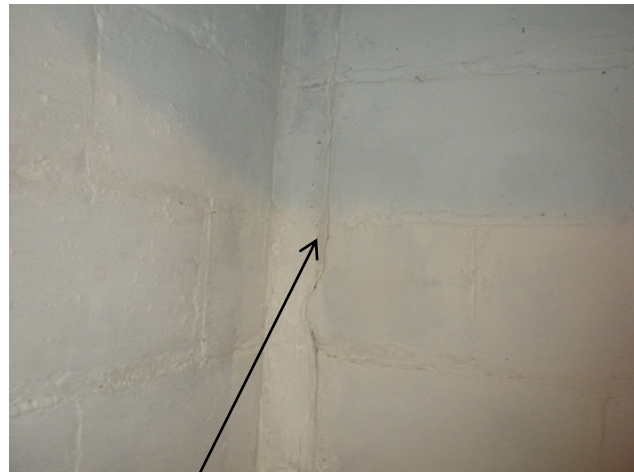
C1. Vertical shear cracks / bowed wall

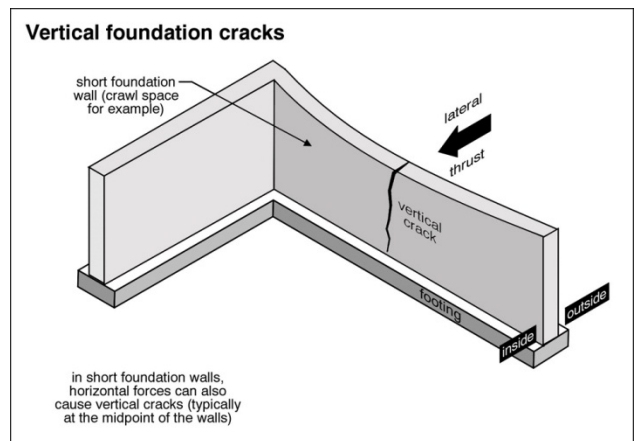
C1. Vertical shear cracks in north wall corners

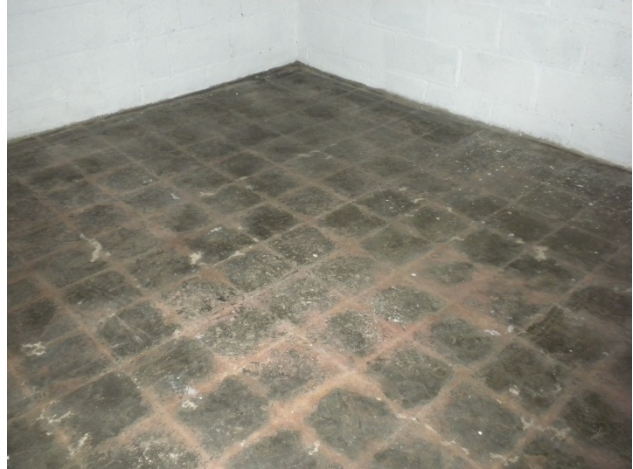
C1. Missing tiles / glue remains

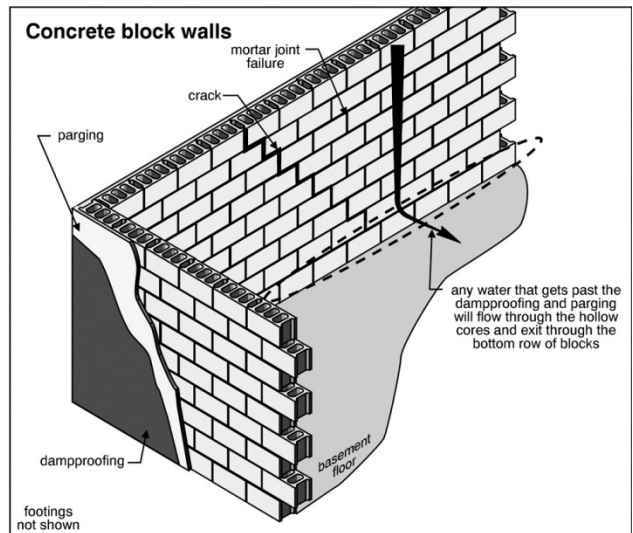
C1. Basement moisture

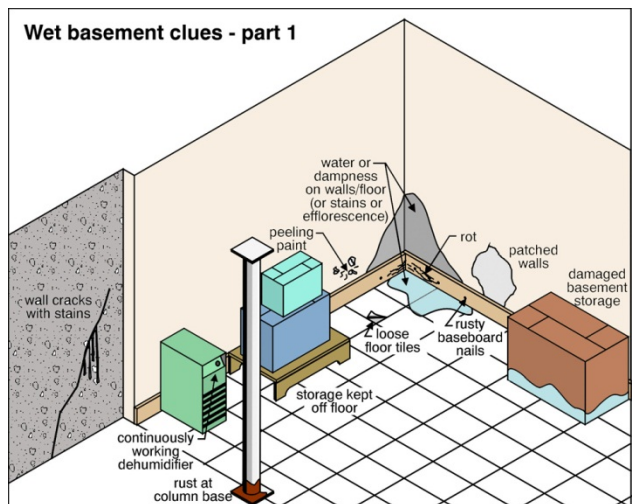
C1. Missing floor tiles

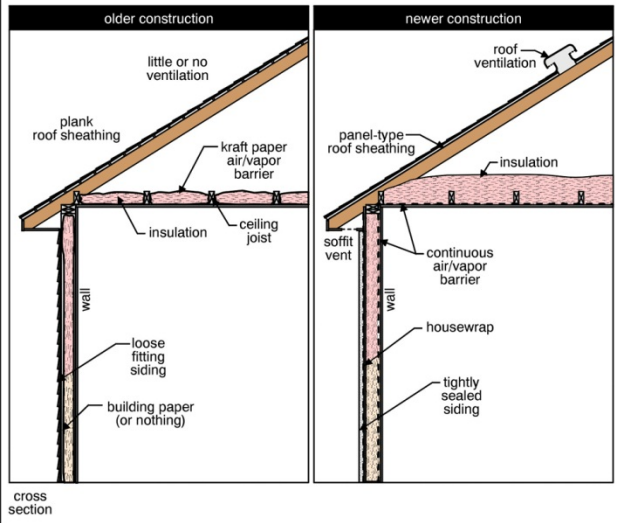
C4. Minimal insulation

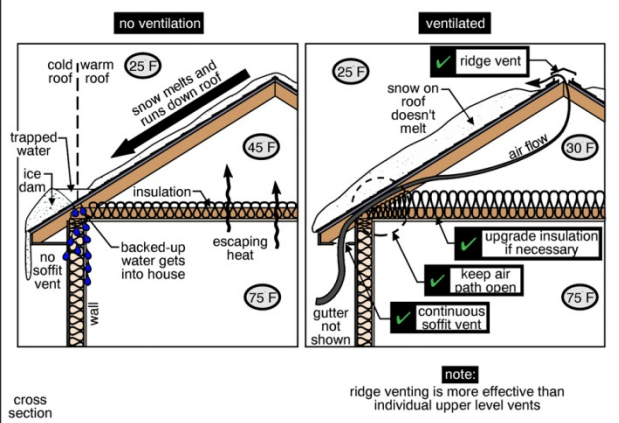
C4. Ice dams

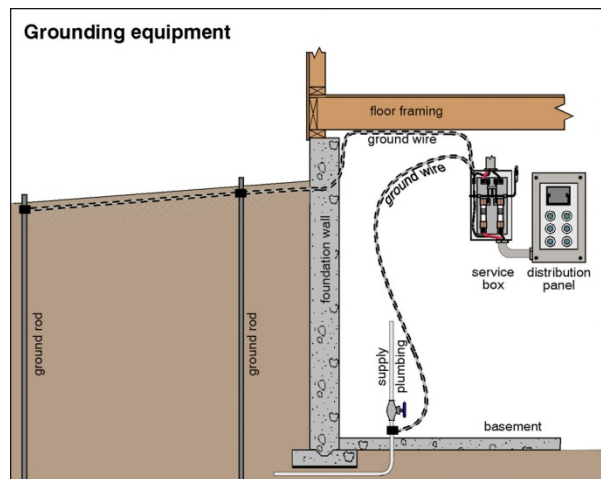
D1. Ungrounded panel

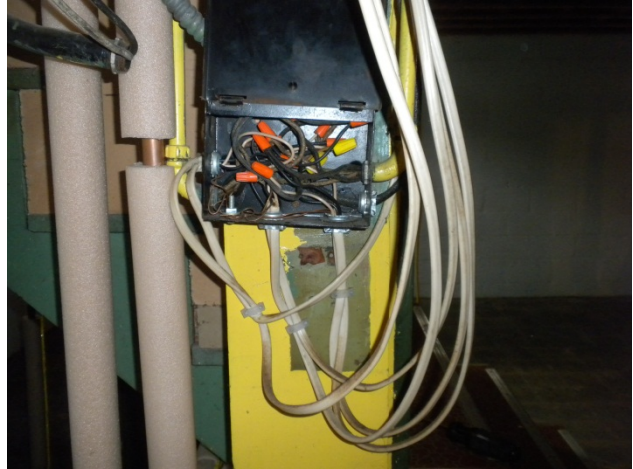
D2. Unsealed panel & unprotected wiring

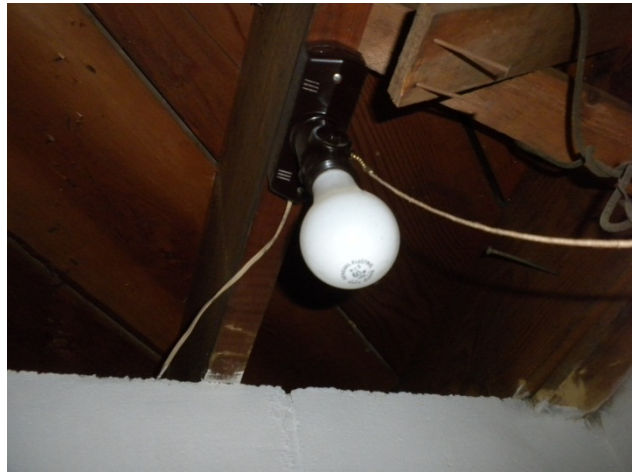
D2. Extension cord fixture wiring

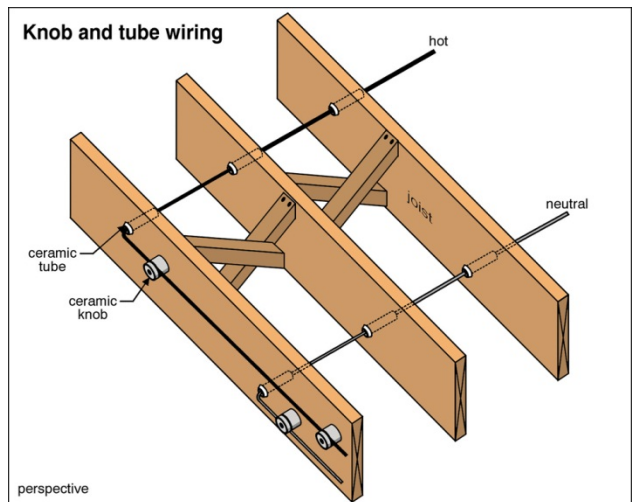
D2. Knob & tube wiring (attic & walls)

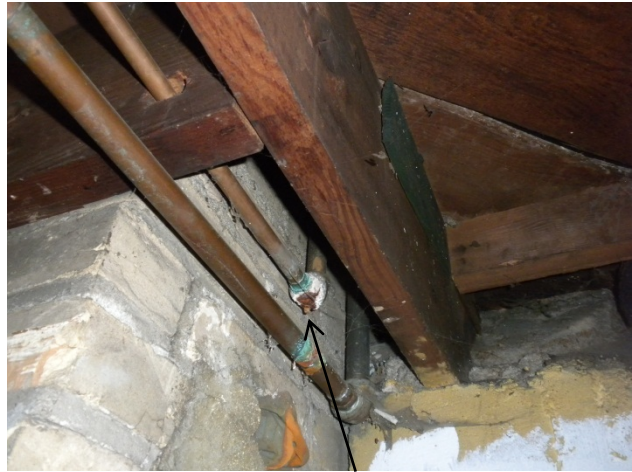
E1. Corroded connection

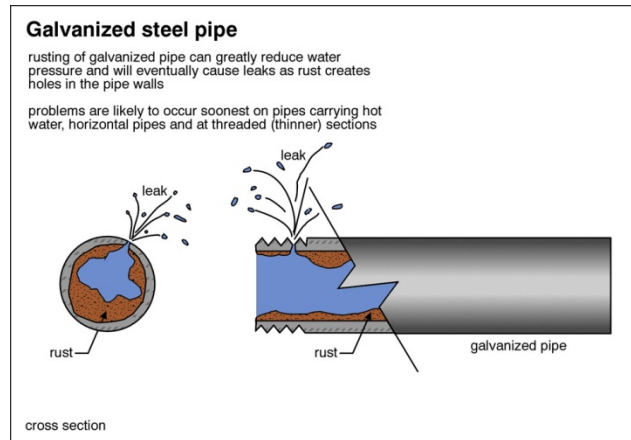
E1. Low water pressure

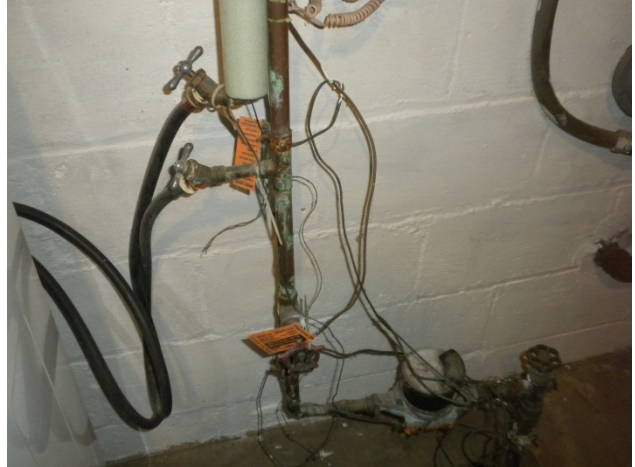
E1. Improperly located clothes washer faucets

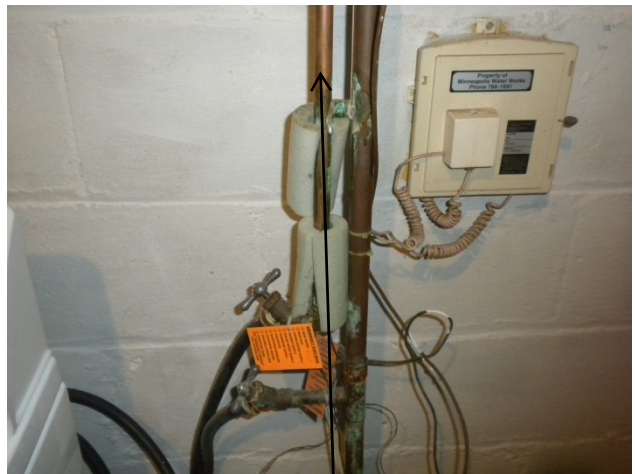
E1. Undersized water pipe

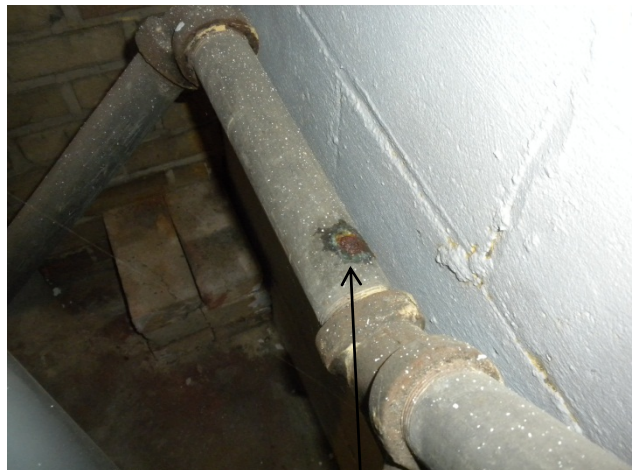
E1. Corroded drain pipe

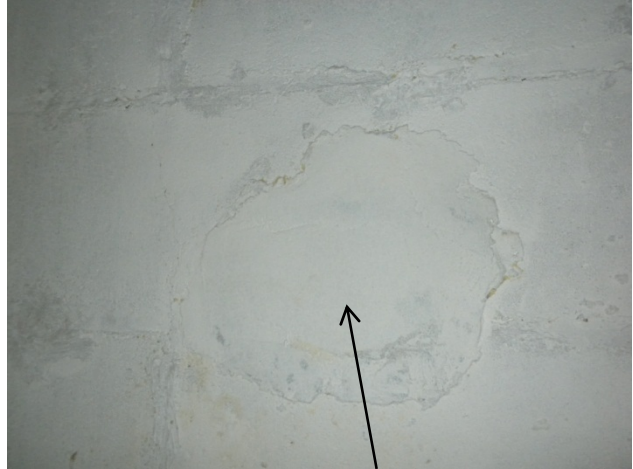
E3. Removed oil pipes

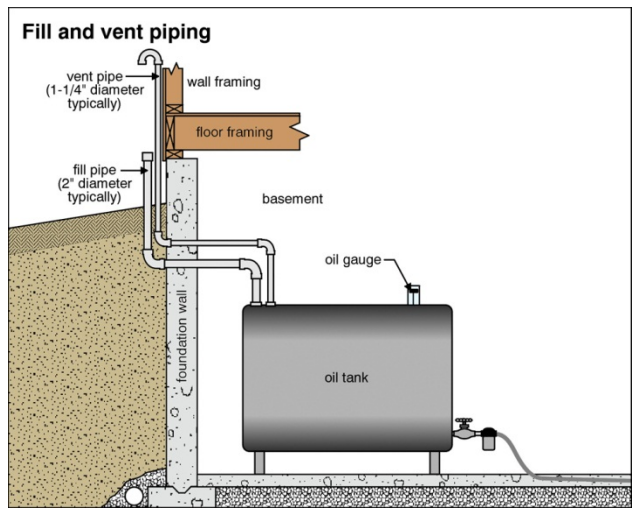
E3. Probably was interior tank & removed

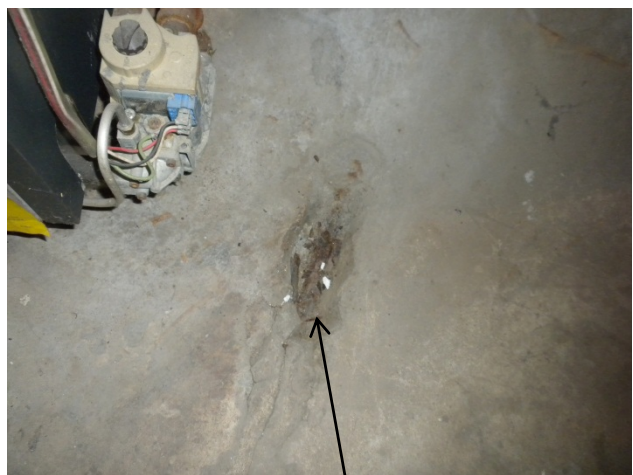
E3. Disconnected oil pipe

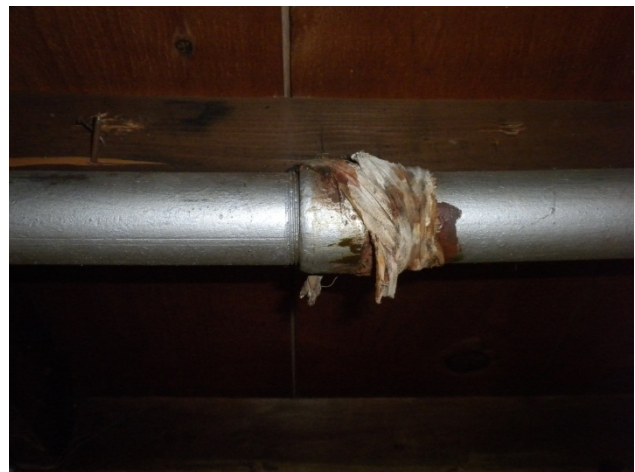
F1. Temporary pipe repair

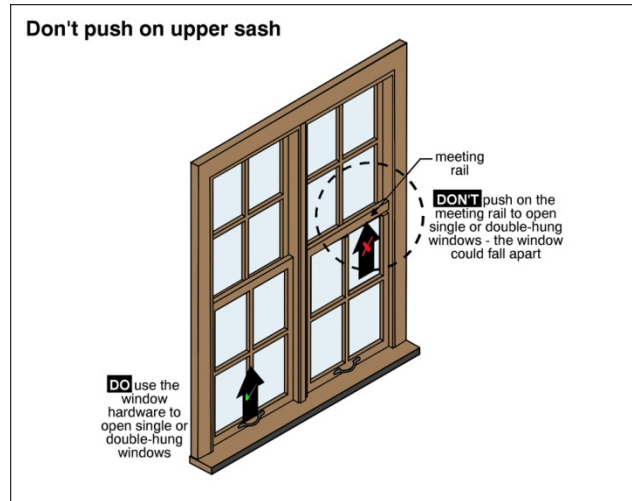
G. All windows

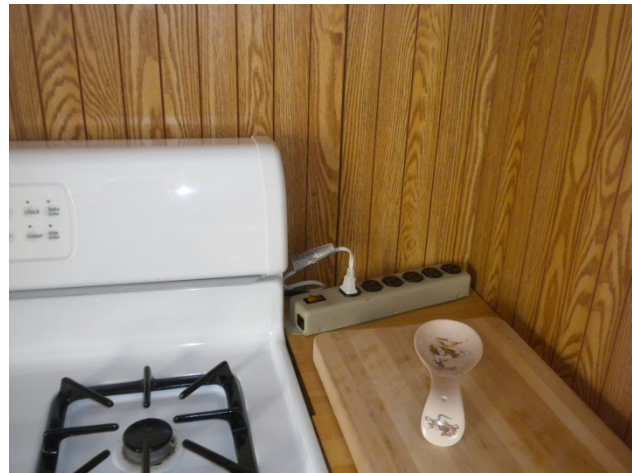
G1. Extension cord kitchen outlet

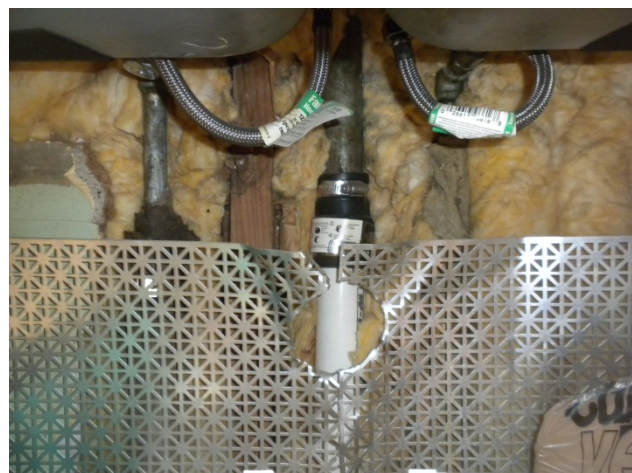
G1. Water pipes in unheated space / improper connector

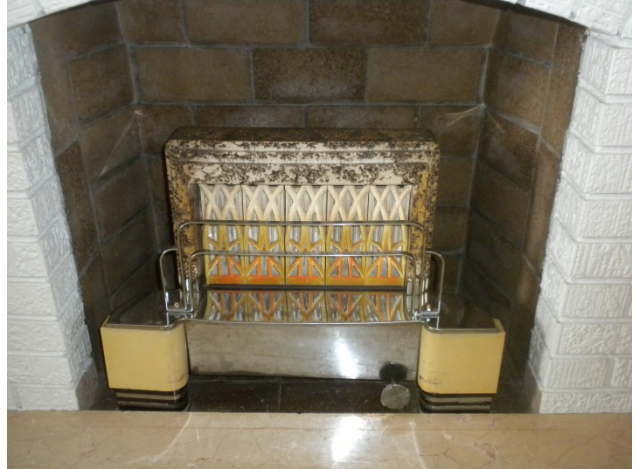
G3. Unsafe gas heater

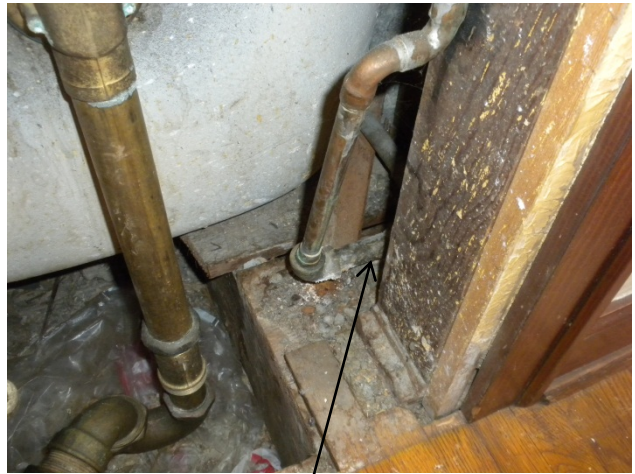
G3. Iron vertical water pipes
