www.citiesinspection.com

October 5, 2015

On 9/29/2015, Cities' Inspection Service, Inc. completed a home inspection of the property located at 123 Oak Street, Someplace, Minnesota for you. Doug Hastings did all the fieldwork related to this project. Doug used the national home inspection protocol; the American Society of Home Inspectors (ASHI) Standards of Practice.

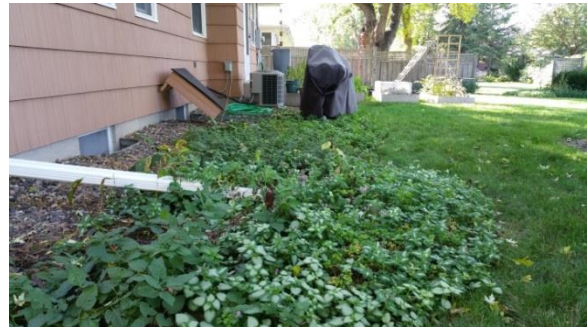
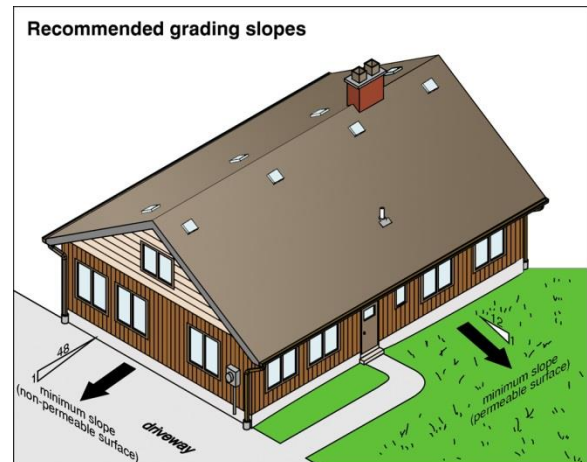
grading _____ ⊗.... flat grade east, west, & north sides

- ✓ Earth grade and patio are flat and do not slope away from the foundation. Although the risk is low, basement moisture will always be a possible problem until corrected.
- ✓ Loose patio door concrete block steps. Cracked backdoor concrete steps.
- ✓ Decayed fence posts.
- ✓ Peeled original window paint, loose and missing glass putty.
- ✓ Cracked and warped front door plastic glass trim.
- ✓ Leaking roof gutter connections.
- ✓ Missing roof ridge shingle.

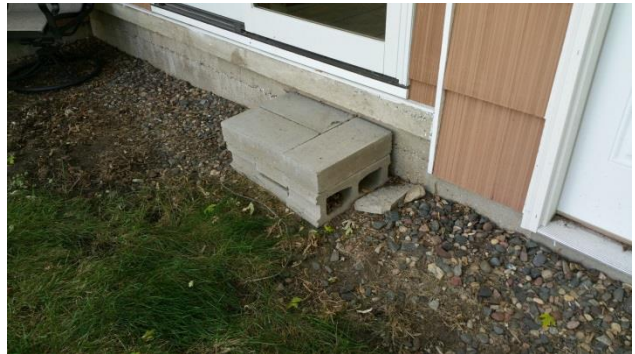
Patio steps

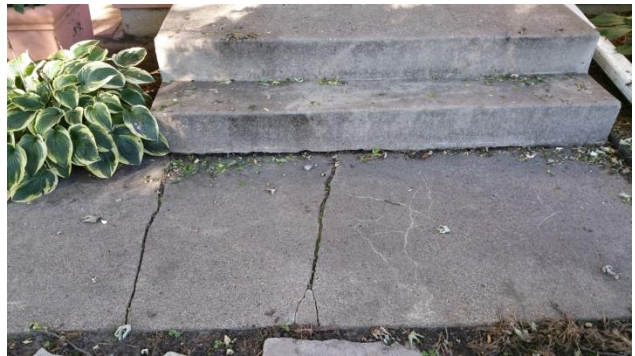
Settled front walk

- ✓ Cracked and settled front walk, patio, and driveway.
- ✓ Incomplete living room fireplace chimney liner (unsafe to burn).

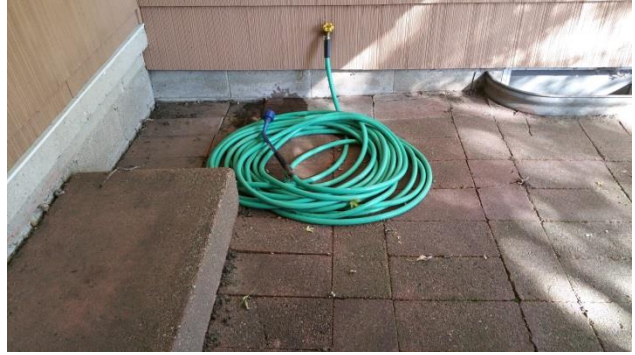
Settled patio

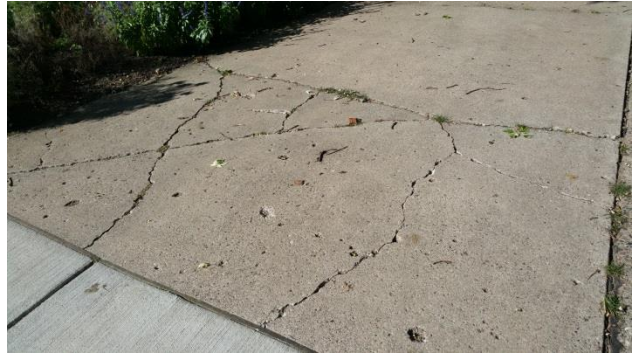
Driveway

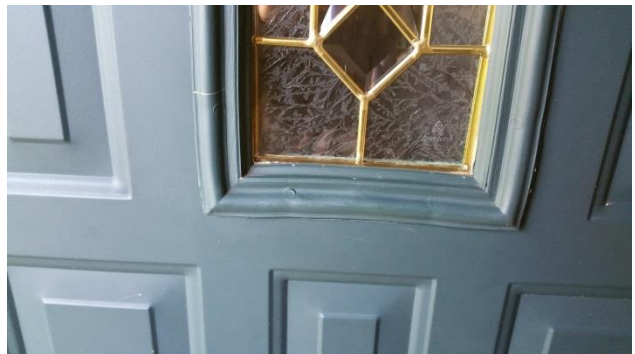
Cracked plastic glass trim

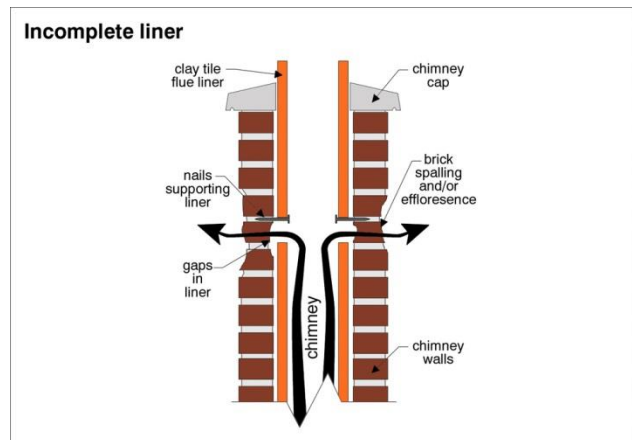
- slope _____ ●
- shingles _____ ○ missing ridge shingle
- flashing _____ ●
- chimney _____ ⊗ incomplete liner

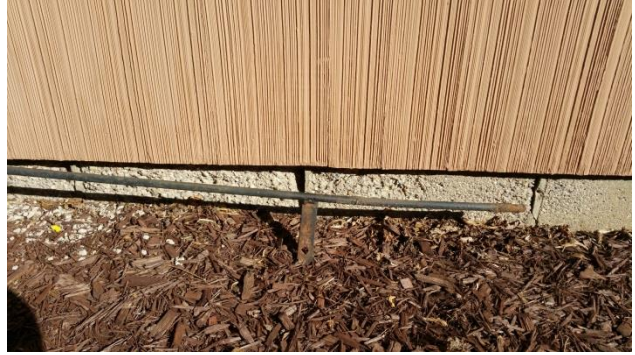
Deteriorated blocks

- ✓ Deteriorated exterior foundation blocks.

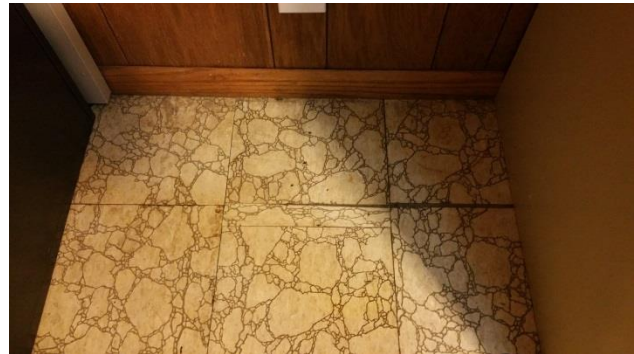
Water stained tiles east side

- ✓ Water stained rec room paneling and floor tiles.
- ✓ Missing basement rim joist insulation.
- ✓ Minimal amount attic insulation and ventilation (ice dams).

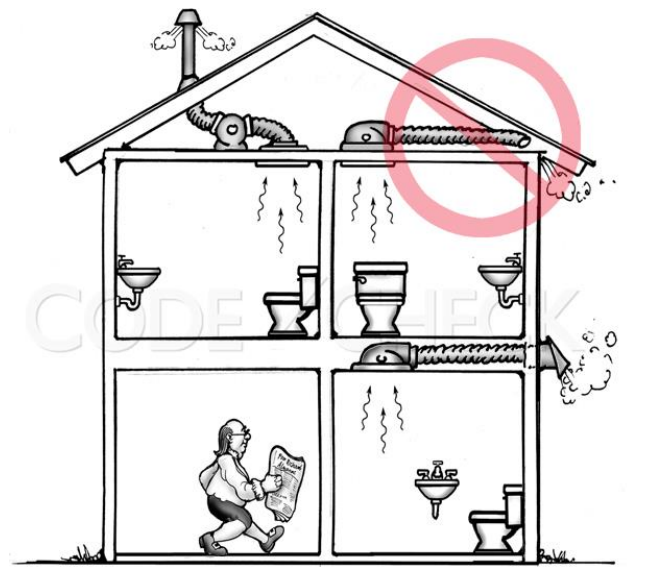
- rafters _____
- chimney _____
- vent pipes _____ unvented or improperly vented kitchen fan

- ✓ Unvented or improperly vented kitchen exhaust fan.

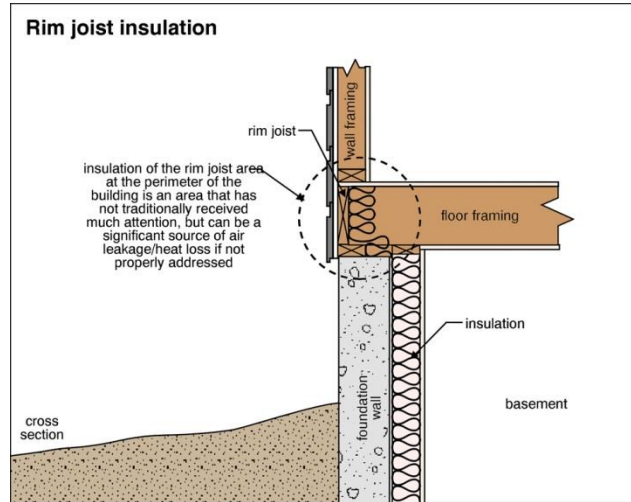
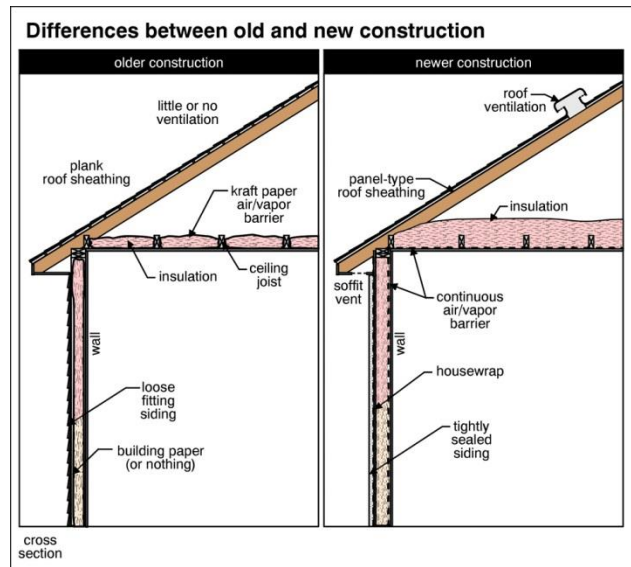
- basement _____ ⊙.... not visible
- floor _____ ⊙.... missing rim joist insulation
- wall _____ ⊙.... finished walls & not visible
- attic _____ ⊙.... minimal insulation / no baffles

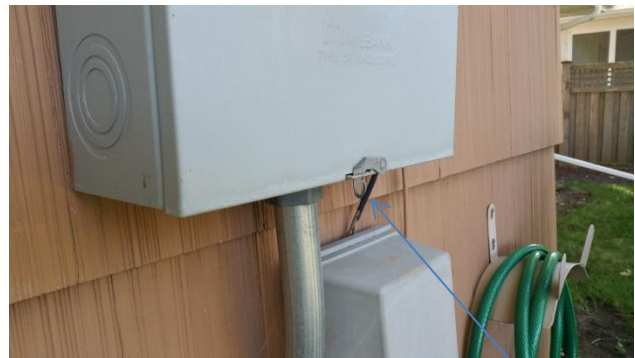
No lockout

- ✓ No exterior utility meter panel lock.
- ✓ Inoperable doorbell.
- ✓ Bad outlet grounds in garage. No garage GFI outlets. Extension cord overhead door opener wiring.

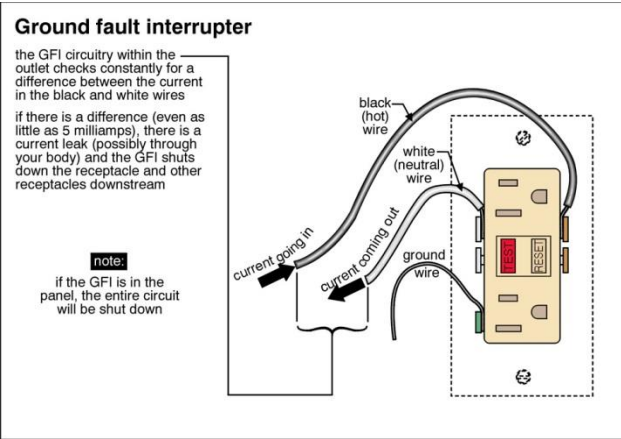
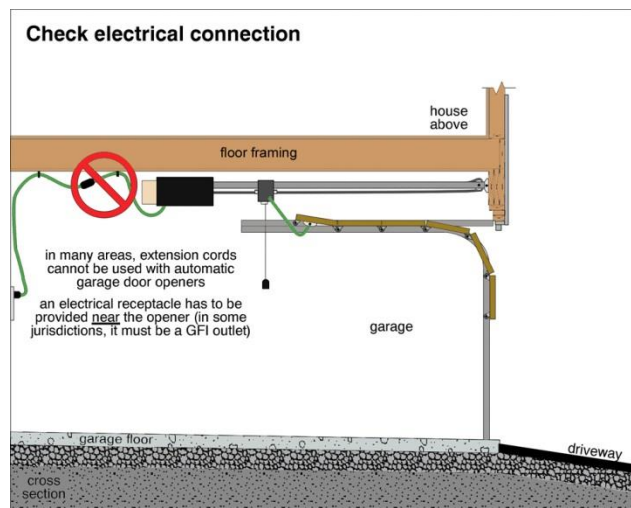
- exterior _____ inoperable doorbell
- garage _____ bad ground / no GFI outlet / extension cord automatic opener wiring
- basement _____
- finished walls _____ not visible
- attic _____

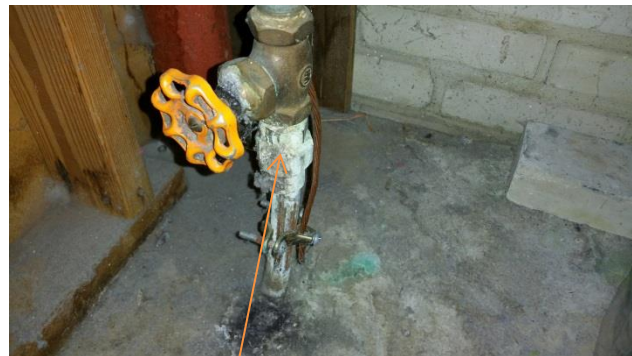
Leaking shutoff valve & pipe connection

- ✓ Leaking main water shutoff valve and adjacent pipe connection.
- ✓ Leaking clothes washer water pipe shutoff valve.
- ✓ No water softener, air conditioner condensate pump, and water purifier discharge pipe air gap (cross connection).
- ✓ No clothes dryer gas pipe drip leg.
- ✓ No water in rough in bath floor drain trap.

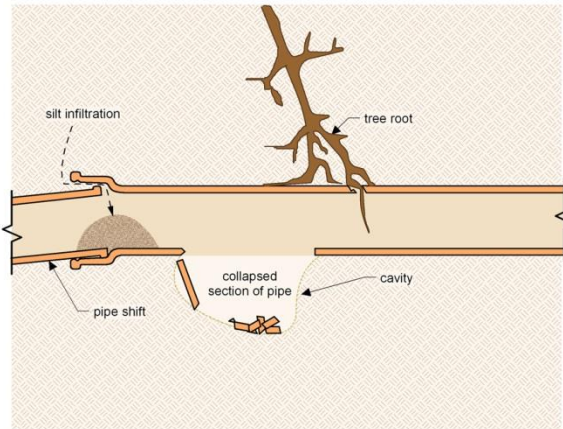
Clay pipe sewer issues - shift, collapse, roots, silt

Sewer concern

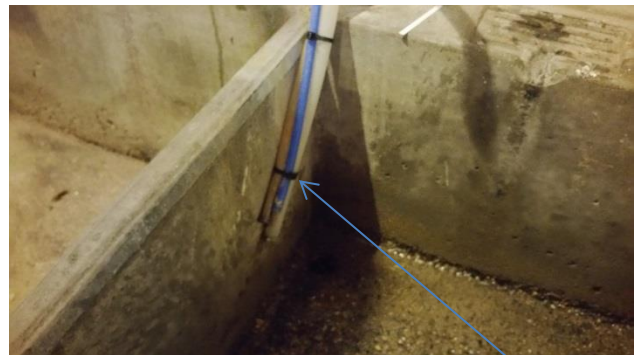
No air gap

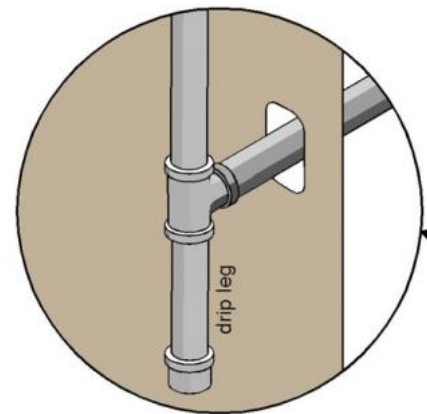
- meter and pipes
- appliances _____ no clothes dryer drip leg

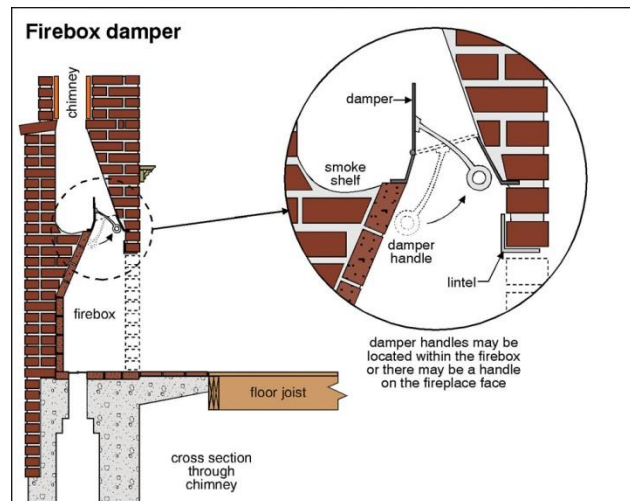
fireplace _____ ⊗.... broken damper handle / backdraft

- ✓ Broken basement fireplace damper handle. Fireplace is back drafting.
- ✓ Worn interior woodwork. Doors, windows, cabinets and trim need stain and varnish.
- ✓ Worn hardwood floors.
- ✓ Missing kitchen closet and sunroom doors.
- ✓ No basement and bedroom smoke detectors.

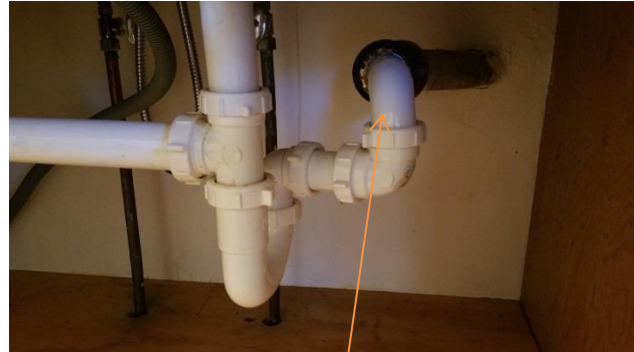
Improperly sloped drain pipe

- ✓ Cracked and leaking concrete laundry tub.
- ✓ Improperly sloped kitchen drain pipe.

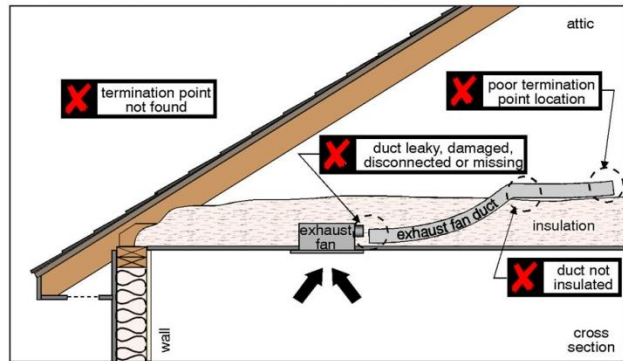
- refrigerator_____ ●
- stove_____ ●
- dishwasher_____ ●
- disposal_____ ●
- vented fan_____ ⊗.... unvented or improperly vented ceiling fan
