On 9/23/2015, Cities' Inspection Service, Inc. completed a **partial** home inspection of the property located at 123 Oak Street, Someplace, Minnesota for you. Doug Hastings did all the fieldwork related to this project. Doug used the national home inspection protocol; the American Society of Home Inspectors (ASHI) Standards of Practice.

Major System Inspection

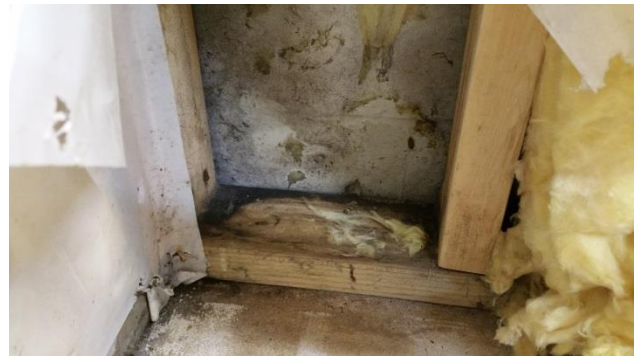
- Foundation_____ wall & floor water stains / wet blocks / water damaged insulation & wood framing
- floor slab_____
- sump_____ old pump / flexible drain pipe / no backflow valve / no battery backup sump pump / no lower level (finished rooms) drain tile
- grading_____ flat grade north, south, east & west sides / high water table / short sump pump drain pipe / no french drain east side
- Floor joists_____
- wood deck_____
- posts_____
- Exterior walls_____
- siding_____ brick veneer support on driveway / decayed patio door trim / rusted front door sidelight panel
- Roof_____
- shingles_____ short nails / two layers / no permit to install / patched gutter / split downspout
- Garage structure_____ rusted service door

Wall & floor water stains

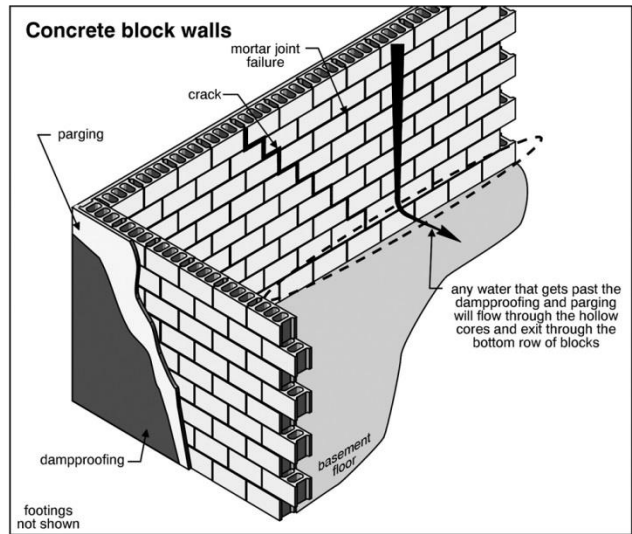
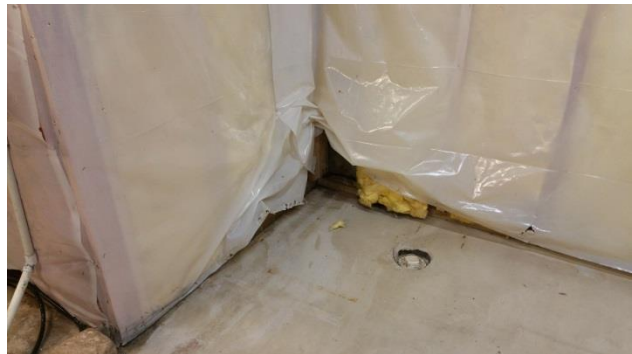
Water damaged wood & insulation

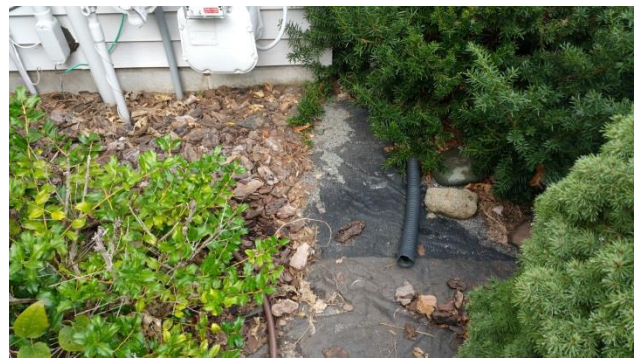
Short exterior sump pump discharge pipe

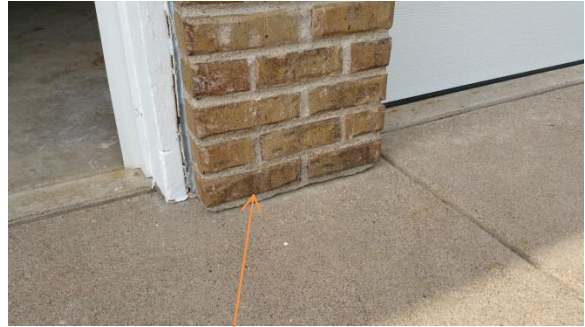
Brick veneer supported on driveway

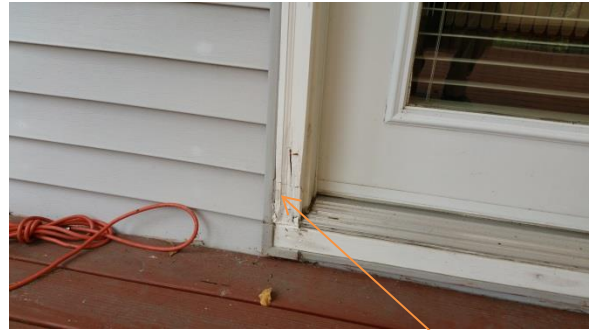
Decayed trim

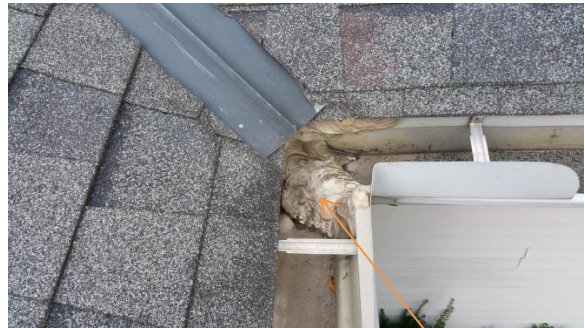
Patched gutter

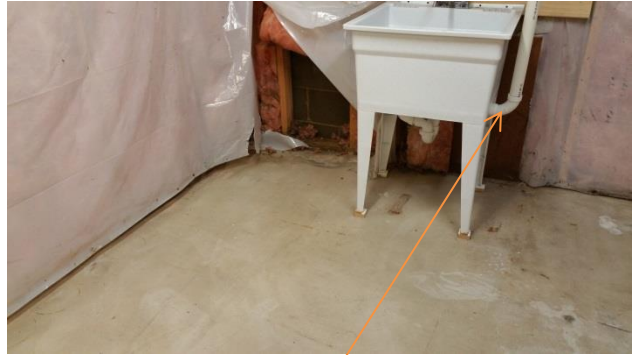
- Main water pipe _____ (●)
- interior pipes _____ (●)
- pressure _____ (●)
- Water heater _____ (●)
- Waste pipe _____ (✗).... improperly vented laundry standpipe
- drain & vent _____ (●)
- Gas pipes _____ (●)

Improperly vented standpipe
