On June 1, 2015, Cities' Inspection Service, Inc. completed a fourth stage new construction inspection of the property located at 123 Oak Street, Someplace Minnesota for you. Doug Hastings did all the fieldwork related to this project. Doug used the 2007 Minnesota State Building Code as the minimum construction standard.

# Final Inspection

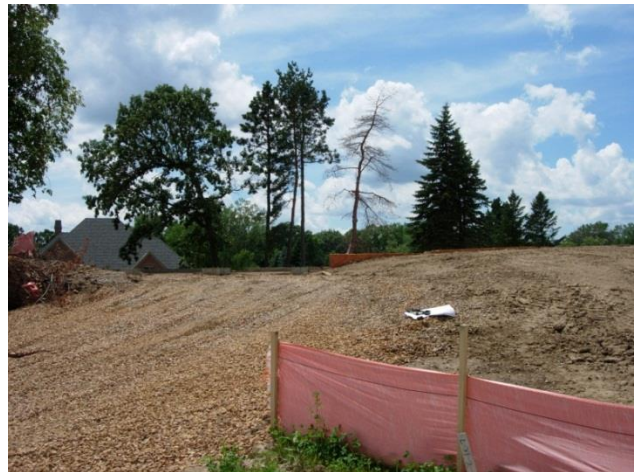
1<sup>st</sup> inspection site

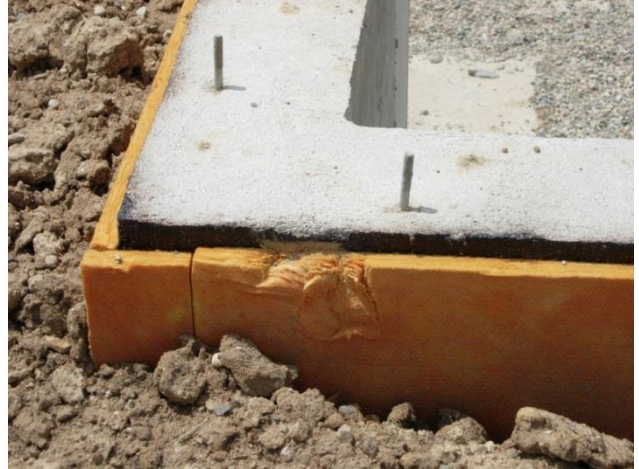
1<sup>st</sup> inspection foundation insulation

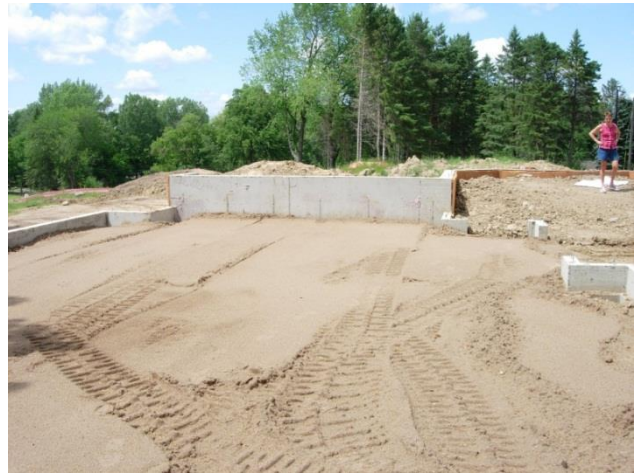
1<sup>st</sup> inspection soils

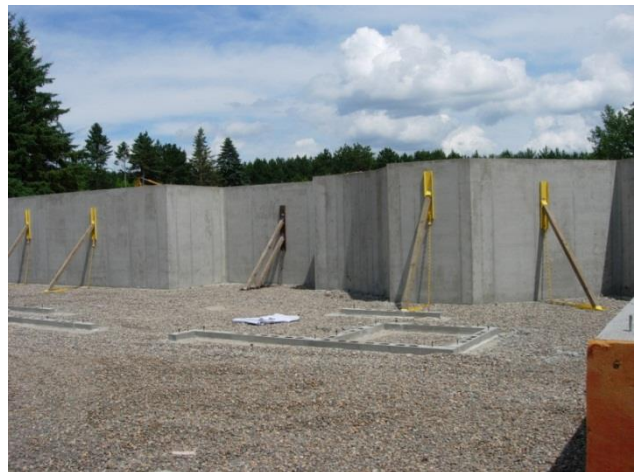
1<sup>st</sup> inspection backfill & wall bracing

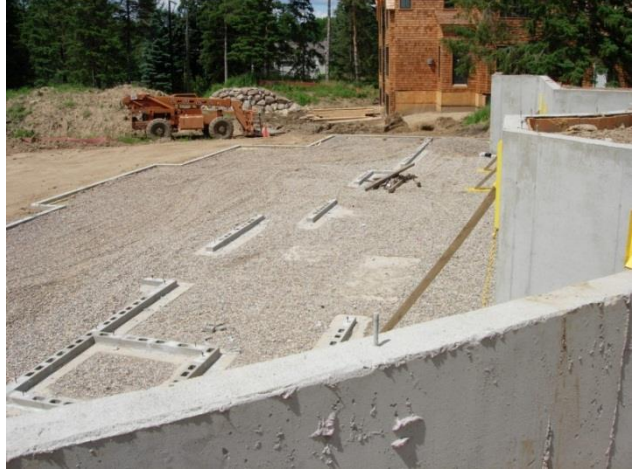
1<sup>st</sup> inspection interior footings

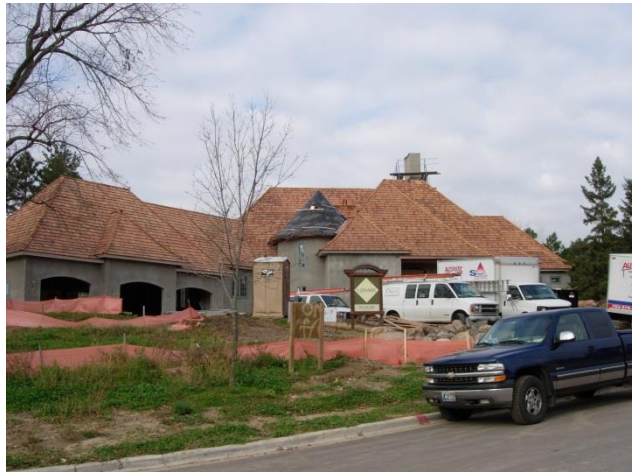
2<sup>nd</sup> inspection building framing

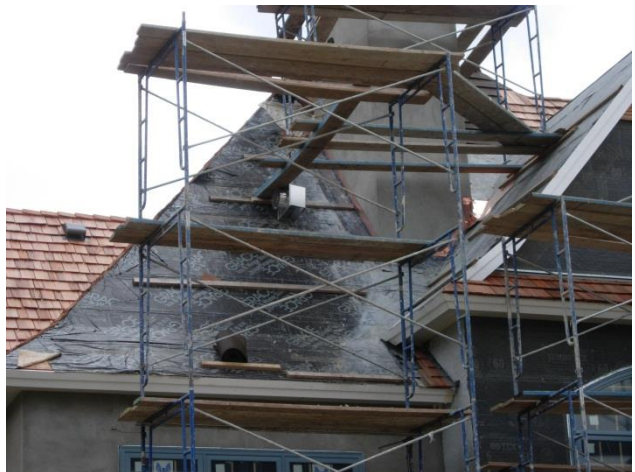
2<sup>nd</sup> Inspection roofing

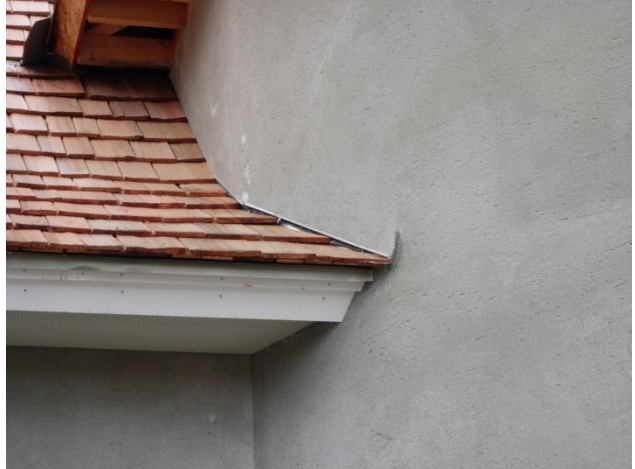
2<sup>nd</sup> inspection flashing

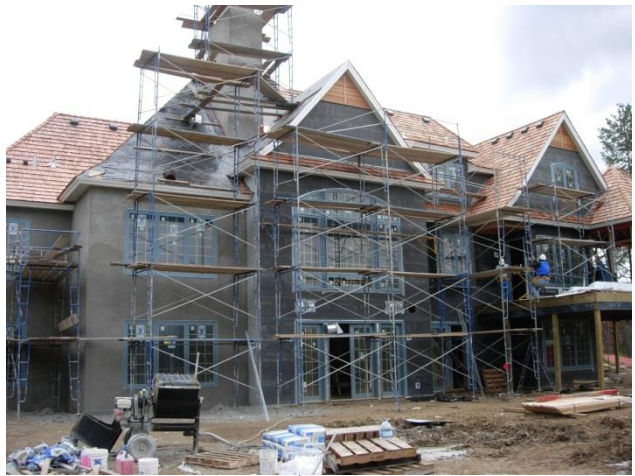
3<sup>rd</sup> inspection exterior barriers

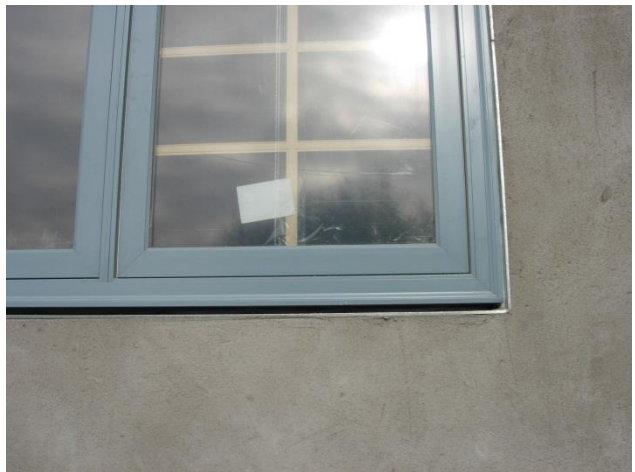
3<sup>rd</sup> inspection caulking

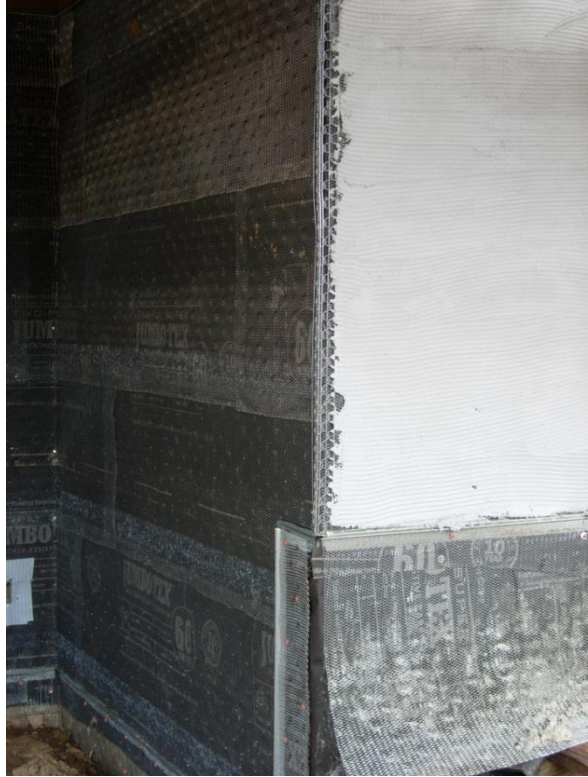
3<sup>rd</sup> inspection stucco

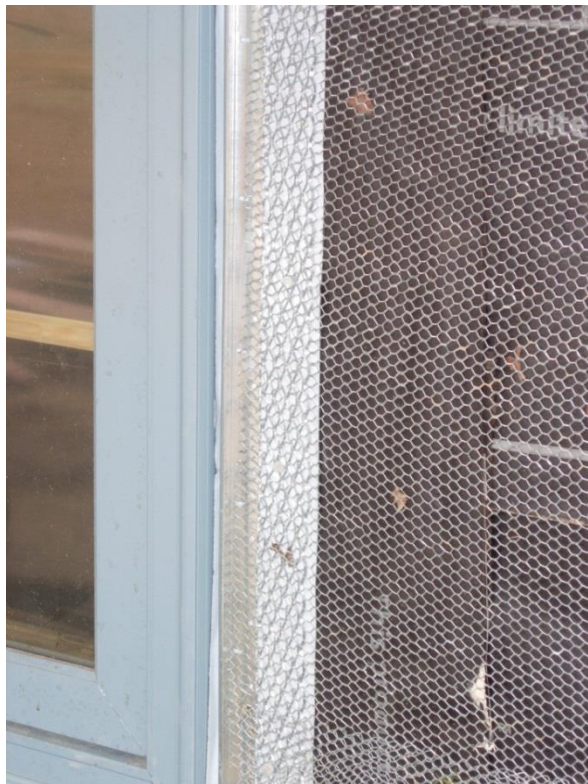
3<sup>rd</sup> inspection flashing

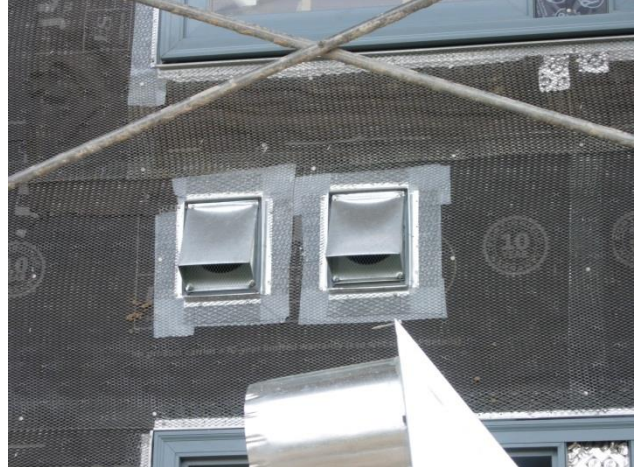
3<sup>rd</sup> inspection flashing

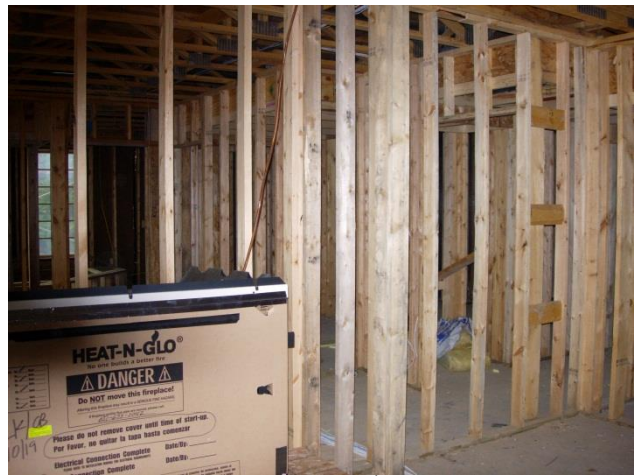
3<sup>rd</sup> inspection basement

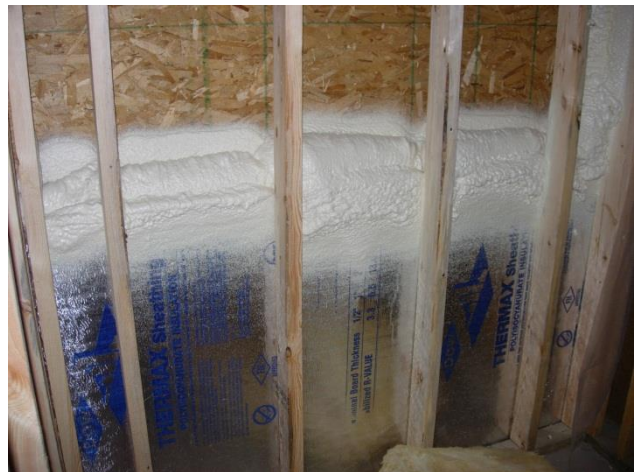
3<sup>rd</sup> inspection insulation

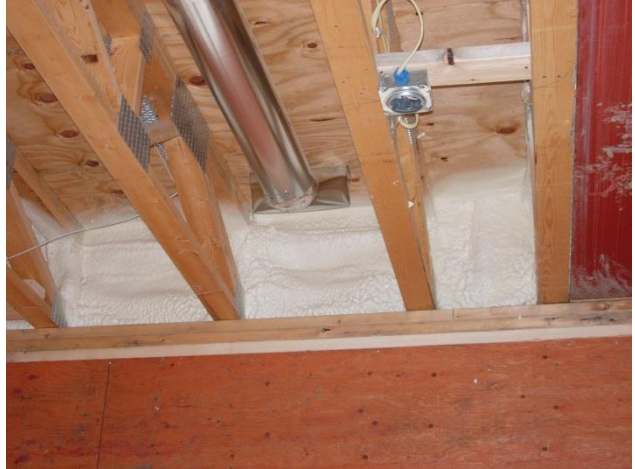
3<sup>rd</sup> inspection insulation

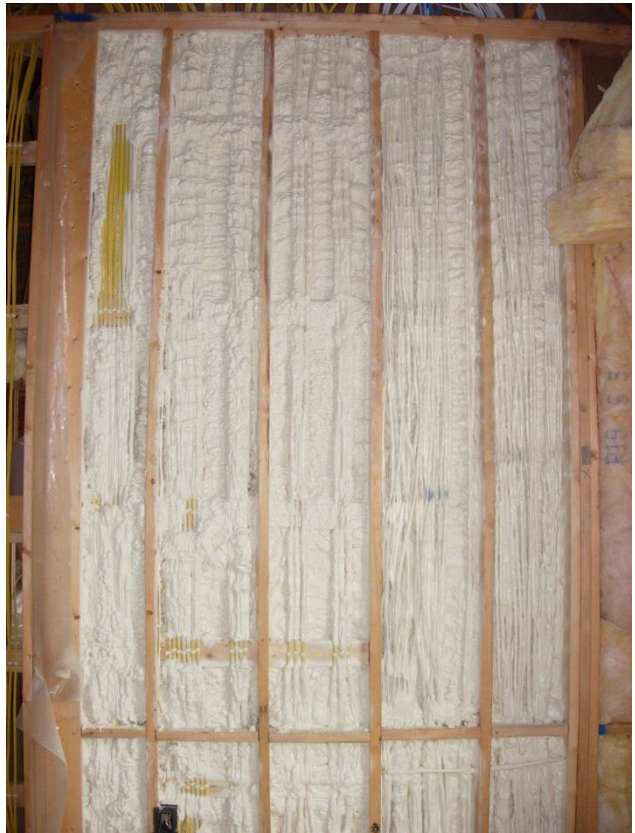
3<sup>rd</sup> inspection insulation

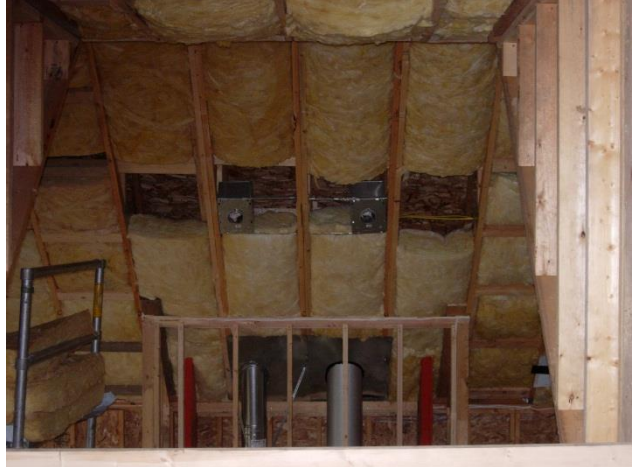
3<sup>rd</sup> inspection vaulted ceilings

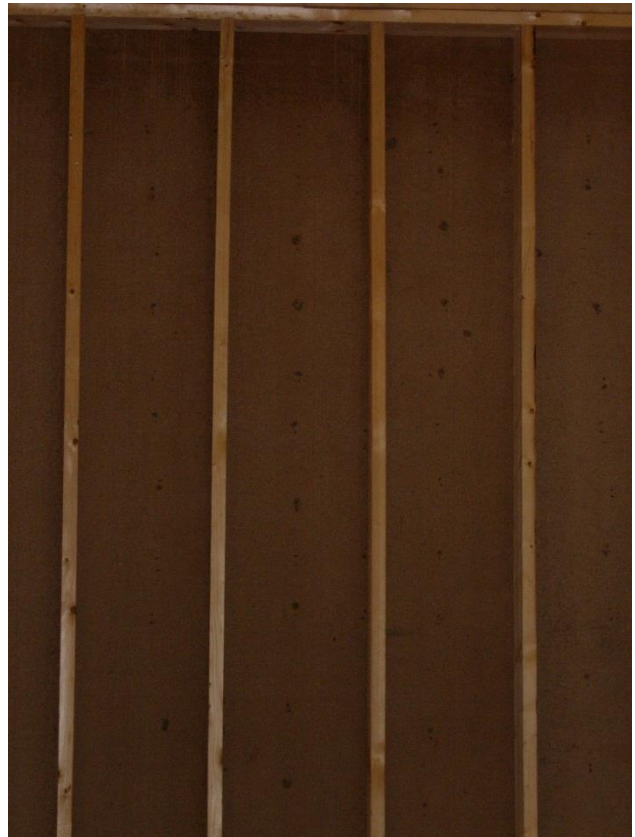
3<sup>rd</sup> inspection exposed nails
