October 5, 2015

On 9/27/2015, Cities' Inspection Service, Inc. completed a home inspection of the property located at 123 Oak Street, Someplace, Minnesota for you. Doug Hastings did all the fieldwork related to this project. Doug used the national home inspection protocol; the American Society of Home Inspectors (ASHI) Standards of Practice.

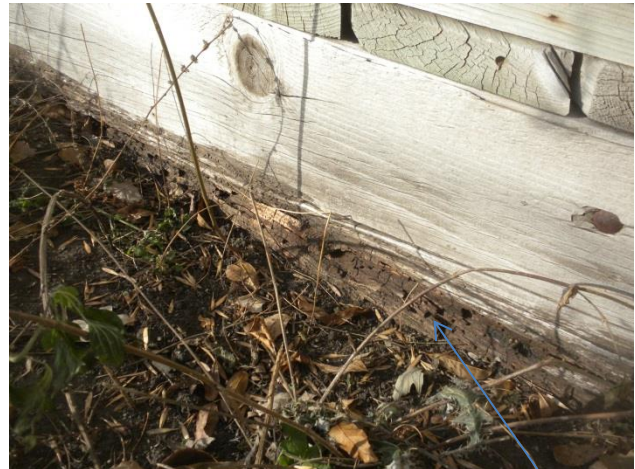
Figure 1

- walks _____ ●
- deck _____ ⊗.... over spaced joists / loose & sagged floor boards
- porch _____ ⊗.... decayed wood rim joists (figure 1) / joists too close to earth (figure 2) / bypass under floor (figure 3) / located over below grade bomb shelter & footings not visible
- driveway _____ ●

- ✓ Over spaced wood deck floor joists, loose and sagged floor boards.
- ✓ Decayed porch perimeter rim joist.

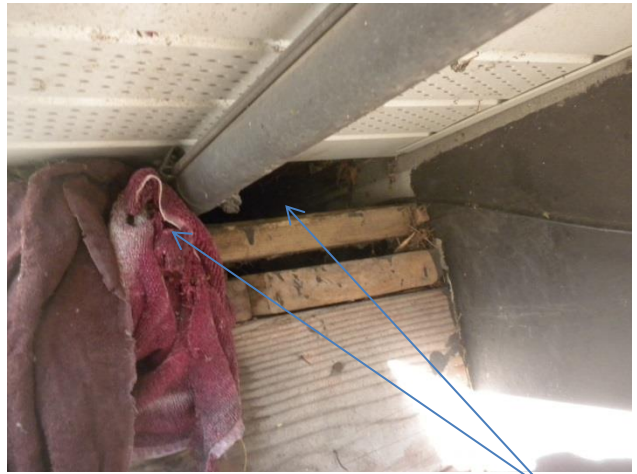
Figure 3

- ✓ Decayed retaining wall timbers.
- ✓ Opening below porch at electrical service pipe.
- ✓ Peeled window paint and loose glass putty.
- ✓ Stained aluminum gutters.
- ✓ Tar patched roof vent flashing.

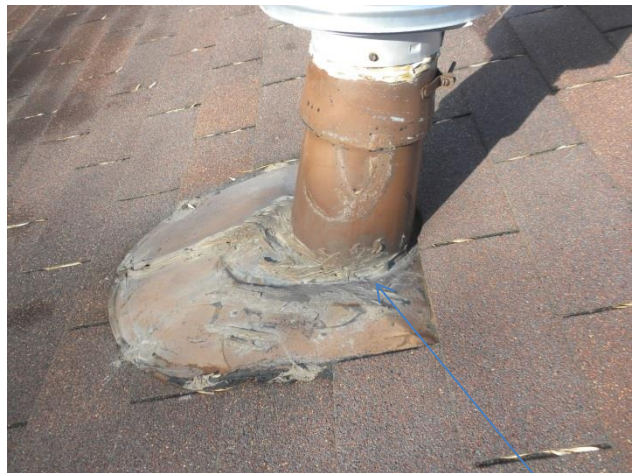
Figure 4

- shingles _____ ●
- flashing _____ ○.... tar patched old vents (figure 4)
- chimney _____ ○.... ash pit full of debris & not visible / flue tiles not visible

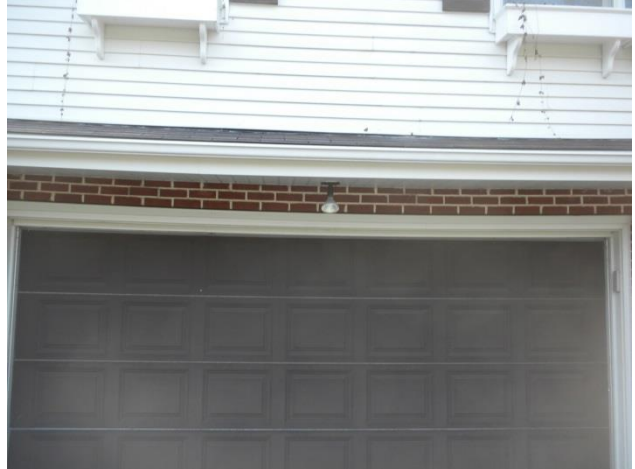
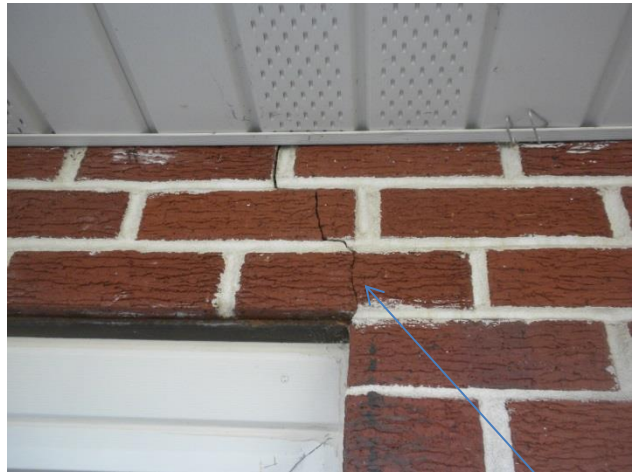
walls _____ ⊗.... sagged overhead door beam (figure 5-6) / opening in ceiling fire barrier (figure 7-9) / water damaged ceiling plaster located below baths (figure 8-10) / exposed styrofoam insulation / limited view

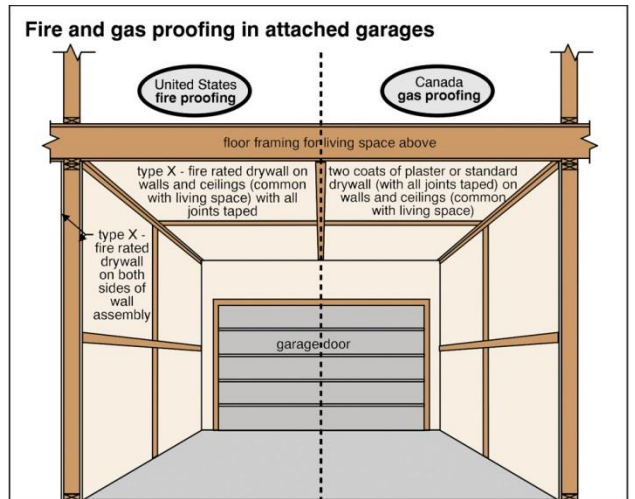
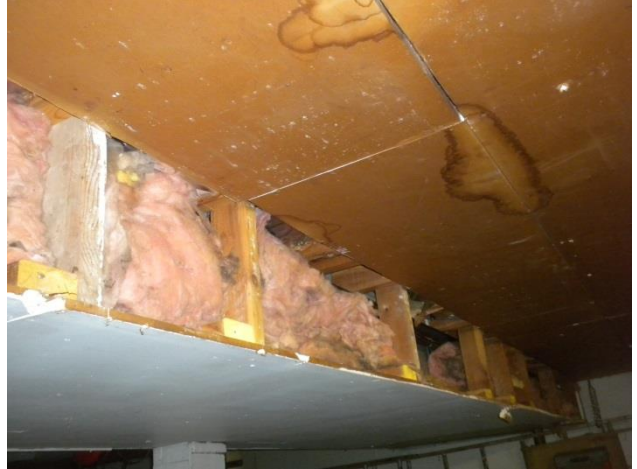
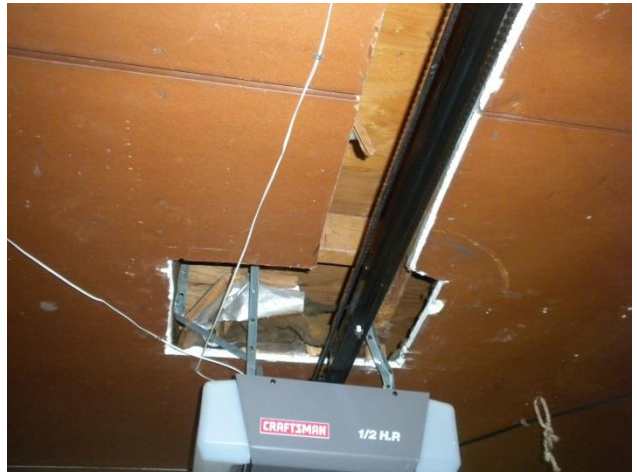
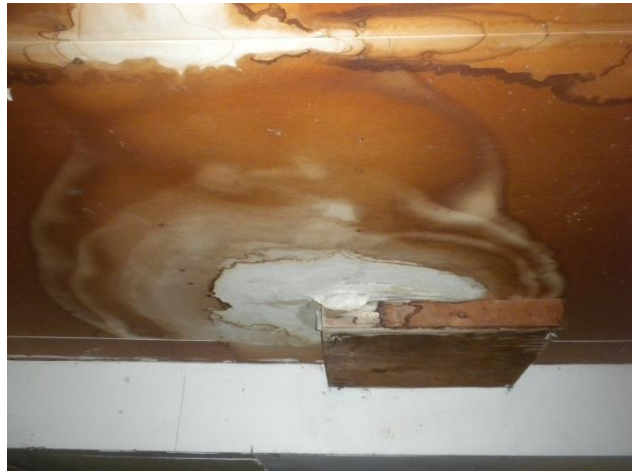
- ✓ Water damaged and open ceiling plaster (fire barrier).

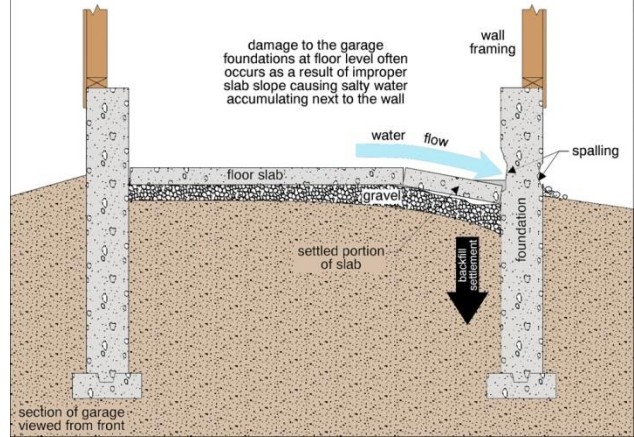
Figure 11

floor slab _____ ⊙.... settled & deteriorated concrete / ponding water on walls (figure 11) / limited view

Poor garage floor drainage

- ✓ Exposed styrofoam wall insulation.
- ✓ Settled and deteriorated floor slab. Ponding water on perimeter walls.
- ✓ Poor automatic opener bracket attachment to overhead door.

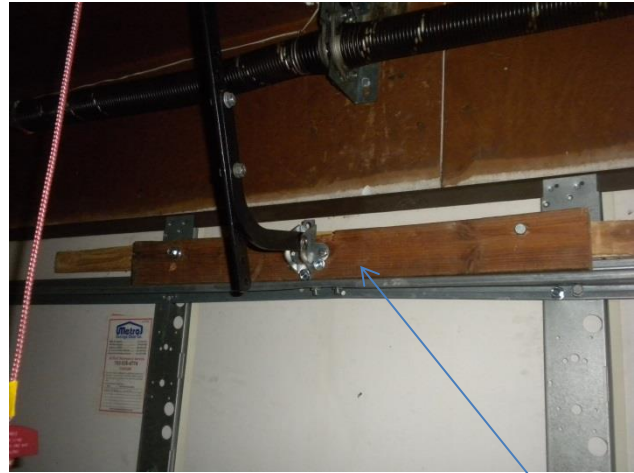
Figure 12

doors _____ ⊗.... poor automatic opener to door bracket (figure 12)

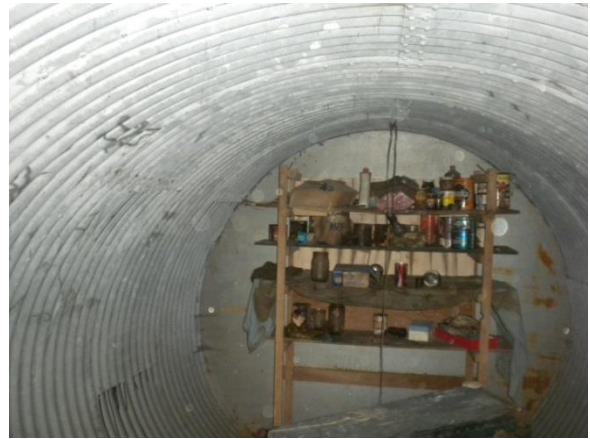
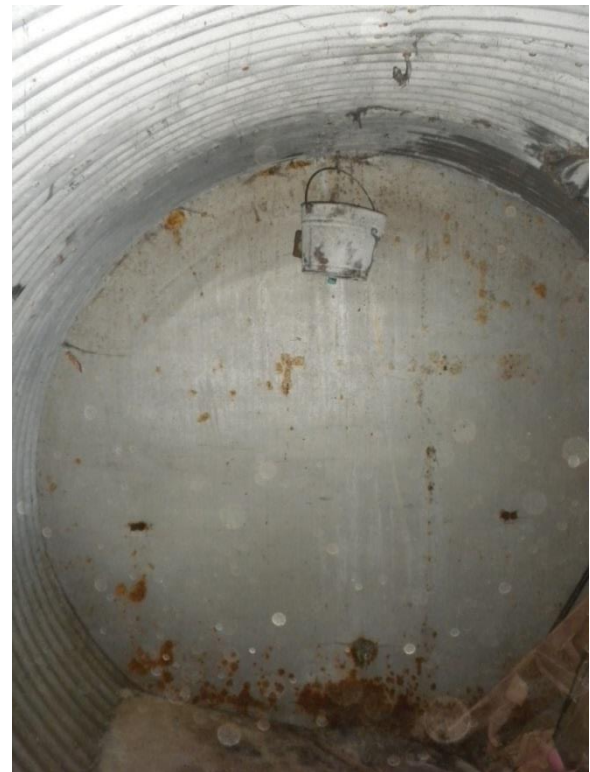
- walls_____ finished walls & not visible
- bomb shelter____ structural stability is unknown / rusted metal / water stained floor (figure 13-14)
- floor slab_____
- drain tiled_____ none

- ✓ Structural stability of bomb shelter is unknown. It is my recommendation that you seal off access to this space.

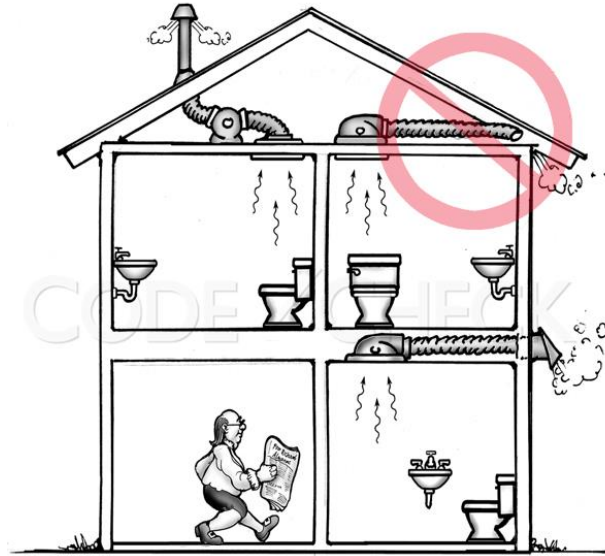
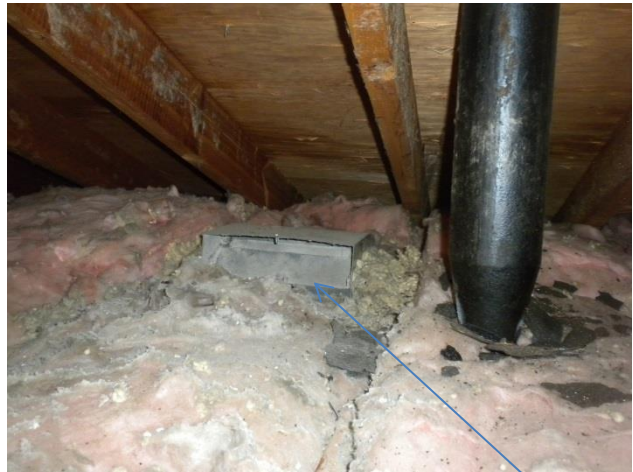
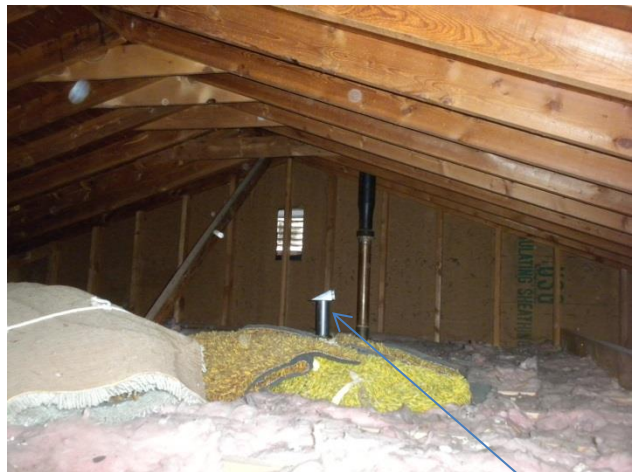
- rafters_____
- chimney_____ wood & chimney stains
- vent pipes_____ unvented bath fans (figure 15-17)

- ✓ Bath fans vented into attic.
- ✓ Water damaged, loose and missing garage ceiling insulation.

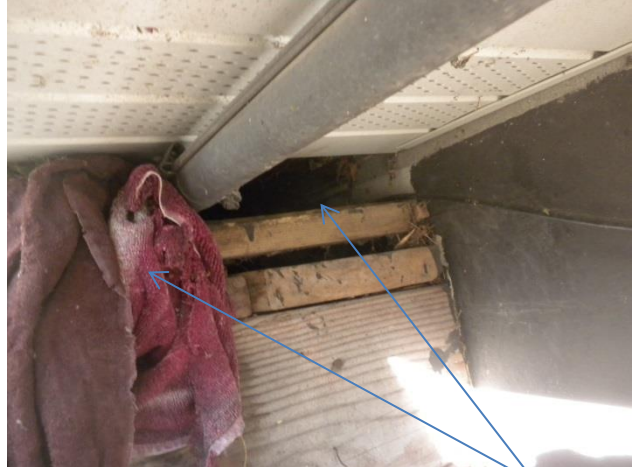
Figure 18

- basement_____ bypass at electrical panel (figure 18)
- floor and wall____ water damaged, loose & missing garage ceiling insulation
- attic_____ no overhang ventilation / ice dams / minimal insulation (figure 19)

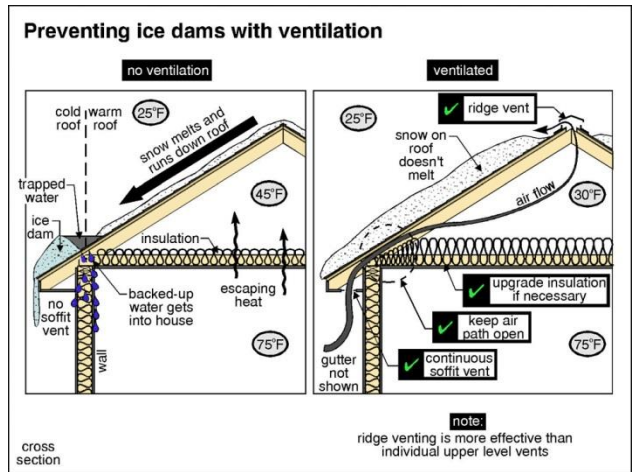
Figure 19

- ✓ Minimal amount attic insulation and ventilation (ice dams).

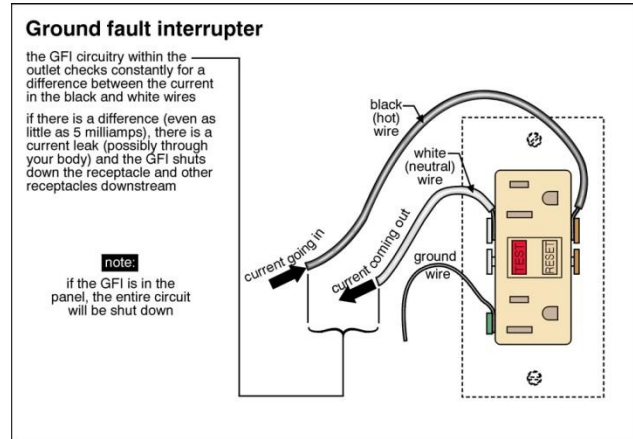
Figure 20

exterior _____ no GFI outlets (figure 20)

outlet and fixture _____ no GFI outlets (figure 20)

- ✓ No exterior, garage, and kitchen GFI outlets.
- ✓ Unprotected and extension cord garage wiring.

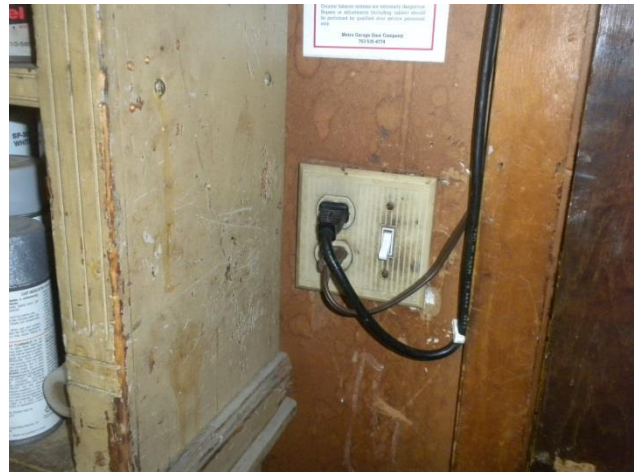
Figure 21

garage _____ extension cord wiring (figure 21) / no GFI outlets / unprotected wiring

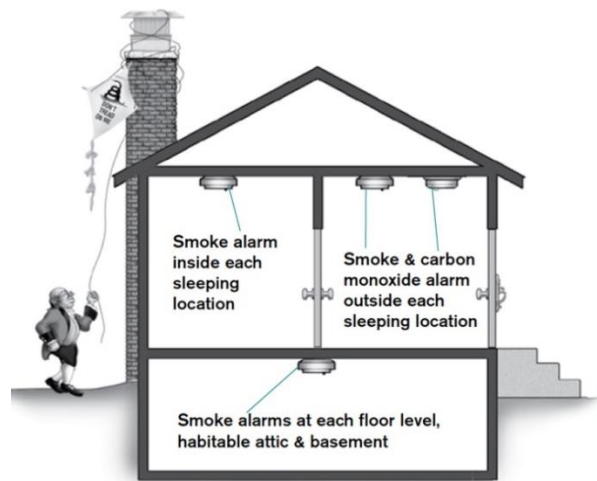
Figure 22

smoke _____ no basement, main level & bedroom smoke detectors (figure 22)

- ✓ Loose stair guardrail posts.
- ✓ Family room and bedroom windows do not stay open.
- ✓ Undersized fireplaces hearths and the mantels are too close to firebox opening.
- ✓ Building code now requires a smoke detector on every floor level and in each bedroom. State law requires a carbon monoxide detector within 10' all bedrooms.

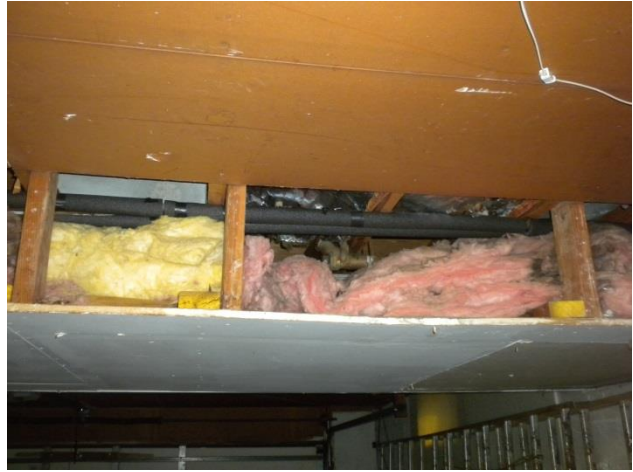
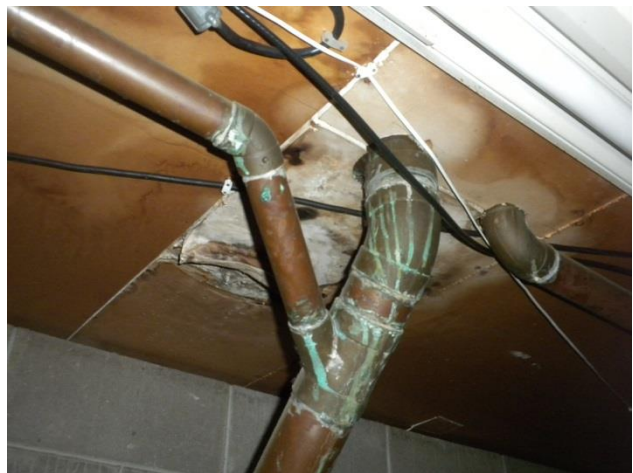
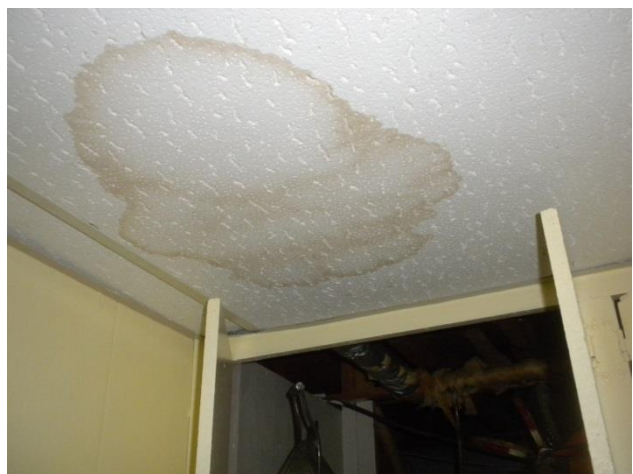
- soil stack_____ located in unheated space / leaking pipes (figure 23-25)
- drain/vent pipes__ located in unheated space / leaking pipes (figure 23-25) / missing floor drain cleanout plug
- laundry tub_____ plugged drain pipe

- ✓ Leaking pipes in garage ceiling and below bathrooms; licensed plumber needs to inspect and repair all broken, rusted and leaking pipes.

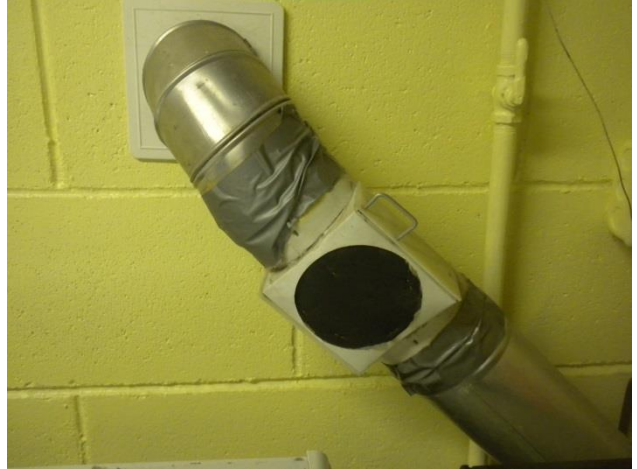
Figure 26

- water heater____ old / short useful life
- water softener__
- clothes washer__
- clothes dryer___ unapproved vent pipe damper (figure 26)

- ✓ Water, drain and waste pipes located in unheated and poorly insulated garage.
- ✓ Missing laundry room floor drain cleanout plug.
- ✓ Slow laundry tub drain.
- ✓ Old water heater; short remaining useful life.
- ✓ Unapproved clothes dryer vent pipe damper.
- ✓ No bathtub drain plug.

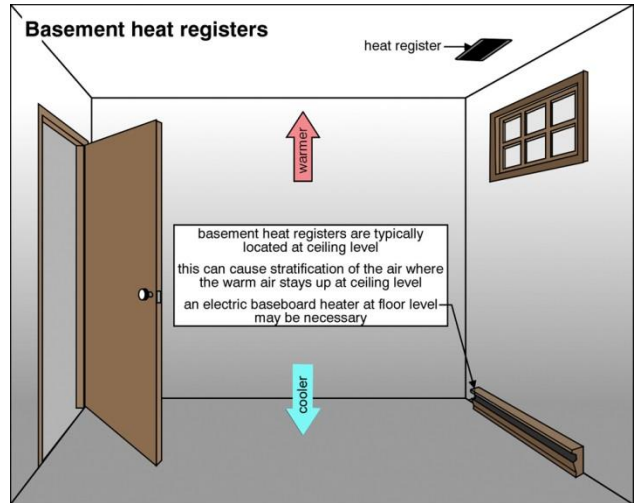
Figure 27

- jacket_____
- heat exchanger__
- distribution_____ no family room supply & return registers (figure 27)
- humidifier_____
- vent and flue_____

- ✓ No family room return and inadequate amount of supply air registers.

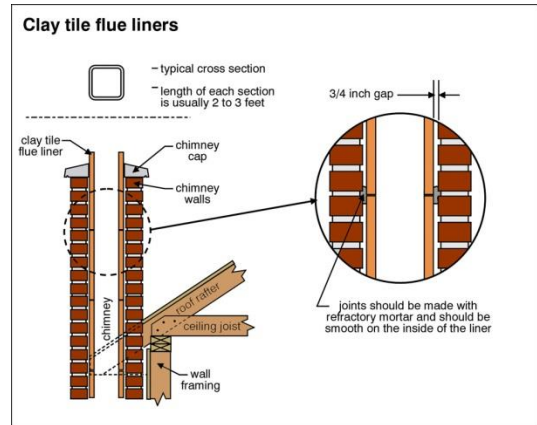
Figure 28

fireplace _____ inoperable damper / flue tile certification required (figure 28) / undersized hearth (figure 29) / mantel too close to fire box opening (figure 30)

- ✓ Condition of fireplaces flue tiles and combustible clearances are not visible; inspection and certification by a licensed fireplace contractor required.

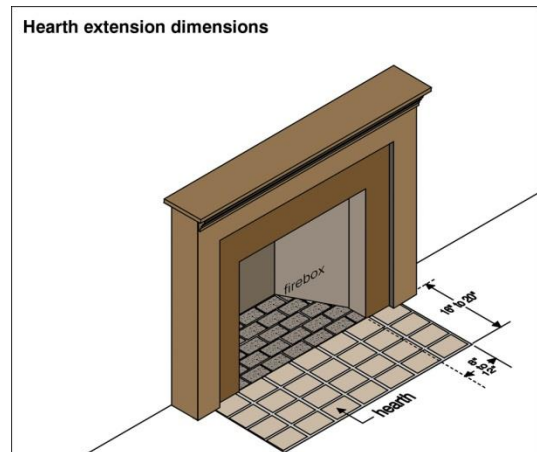
Figure 29

fireplace_____ undersized hearth (figure 29) / limited view flue tiles / mantel too close to fire box opening (figure 30)
