October 5, 2015

On 8/3/2015, Cities' Inspection Service, Inc. completed a home inspection of the property located at 123 Oak Street, Someplace, Minnesota for you. Doug Hastings did all the fieldwork related to this project. Doug used the national home inspection protocol; the American Society of Home Inspectors (ASHI) Standards of Practice.

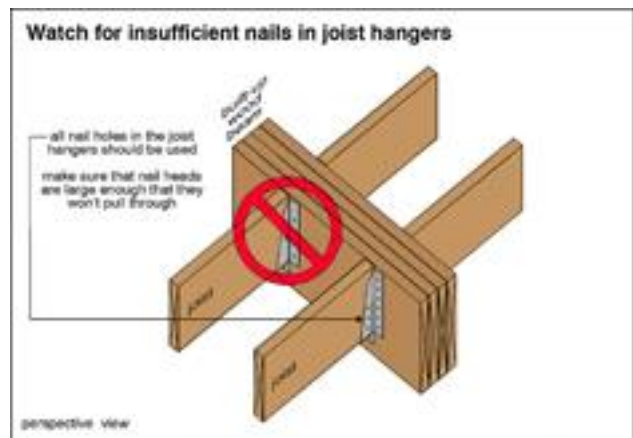
deck/porch \_\_\_\_\_ ⊗ .... rusted joist hanger nails

driveway \_\_\_\_\_ ○ .... patched & settled concrete

- ✓ Rusted wood deck metal floor joist hanger nails.

- ✓ Patched and settled driveway.

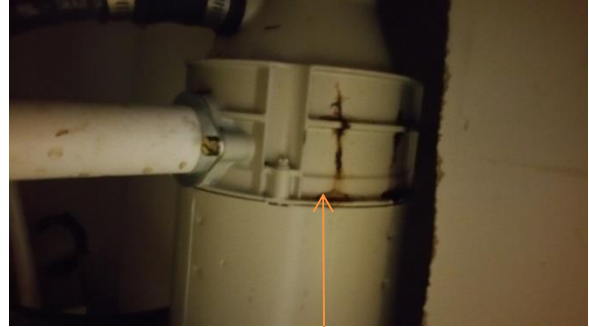
disposal \_\_\_\_\_  .... cracked & leaking

Cracked & leaking disposal

- ✓ Cracked and leaking disposal.
