October 5, 2015

On 9/14/2015, Cities' Inspection Service, Inc. completed a building inspection of the property located at 123 Oak Street, Someplace, Minnesota for you. Doug Hastings did all the fieldwork related to this project. Doug used the commercial inspection protocol; the Standard Guide for Property Condition Assessment – ASTM Standard E2018-01.

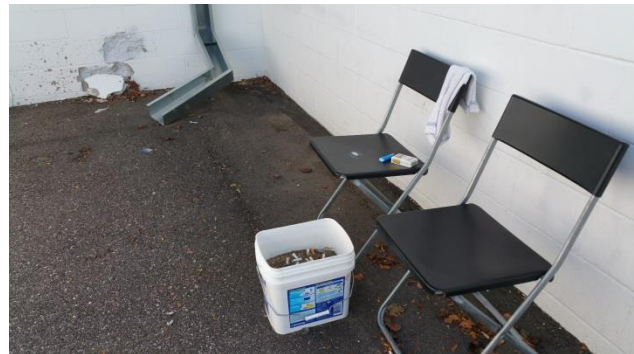
grading_____ ✗.... flat grade (east side) / flat asphalt (north side)
 planters_____ ✗.... deteriorated bricks / decayed wood timbers

Flat asphalt (north side)

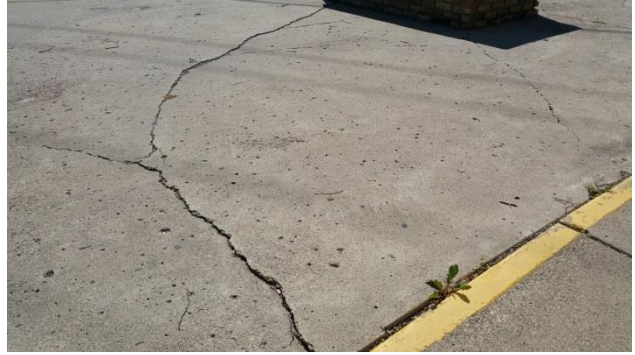
walks_____ ✗.... cracked & settled concrete (city assessment) / negative slope
 handicap ramp___ ●
 fence_____ ✗.... bent posts & mesh

Cracked & uneven city sidewalk (assessment)

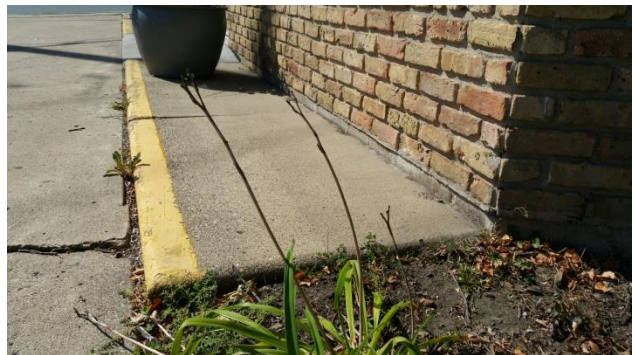
Negative curb slope

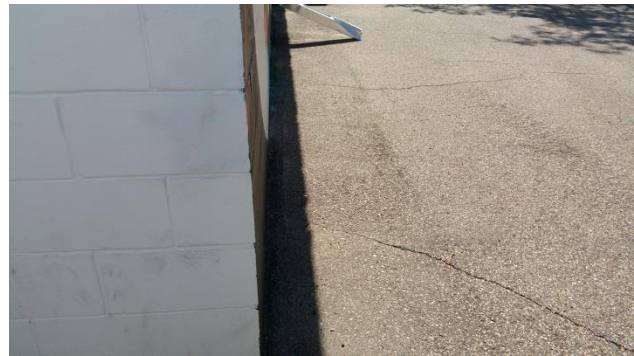
Flat parking surface

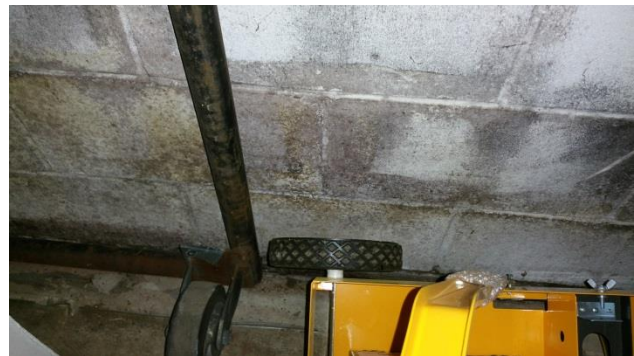
Water stained blocks

- ✓ Water stained foundation blocks (north side).
- ✓ Dryer vent is a breach in the fire barrier.
- ✓ Overhead door opener does not have safety reverse.
- ✓ Rusted out service door frame.

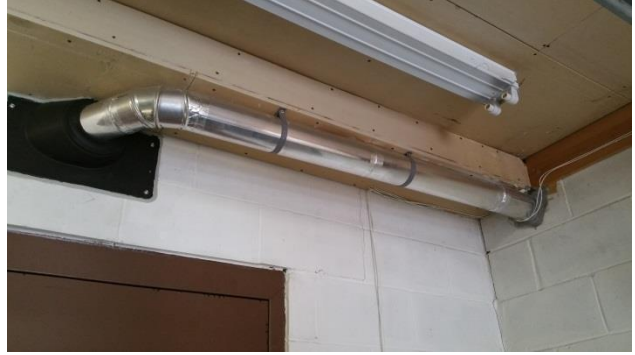
Unprotected dryer vent

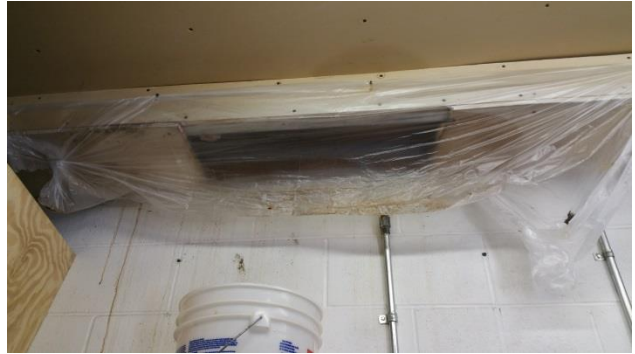
Water damaged ceiling plaster

- ✓ Water damaged garage ceiling plaster (fire barrier).

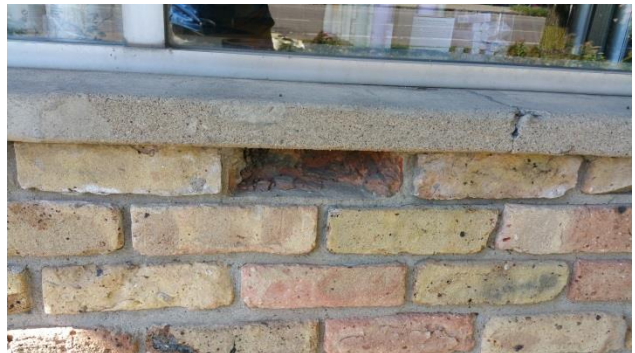
Deteriorated bricks

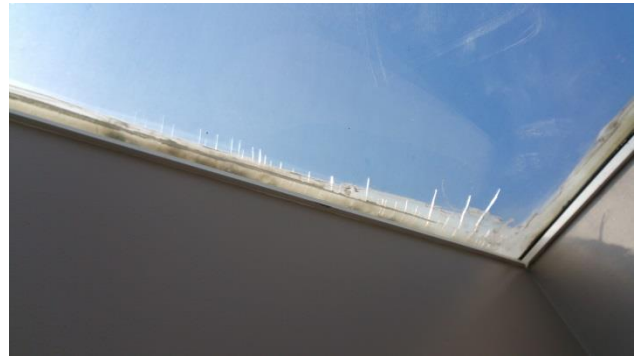
skylights _____ ☒.... cracked & leaking glass (8) / caulked glazing (2)

Cracked skylights

- ✓ Cracked and settled city sidewalks (property assessment).
- ✓ Deteriorated wood wall shakes.
- ✓ Broken section of front window glass.
- ✓ Deteriorated and patched tar and gravel roof membrane. Worn out and patched curbs and flashings. Replace roof.
- ✓ Cracked and leaking 8 out of 10 skylights. The 2 remaining skylights are excessively caulked at the frame to glass connection. Recommend replacing skylights.

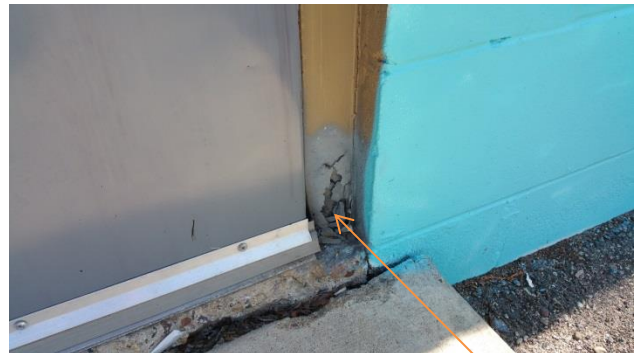
garage service _____ ☒.... rusted frame

Rusted frame

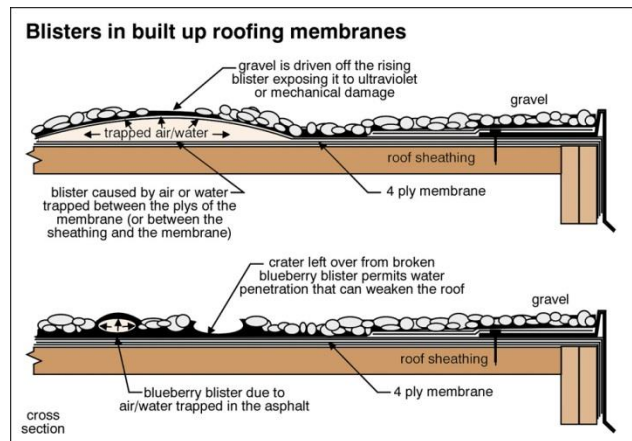
Flat roof alligating

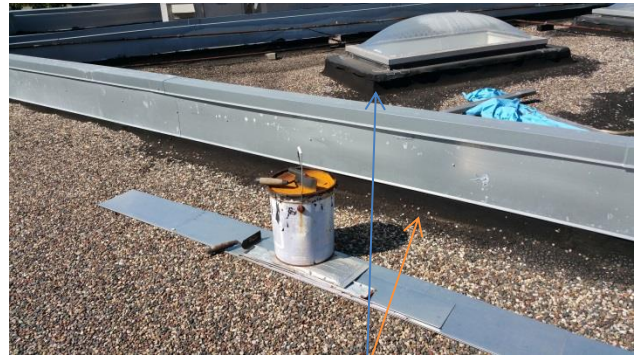
Tar coating perimeter curbs

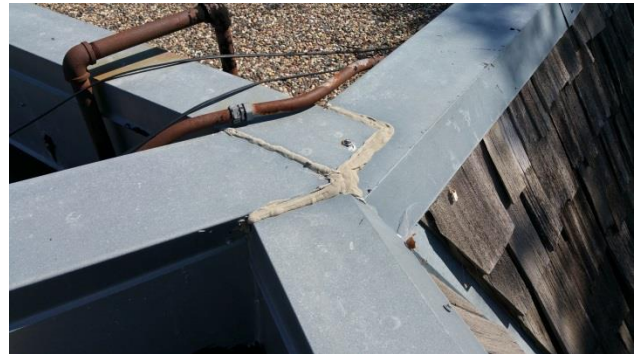
Loose metal coping

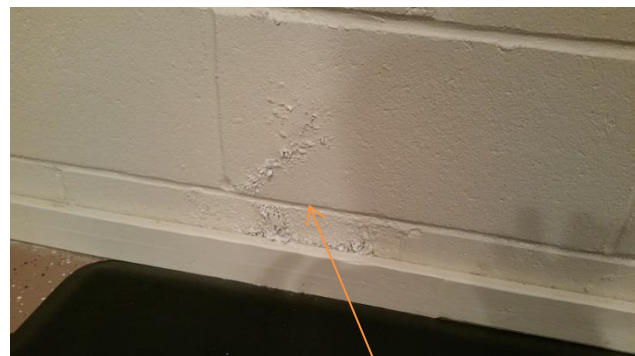
Water stained north wall

- ✓ Water stained basement wall.

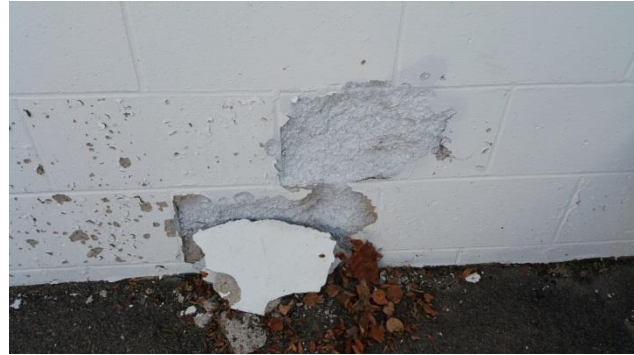
Deteriorated exterior blocks

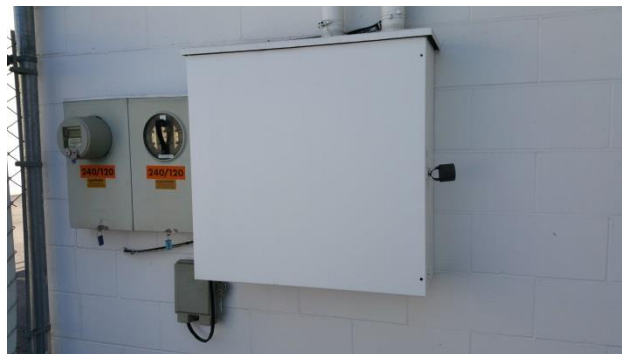
Utility locked & not visible

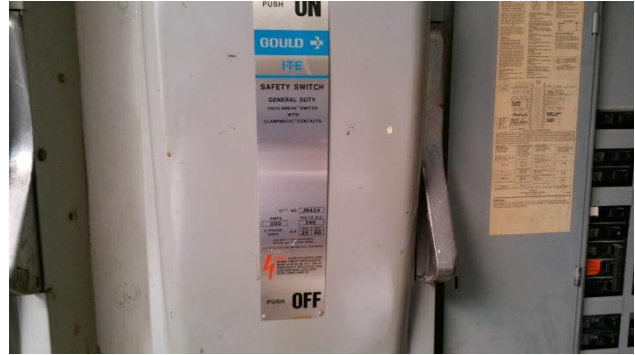
3 phase panel locked & interior not visible

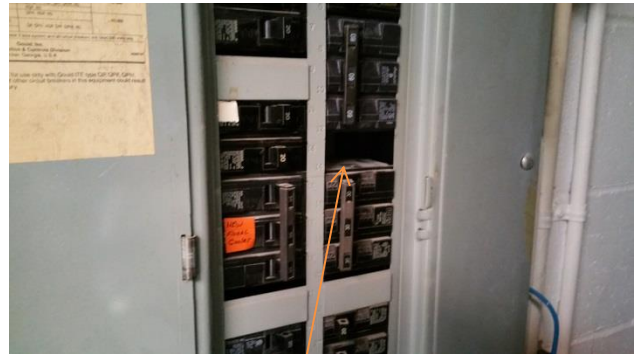
Missing circuit breaker knockouts

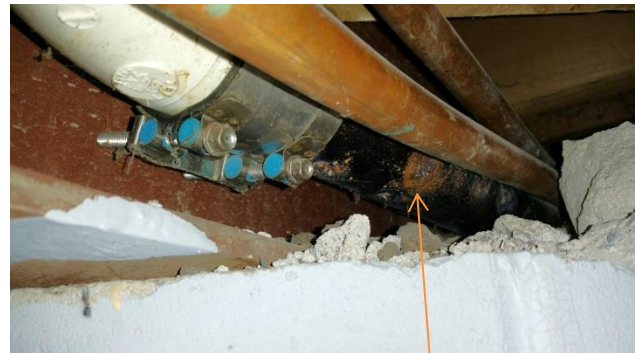
Corroded drain pipe

- ✓ Corroded basement drain pipe.
- ✓ Leaking water heater pipe connection.

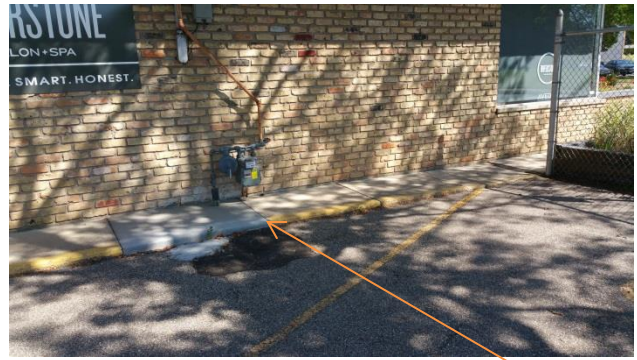
No bollard

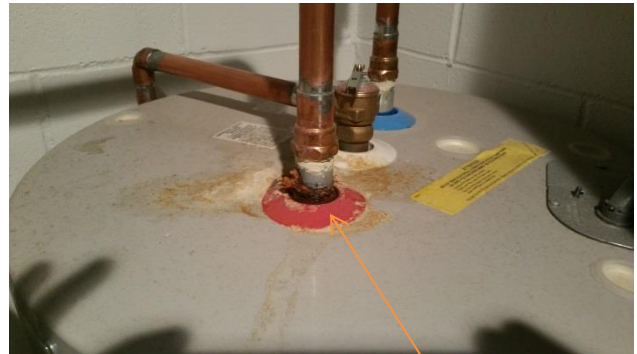
water heaters___⊗.... leaking pipe connection

Leaking water pipe

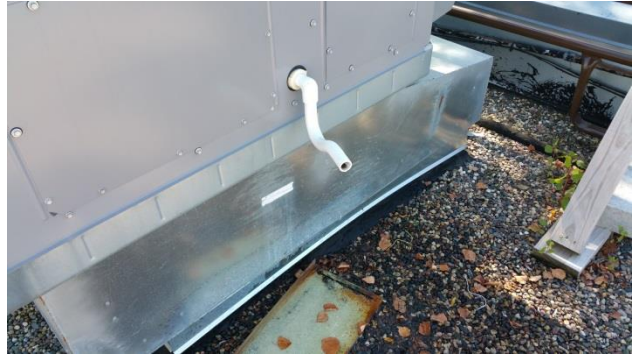
No condensate drain line

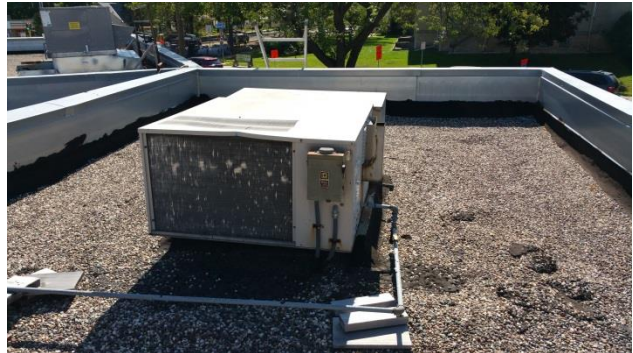
Inoperable air conditioner

- ✓ Old garage roof top furnace; short useful life. Inoperable garage roof top air conditioner.

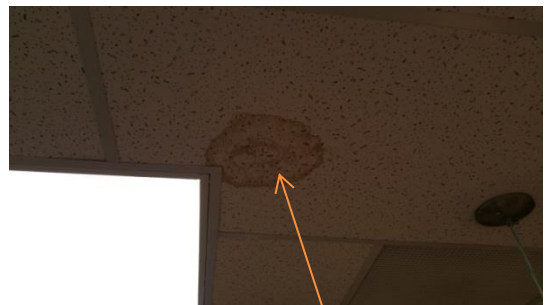
- wall, ceiling, floor___⊗.... water stained ceiling tiles
- window and door___●
- outlet and fixture___●
- heat_____●

Water stained ceiling
