October 5, 2015

On 8/3/2015, Cities' Inspection Service, Inc. completed a home inspection of the property located at 123 Oak Street, Someplace, Minnesota for you. Doug Hastings did all the fieldwork related to this project. Doug used the national home inspection protocol; the American Society of Home Inspectors (ASHI) Standards of Practice.

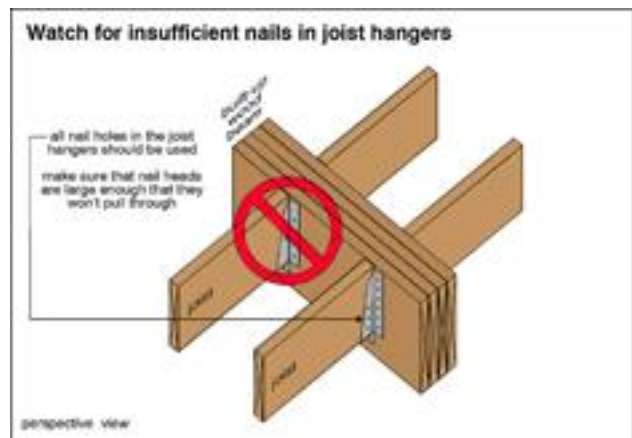
deck/porch _____ ⊗ rusted joist hanger nails

- ✓ Rusted wood deck metal floor joist hanger nails.

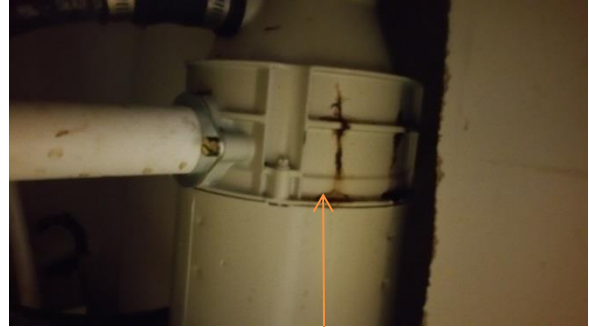
disposal _____ cracked & leaking

Cracked & leaking disposal

- ✓ Cracked and leaking disposal.
