On 4/27/2018, Cities' Inspection Service, Inc. completed a building inspection of the property located at XXXXXXXX, XXXXXXXXXX, Minnesota for you. Doug Hastings did all the fieldwork related to this project. Doug used the commercial inspection protocol; the Standard Guide for Property Condition Assessment – ASTM Standard E2018-01.

Building: 1 level 10 unit apartment	Parking: 15 spaces	Approx. age: 58 years
Wall covering: veneer bricks	Layers: 1	Approx. age: 58 years
Windows: slider	Glass: 1 pane	Approx. age: 58 years
Roof covering: PVC single ply plastic	Layers: 1	Approx. age: 15 years

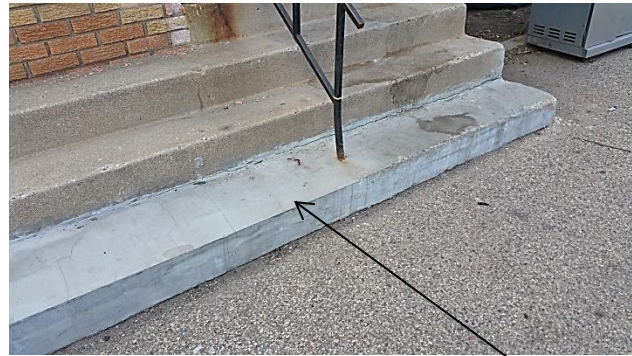
steps and walks\_\_ ⊗.... deteriorated rear steps / patched front step

Rear steps

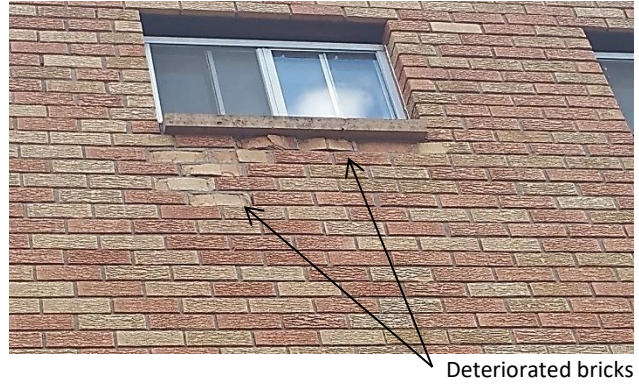
bricks\_\_\_\_\_ ⊗.... deteriorated bricks below windows & AC boxes / rusted lintels  
 AC sleeves\_\_\_\_\_ ⊗.... flat, not weather tight & no winter cover  
 flashing/caulking\_ ⊙

Deteriorated bricks

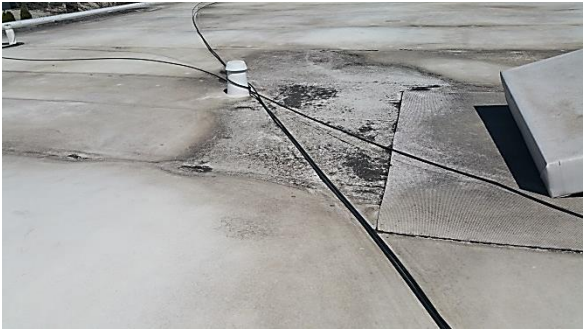
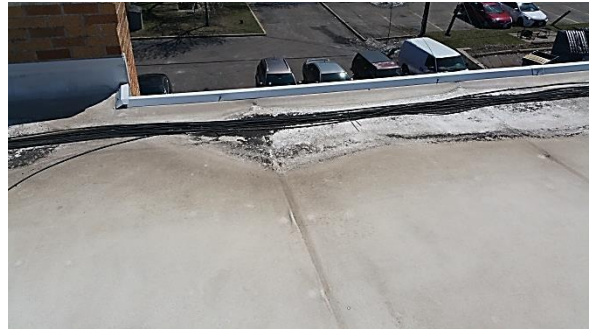
- drainage \_\_\_\_\_ ☒.... ponding water
- materials \_\_\_\_\_ ☒.... loose & buckled insulation
- flashings \_\_\_\_\_ ☉
- chimney \_\_\_\_\_ ☒.... deteriorated bricks
- gutters \_\_\_\_\_ ☉.... missing downspout extensions / peeled paint

Ponding water

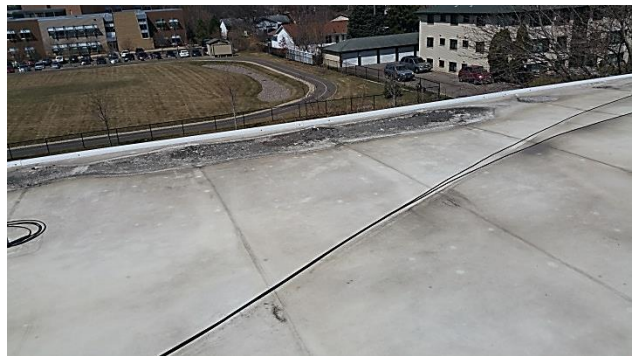
Buckled insulation

- ✓ Earth grade does not slope away from the lower level (moisture intrusion).
- ✓ Deteriorated and top coated rear entry concrete steps.
- ✓ Water damaged wall bricks below windows and AC boxes (moisture intrusion).
- ✓ Single pane windows and no thermal break (moisture intrusion).
- ✓ Damaged and flat AC thru wall sleeves (moisture intrusion). No insulated winter covers (moisture intrusion).
- ✓ Leaking front and rear entry portico roofs.
- ✓ Loose and buckled roof insulation, loose PVC membrane and no ballast.
- ✓ Deteriorated chimney bricks.

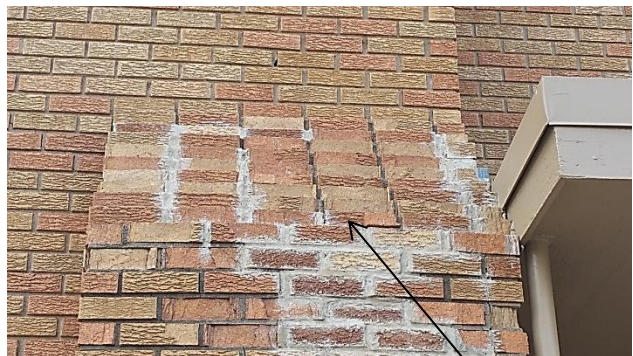
Chimney bricks

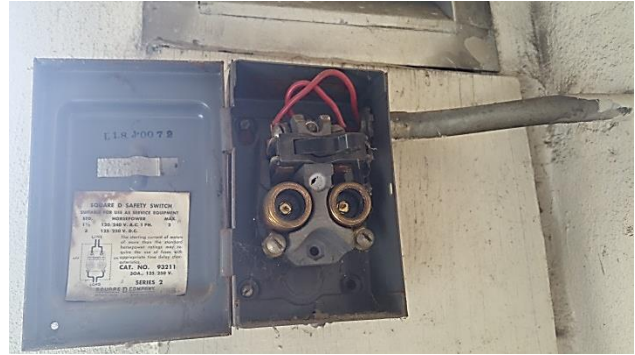
basement \_\_\_\_\_ ○.... unsecured junction panel

Junction panel

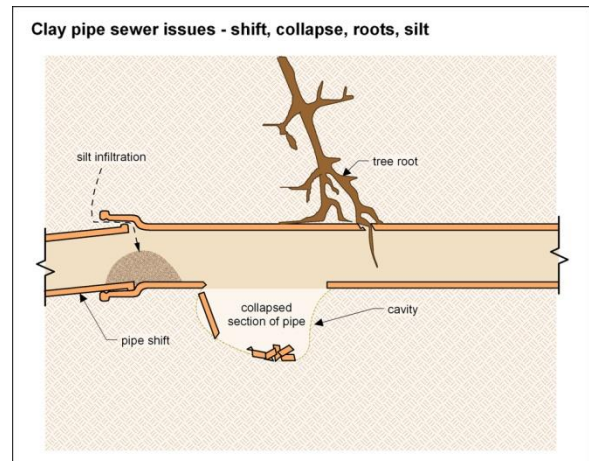
- sewer \_\_\_\_\_ ⚠..... not visible / recommend contractor camera scope pipe to street
- soil stack \_\_\_\_\_ ⚠..... not visible
- drain/vent pipes \_\_\_\_\_ ⊗..... missing floor drain cleanout plug / temporary bathtub drain pipe to floor repair
- laundry tub \_\_\_\_\_ ⊗..... temporary drain pipe repair

Sewer concern

- ✓ Building; all units are extensively moisture damaged; recommend invasive testing.
- ✓ Old sewer pipes can fail; recommend you hire a contractor to camera scope the underground pipe.
- ✓ This is not a pollution or environmental inspection.

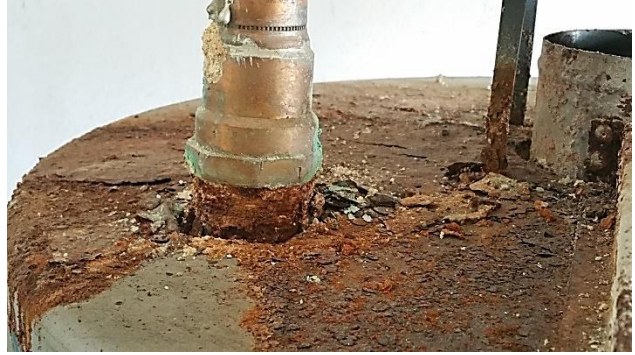
water heater \_\_\_\_\_ ⊗..... rusted & leaking water pipe connection / inoperable vent damper / slugging

Water heater

- ✓ Temporary slop tub drain pipe to floor connection repair. Temporary drain pipe to concrete tub repair.
- ✓ Corroded water heater (replace).

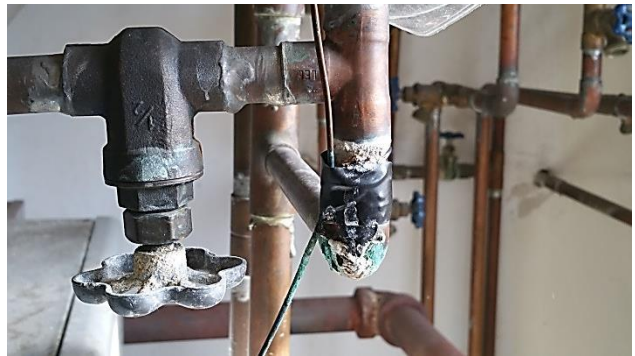
Leaking water pipe

- ✓ Low boiler water pressure.
- ✓ Rusted and leaking water pipe.

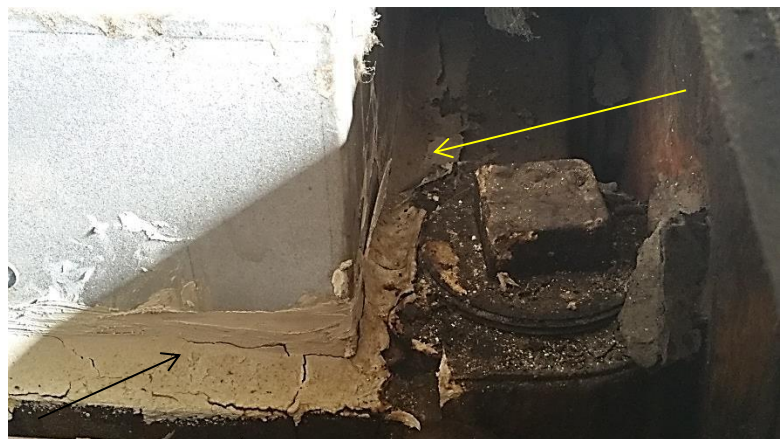
- jacket \_\_\_\_\_ ○.... painted & hot jacket / old (short useful life)
- heat exchanger\_\_ ⊗.... temporary cast iron repairs
- distribution \_\_\_\_ ⊗.... low water pressure / rusted & leaking water pipe
- expansion tank\_\_ ●
- pump \_\_\_\_\_ ●
- 10 zone controls\_ ⚠.... not tested
- vent and flue \_\_\_ ⊗.... temporary vent connector repairs

Temporary cast iron repairs

- ✓ Temporary old boiler repairs (short useful life).

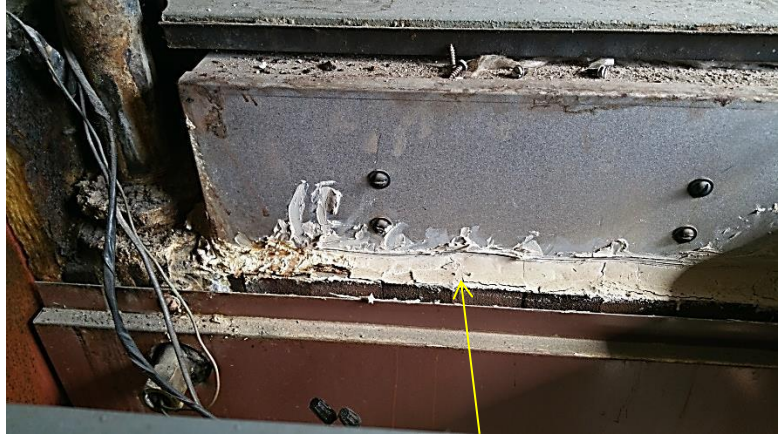
Temporary vent connection repair

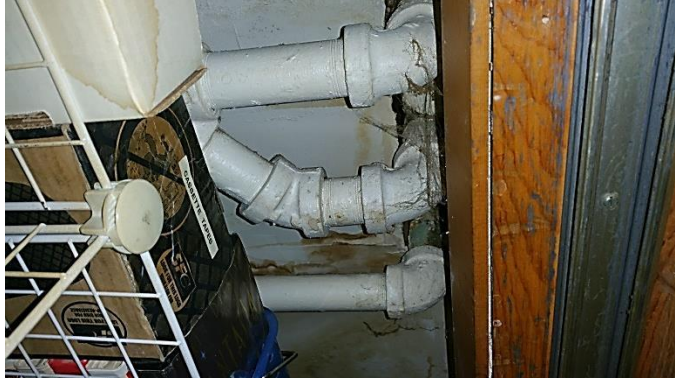
- wall, ceiling, floor \_\_\_\_\_ ⊗.... water damaged ceilings & walls, below bath, foundation wall, air conditioner, bathtub wall plaster & tile
- window and door \_\_\_\_\_ ⊗.... no window thermal breaks & single pane / fire door out of adjustment / damaged & missing doors
- outlet and fixture \_\_\_\_\_ ◉.... missing covers
- heat \_\_\_\_\_ ⊗.... damaged radiator covers
- plumbing \_\_\_\_\_ ◉.... temporary bath sink drain pipe repair
- cabinet and top \_\_\_\_\_ ◉.... worn wood / unfinished countertop edges

Below bath

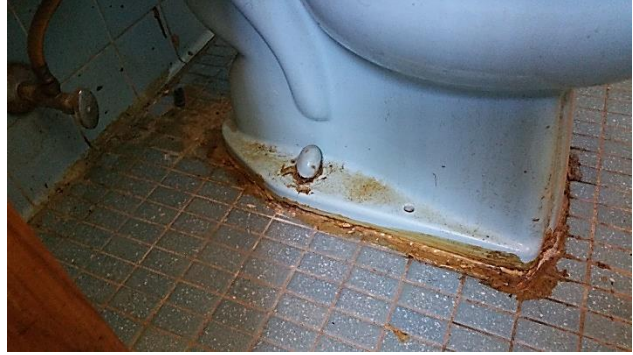
Leaking toilet

- ✓ Leaking toilet. Slow bathtub drain.

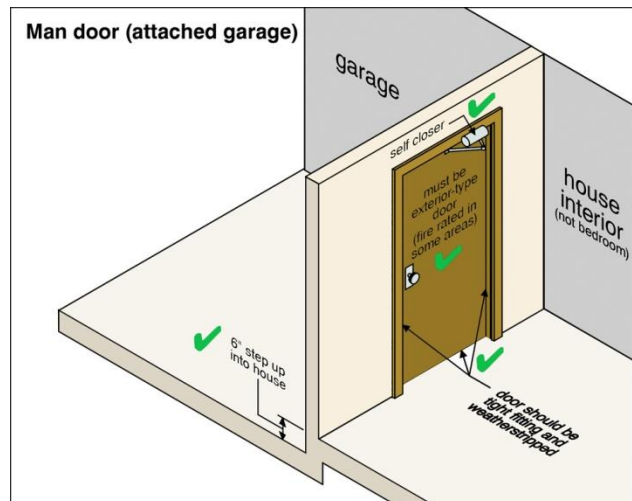
Fire doors

- ✓ Damaged doors. Hallway fire door out of adjustment.
- ✓ No bath GFI outlet.
- ✓ Disconnected kitchen fan vent pipe.

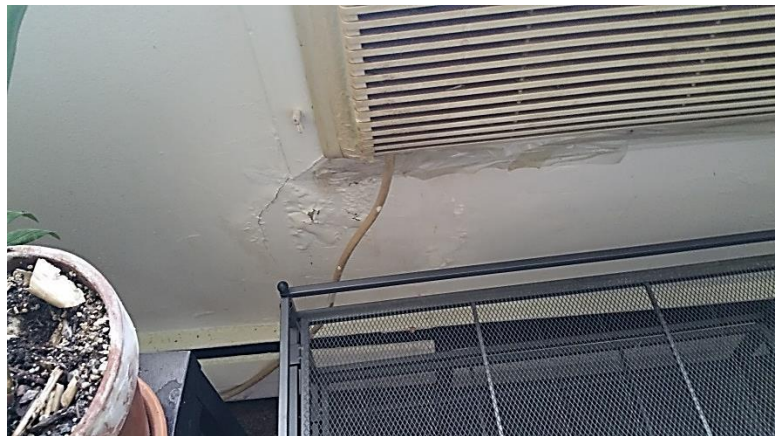
Damaged plaster at AC

- ✓ Extensive water damage to ceilings, walls, and floor. Biggest problems around windows, air conditioners, bathtub walls and tiles.
