September 1, 2019

On 8/27/2019, Cities' Inspection Service, Inc. completed a home inspection of the property located at XXXXX, XXXXXXXX, Minnesota for you. Doug Hastings did all the fieldwork related to this project. Doug used the national home inspection protocol; the American Society of Home Inspectors (ASHI) Standards of Practice.

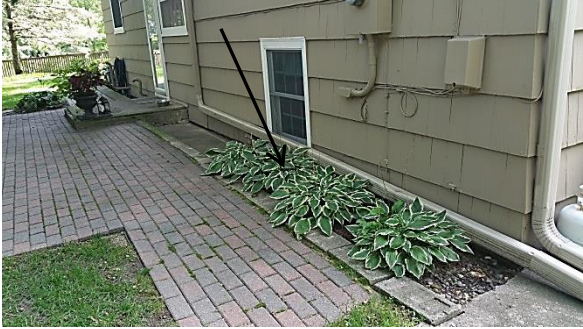
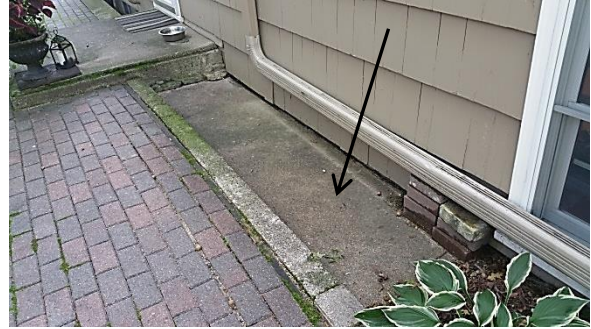
Rear – ponding water

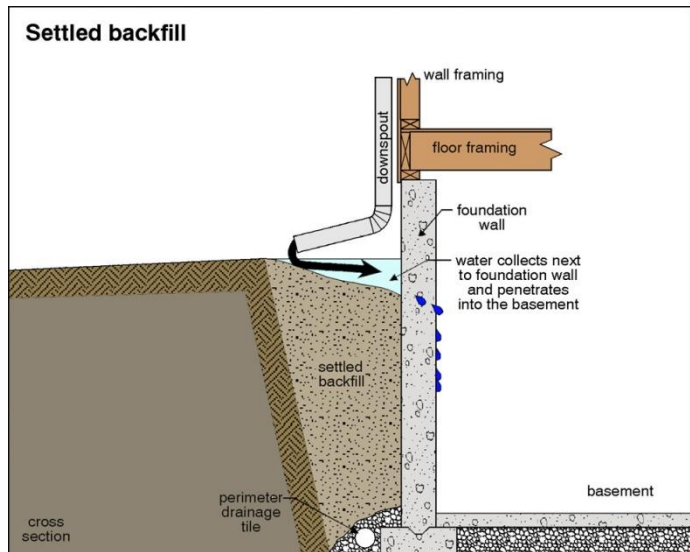
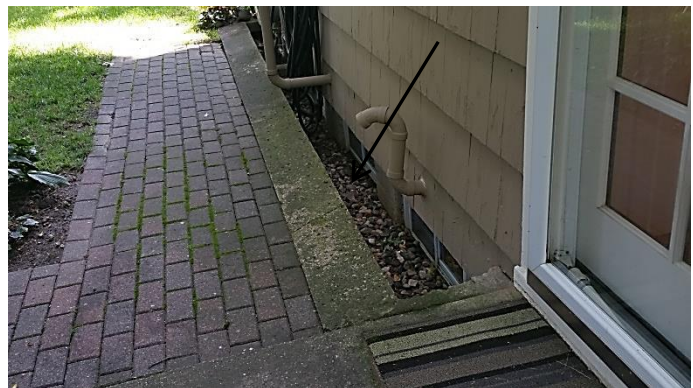
- front _____ ●
- left side _____ ⊗.... negative slope
- right side _____ ●
- rear _____ ⊗.... ponding water on foundation

Rear – ponding water

- ✓ Earth grade does not slope away from and is ponding water on the foundation (basement, lower level, and garage moisture intrusion). Only the portions adjacent to the lower level bedroom and garage can be corrected.
- ✓ Loose, tipped and bowed retaining walls.

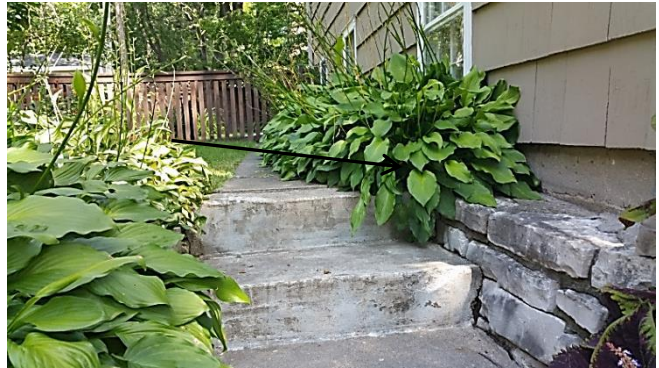
Walk – negative slope

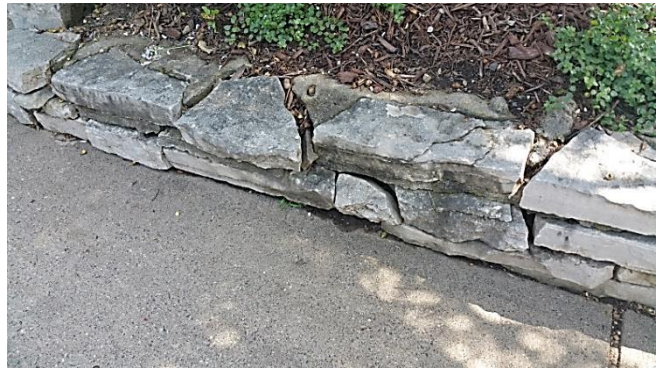
Retaining wall – loose stones

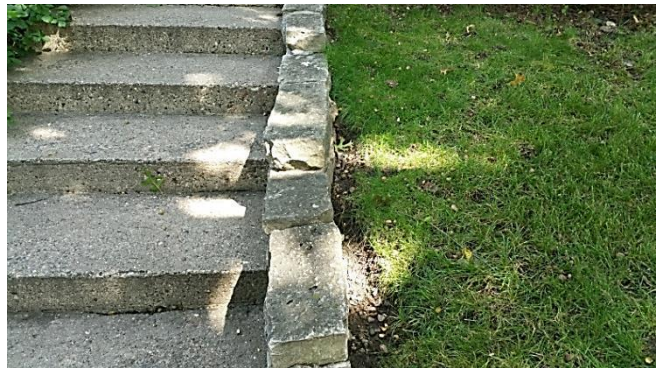
Retaining wall – tipped stones

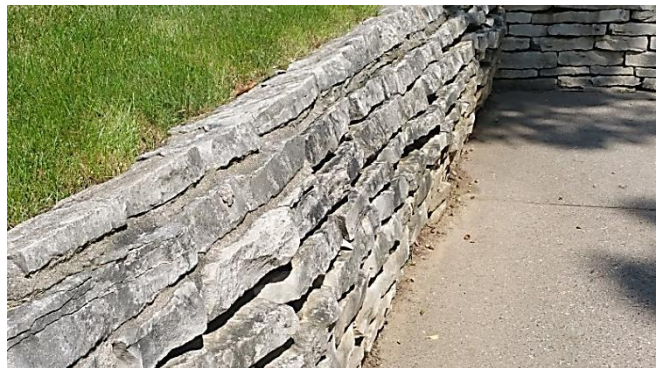
Retaining wall – bowed stones

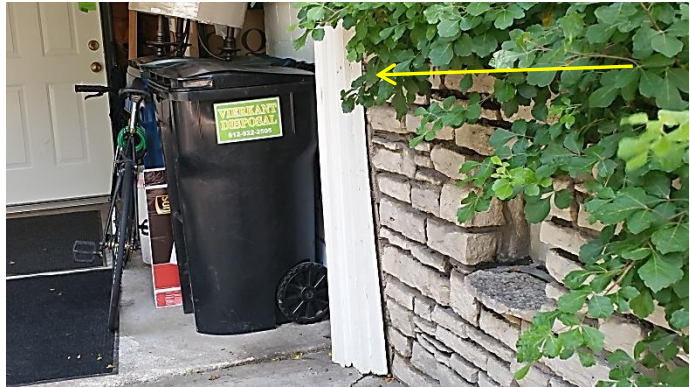
Retaining wall – tipped stones

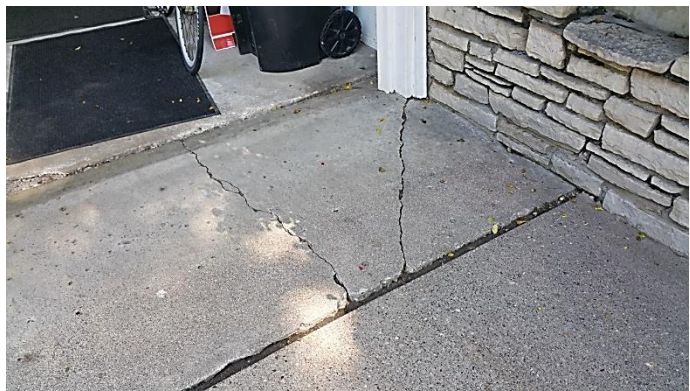
Cracked driveway apron

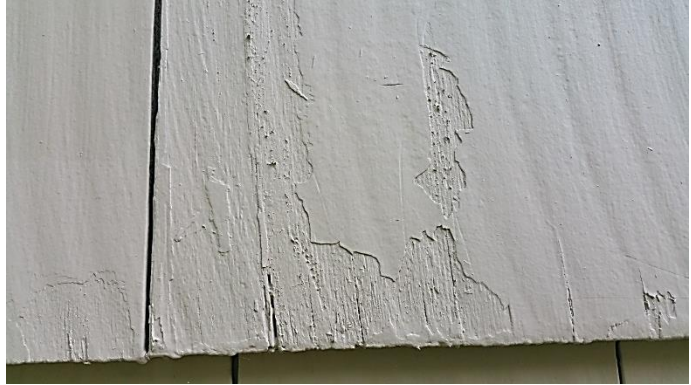
Weathered wood

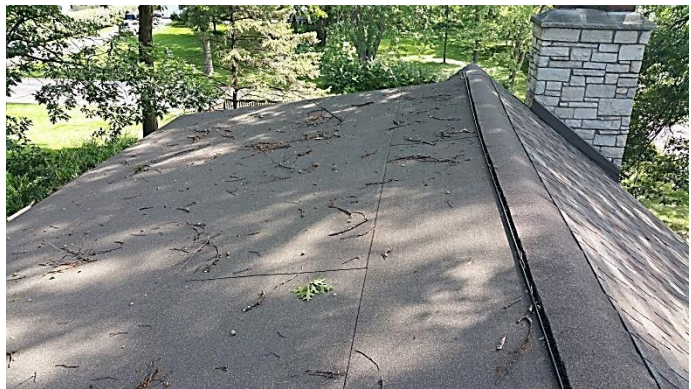
Low slope roof – no problems

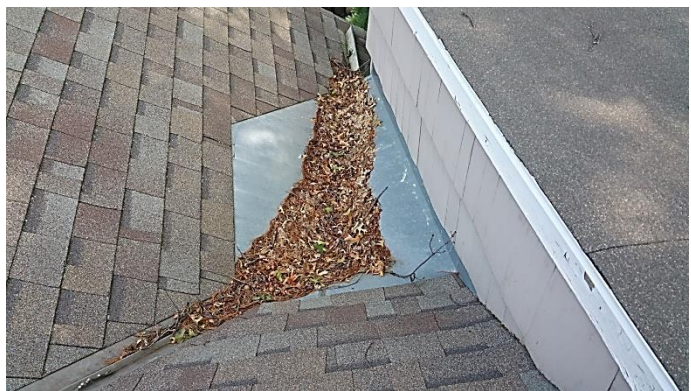
Restricted drainage – ice dams

- ✓ No front entry and garage step handrails.
- ✓ Cracked driveway apron.
- ✓ Decayed fence posts and boards.
- ✓ Deteriorated shed roof shingles.
- ✓ Cracked paint and weathered wood wall shakes and trim (high maintenance).
- ✓ Missing roof gutter guards; plugged gutters.
- ✓ Restricted rear roof valley drainage (ice dams); this is a built in design deficiency and cannot be corrected.

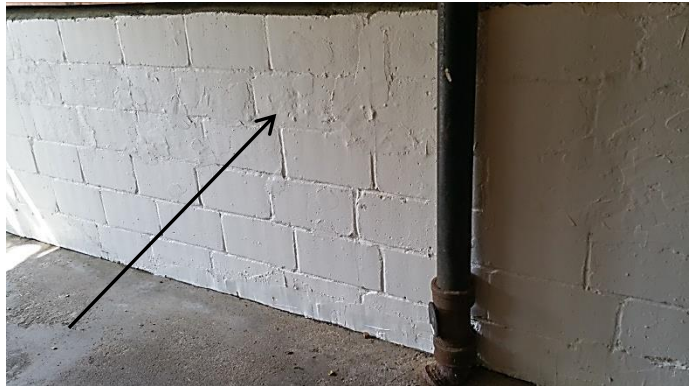
Patched blocks (water damaged)

- ✓ Water damaged foundation blocks and water stained wood paneling.
- ✓ Unprotected heat duct (not fire rated). Wood wall paneling is not fire rated.
- ✓ Water stained ceiling below upper bath.

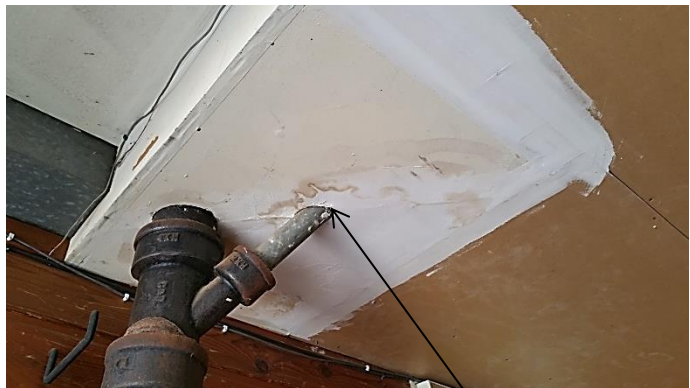
Water stained ceiling

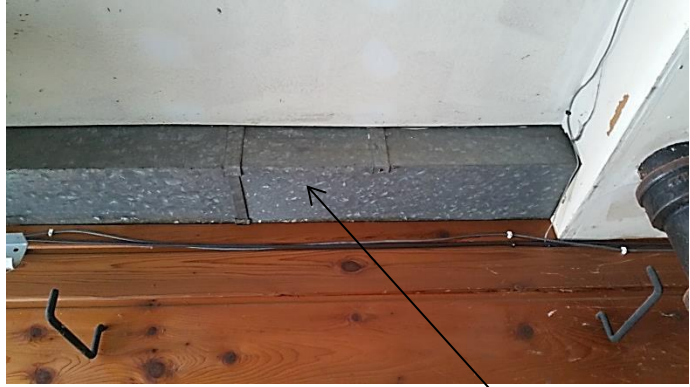
Unprotected duct

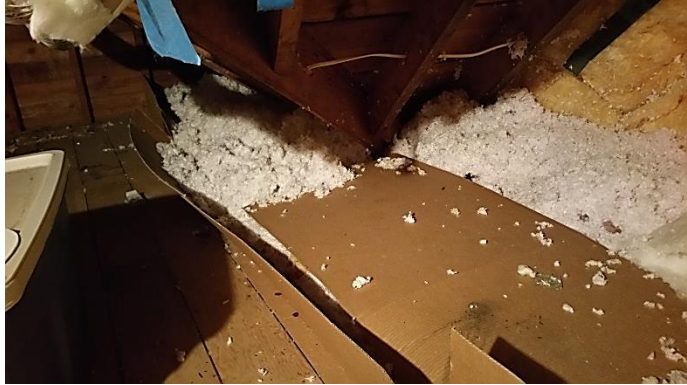
No ventilation

- ✓ Inadequate amount attic insulation and ventilation (ice dams and moisture intrusion). The existing improvements are poor. A good portion of the attic is inaccessible and will be difficult to correct.

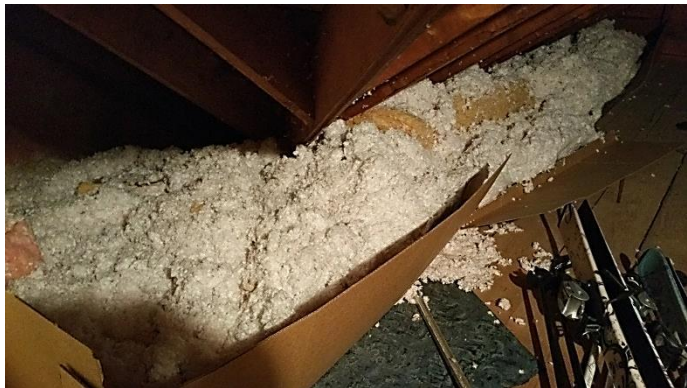
No ventilation

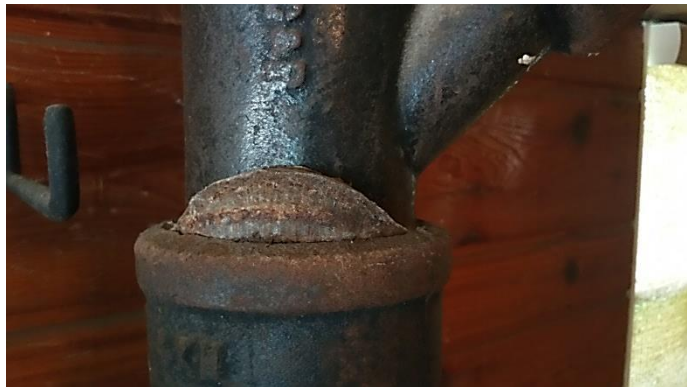
Loose lead connection

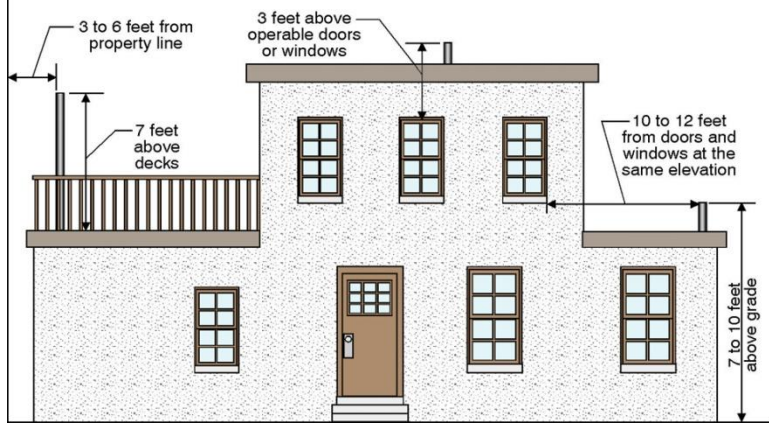
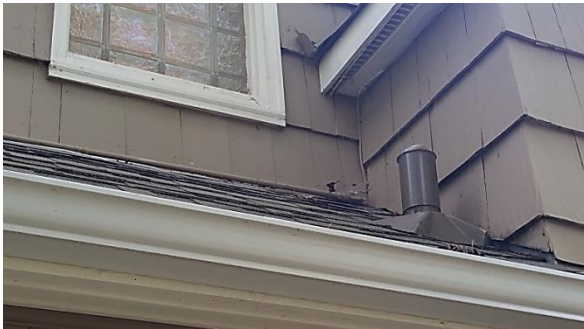
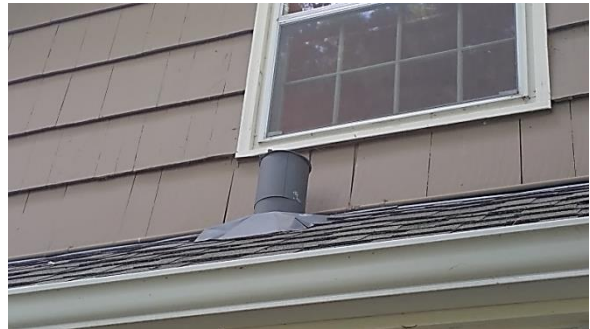
Too close to window

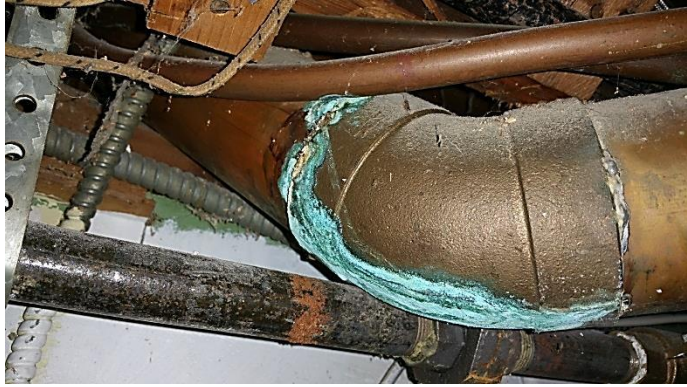
Leaking pipe

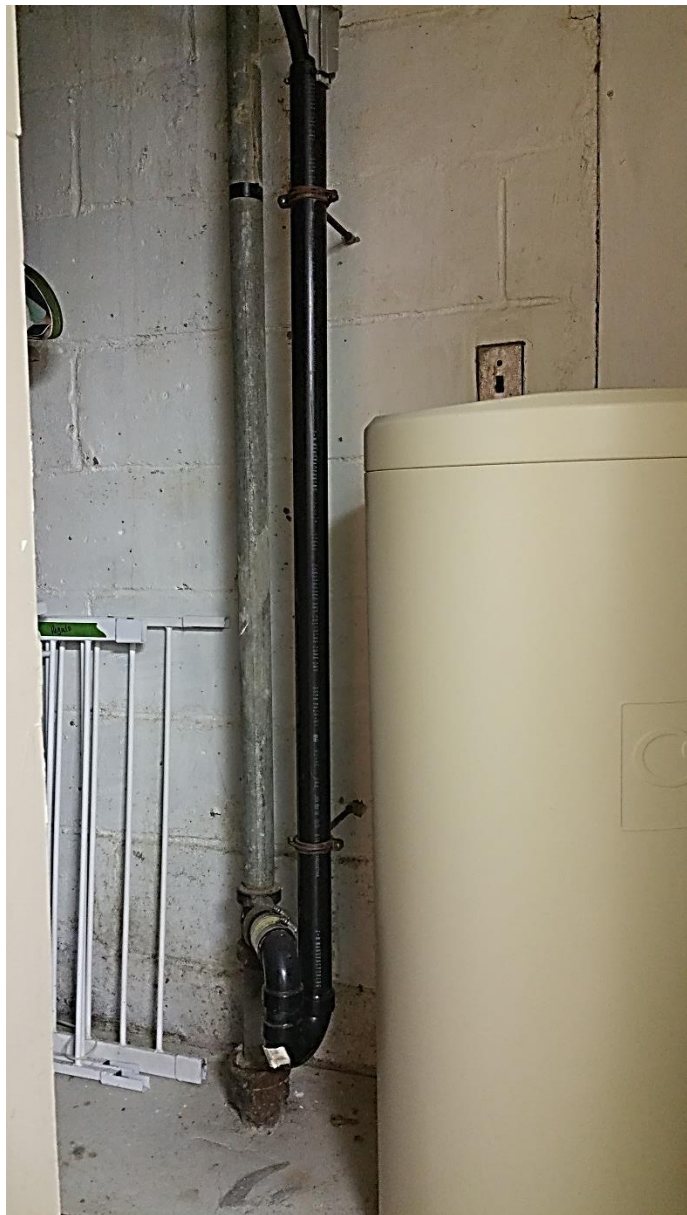
Standpipe too high

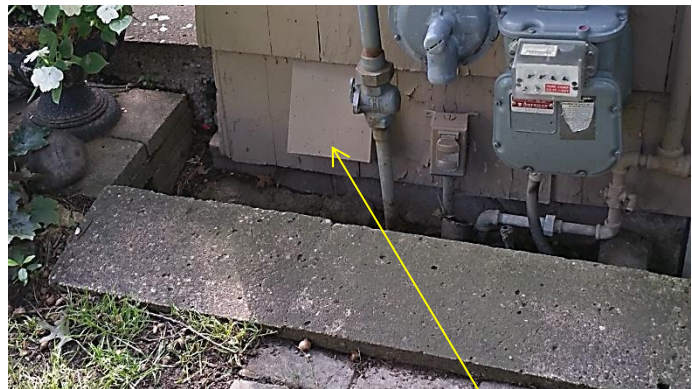
Too close to ground

- ✓ Furnace outside air supply exterior vent cover is too close to grade (snow will block).
- ✓ No lower level bedroom supply and return air registers. Inadequate amount upper top level supply registers and no return air register. No upper level top bath supply air register.
- ✓ One basement rec room supply register has no air flow. No rec room return air register.
- ✓ Old air conditioner; short useful life.

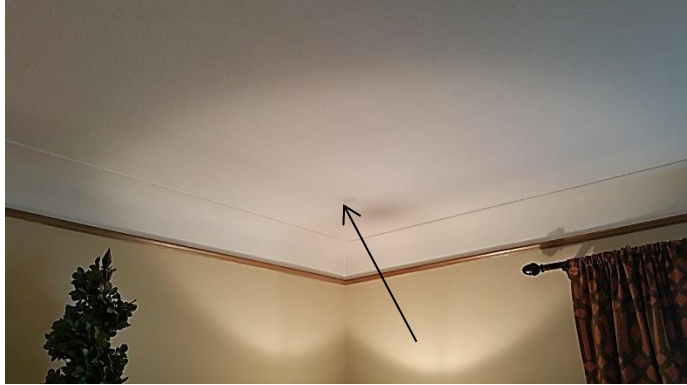
Water stained ceiling

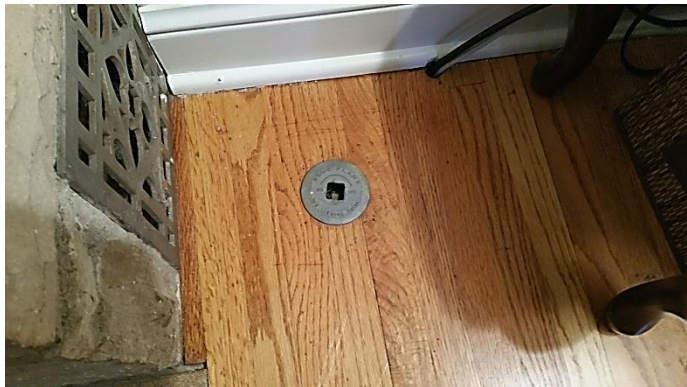
Fireplace gas shutoff
