September 1, 2019

On 7/30/2019, Cities' Inspection Service, Inc. completed a home inspection of the property located at XXXXXXXX, XXXXXXXXXXXXX, Minnesota for you. Doug Hastings did all the fieldwork related to this project. Doug used the national home inspection protocol; the American Society of Home Inspectors (ASHI) Standards of Practice.

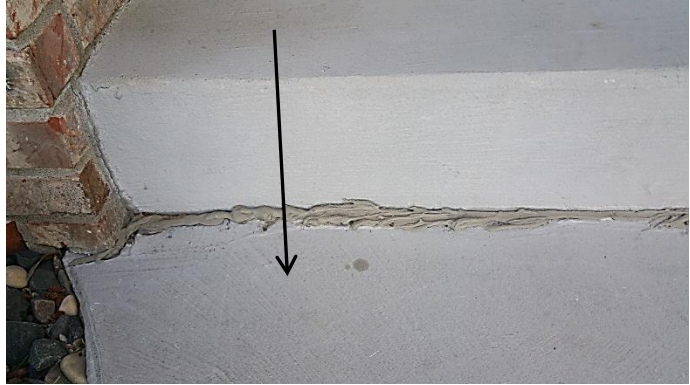
Settled front section walk

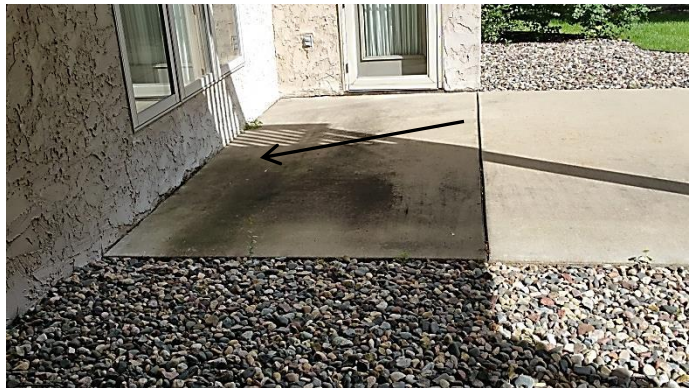
- steps _____ ⊗.... top coated
- walks _____ ⊗.... top coated / settled section at steps
- patio _____ ⊗.... settled concrete / negative slope / ponding water
- driveway _____ ⊗.... top coated / pitted concrete

Patio

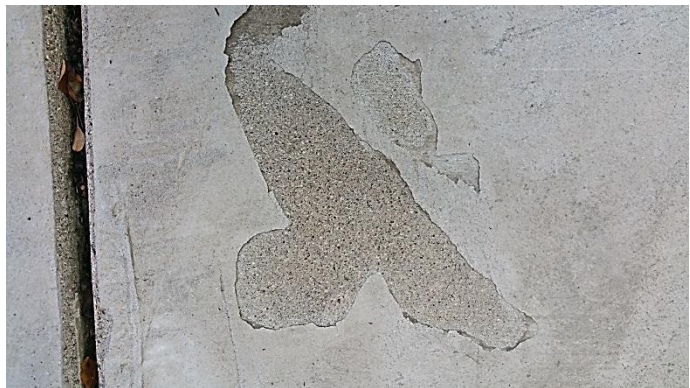
Top coated concrete

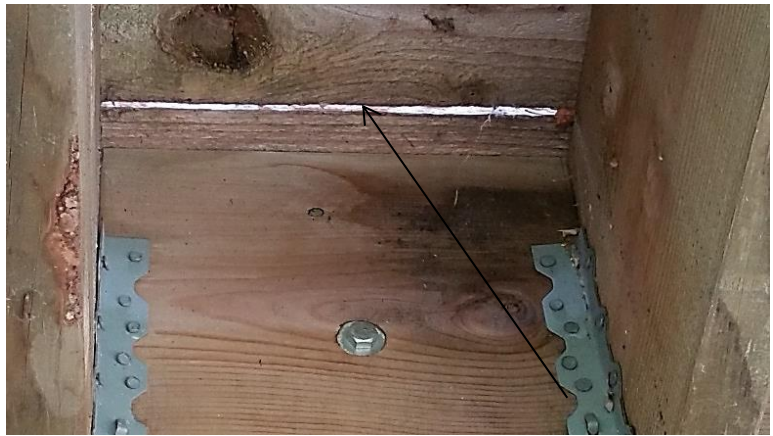
No ledger flashing

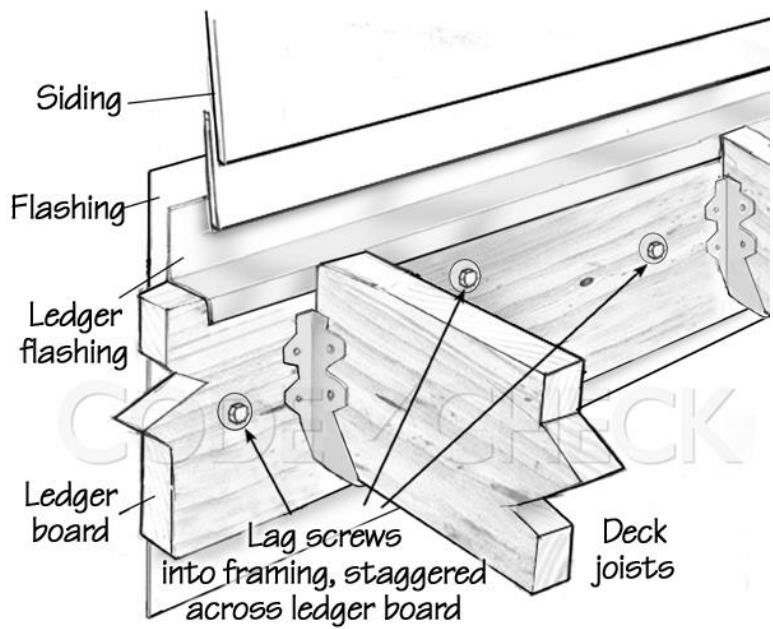
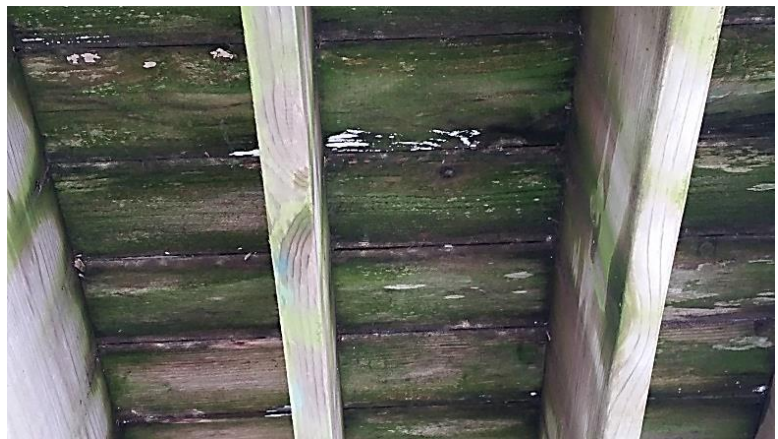
Decayed floor boards

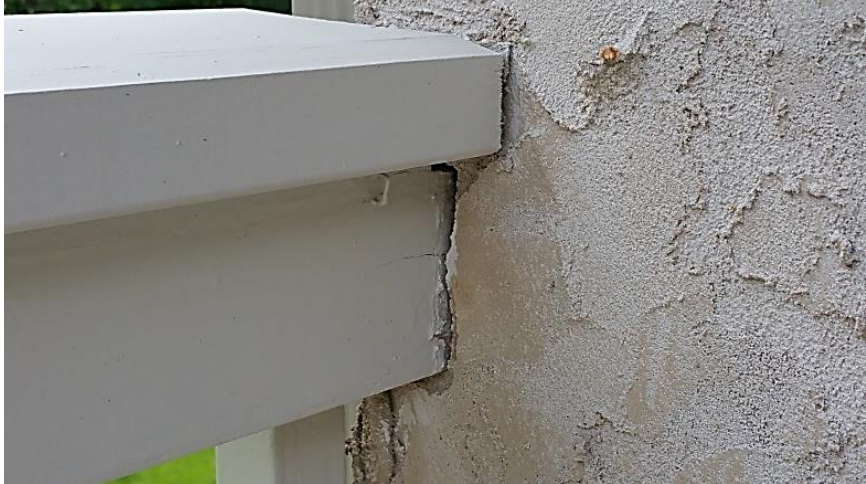
Guardrail in stucco (moisture intrusion)

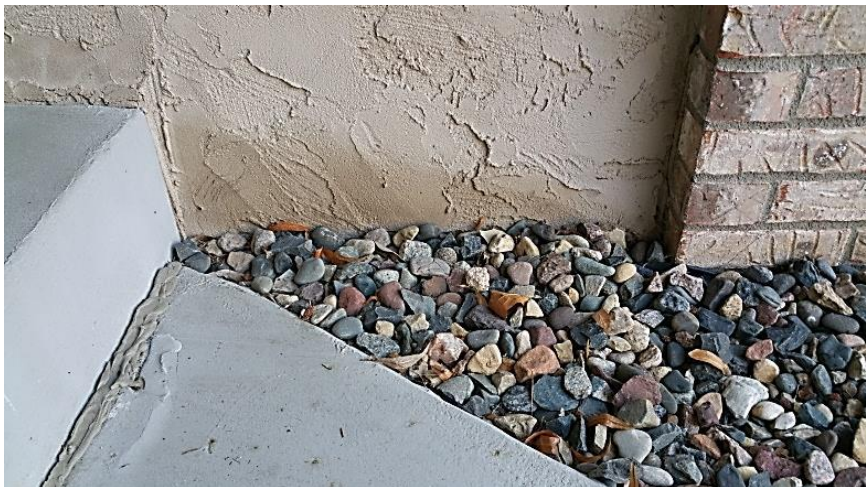
Stucco contacting earth

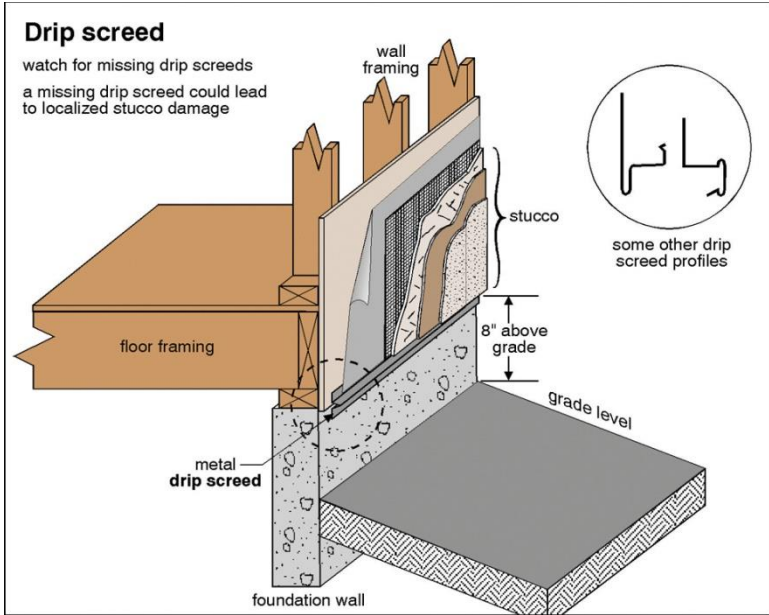
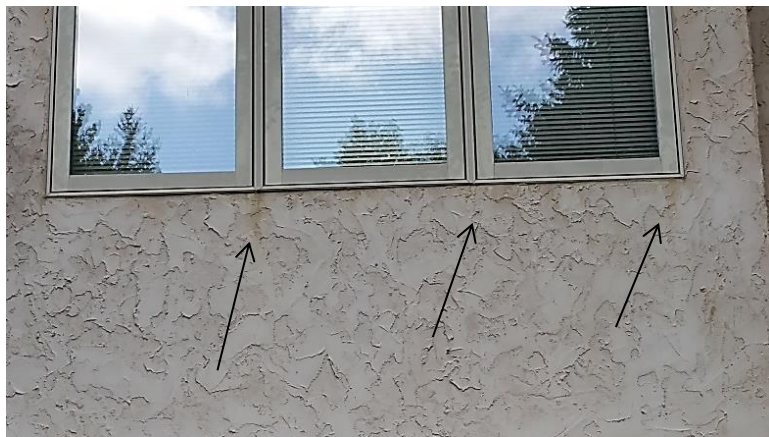
Water stains

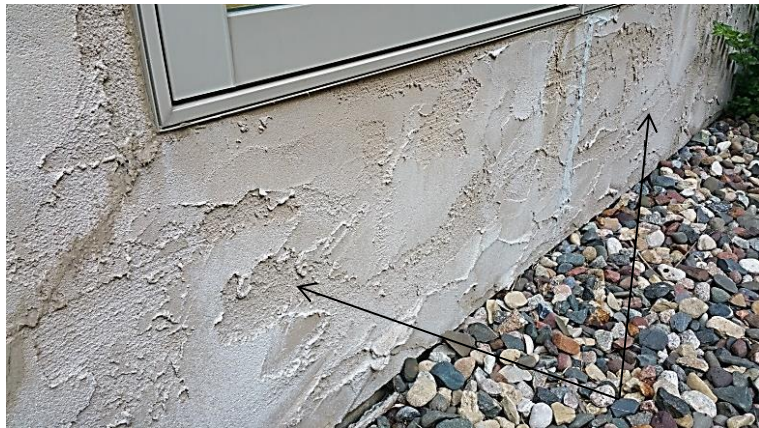
Loose stucco

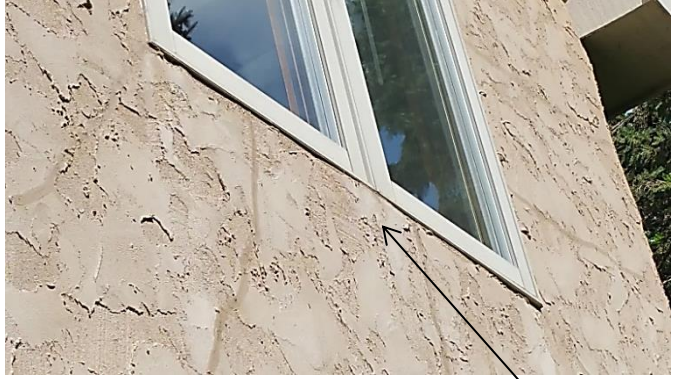
Loose stucco

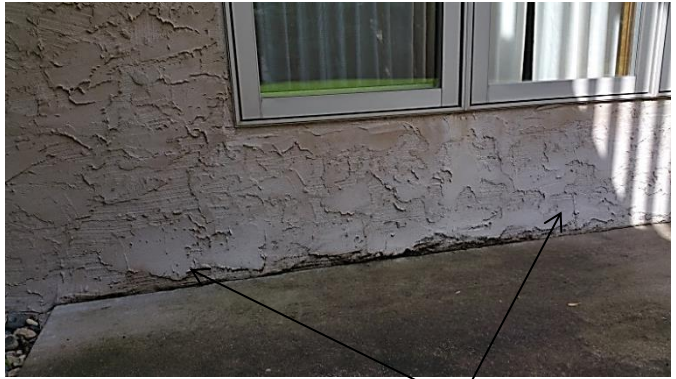
Water stained stucco

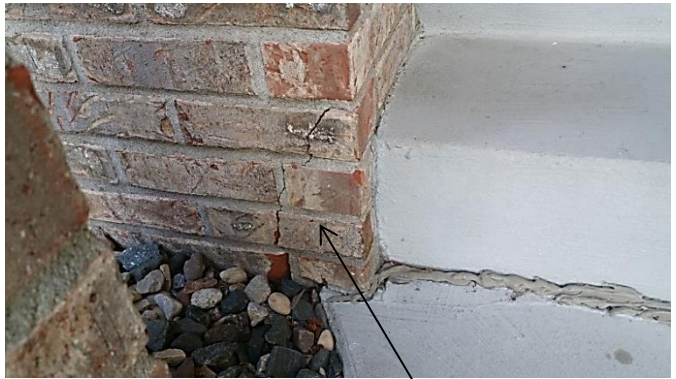
Cracked & settled bricks

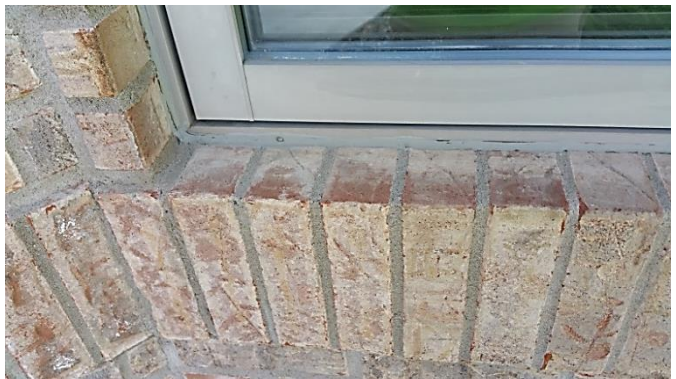
Flat window sill

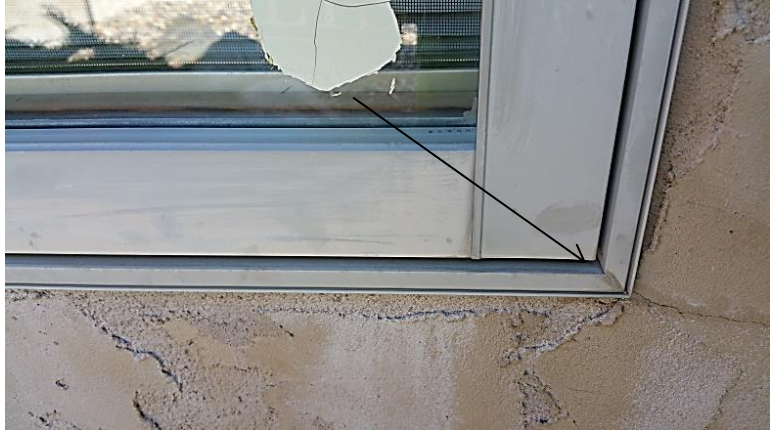
No corner joint caulking

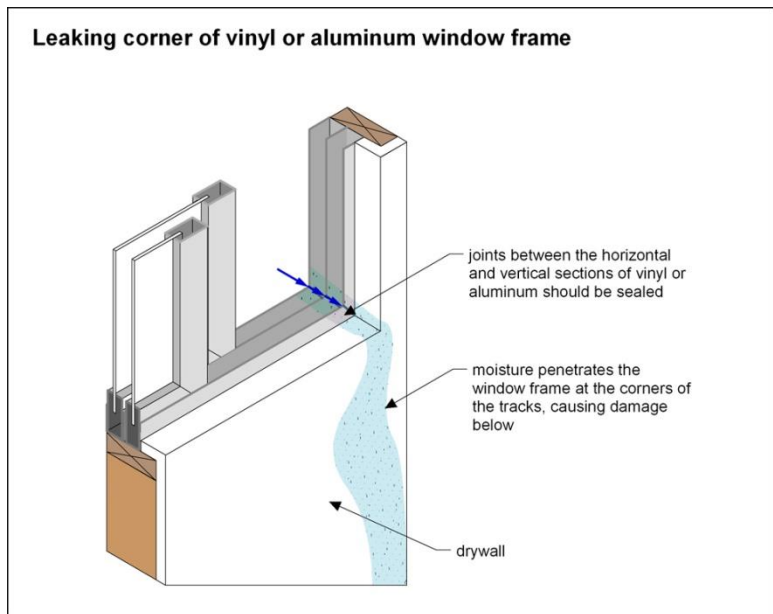
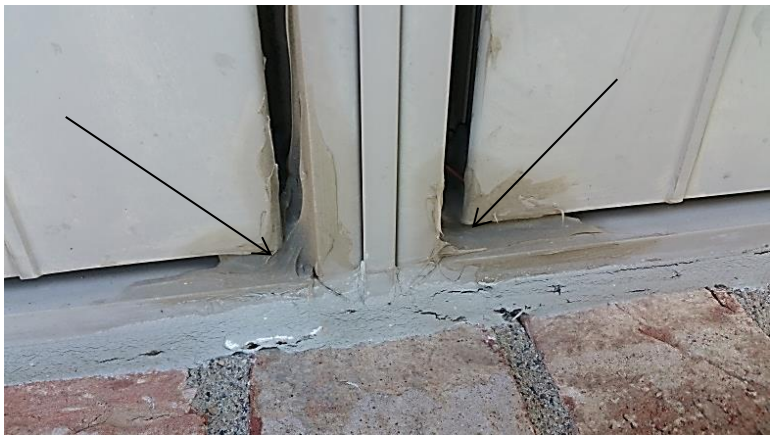
Excessive corner caulking (front only)

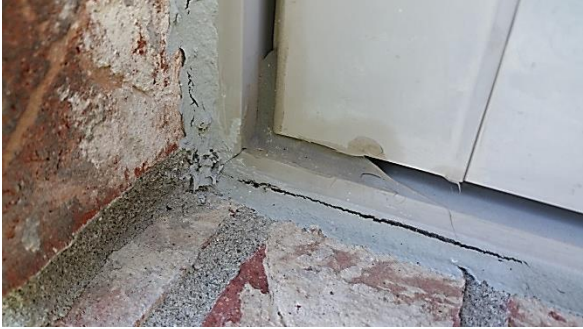
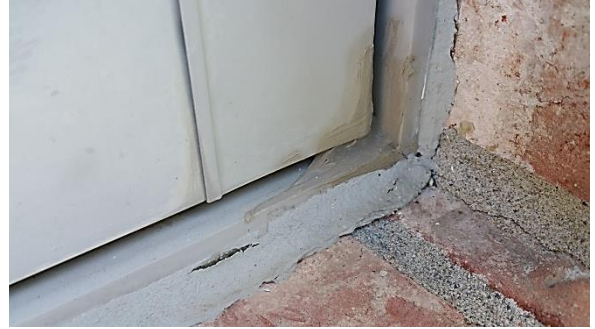
Excessive corner joint caulking (front only)

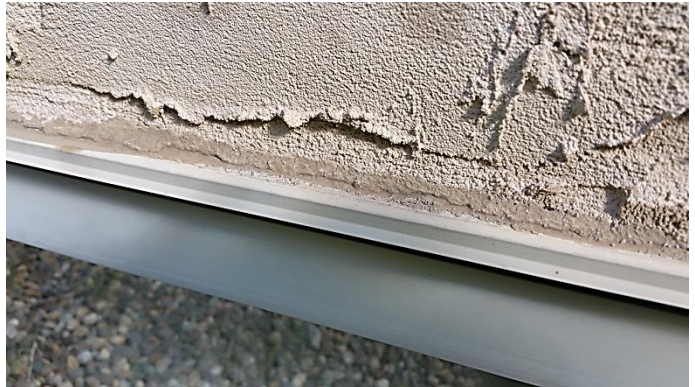
Caulked window top (traps moisture)

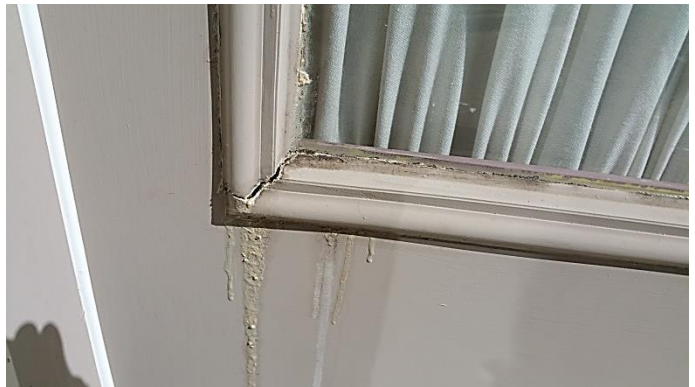
Cracked door trim

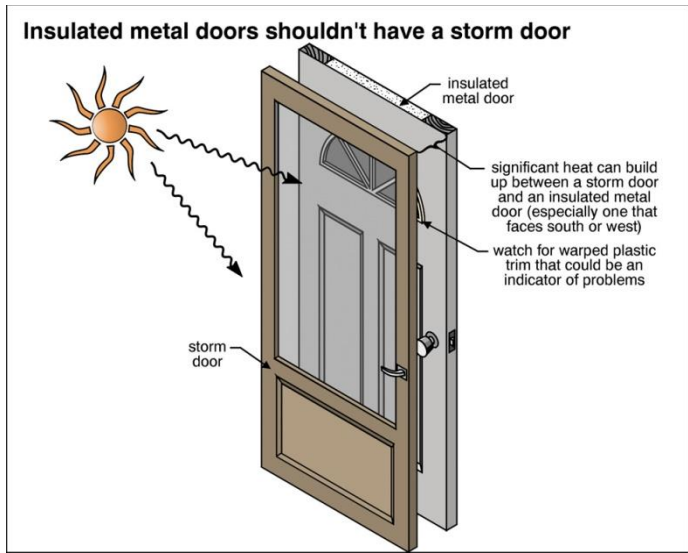
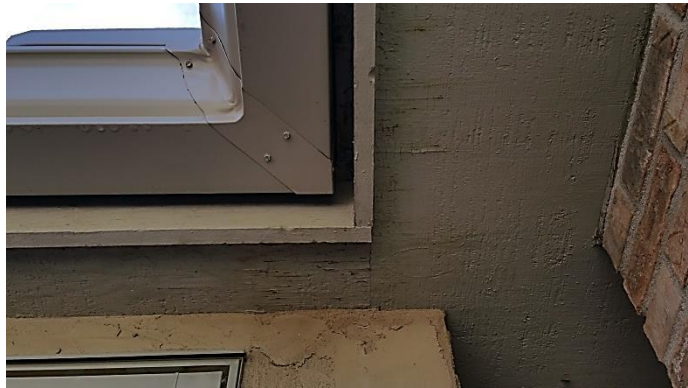
Water damaged soffit (front)

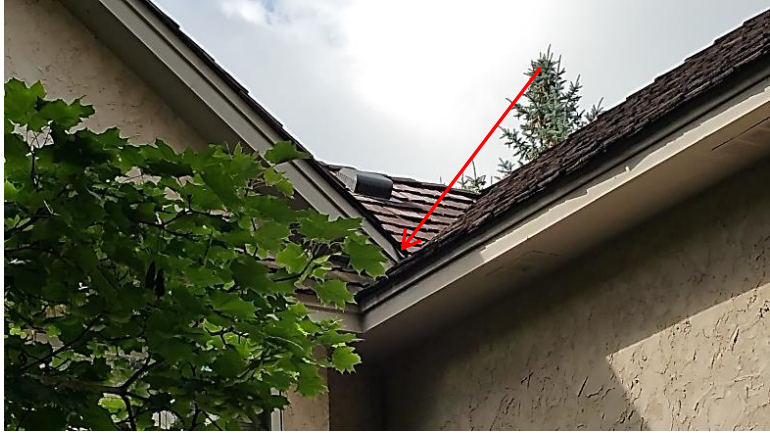
Restricted drainage (ice dam)

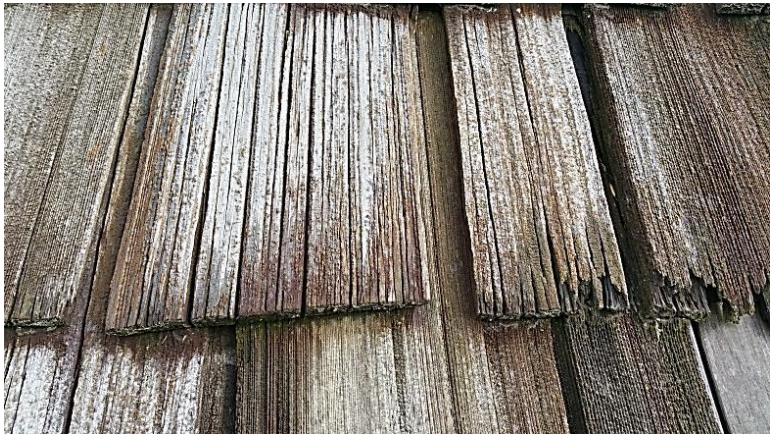
Split shakes

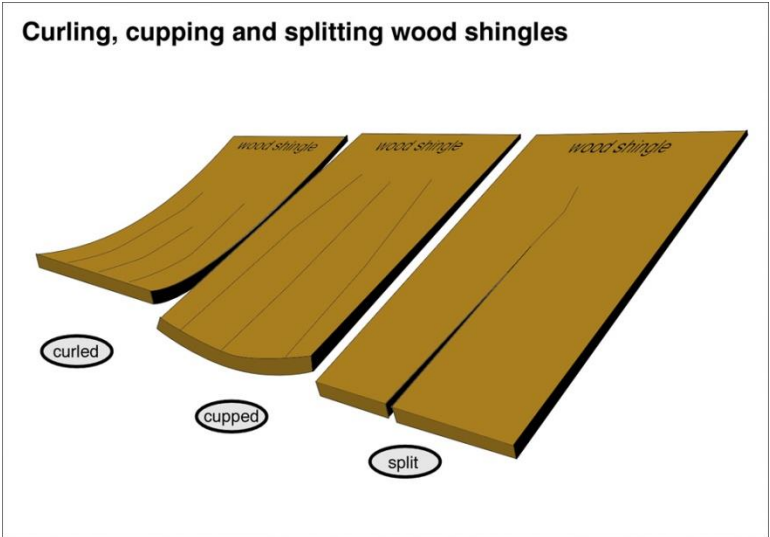
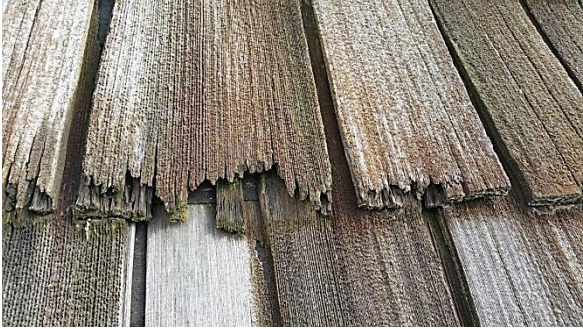
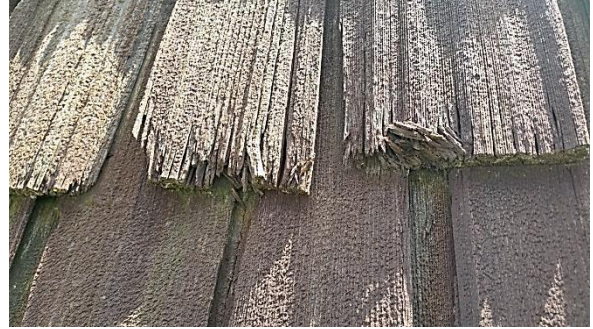
Decayed shakes

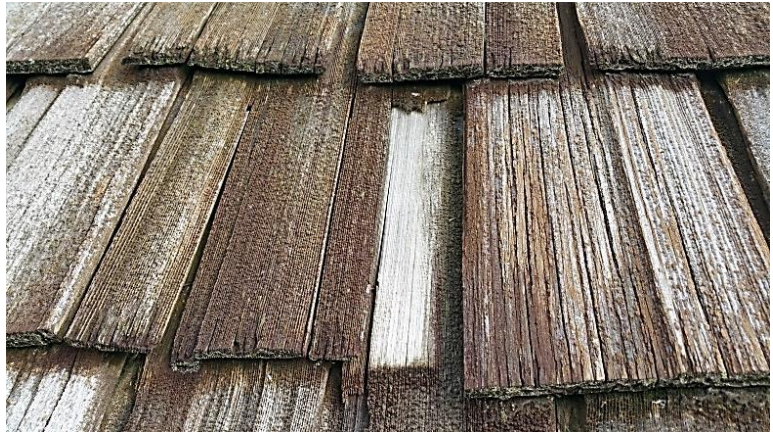
Missing shakes

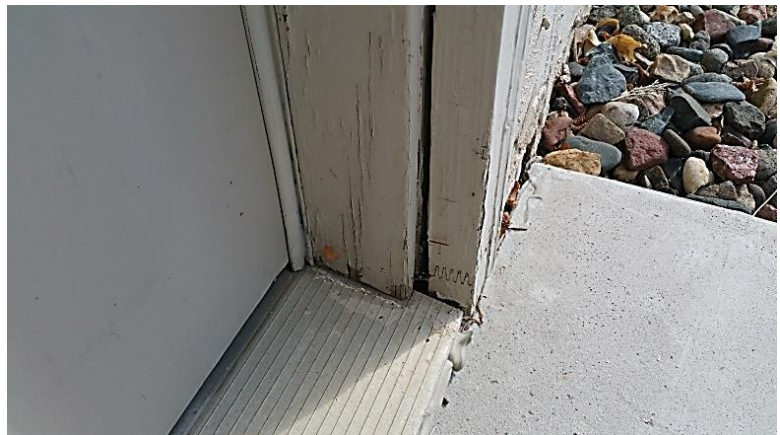
doors _____ ⊗... loose & worn wood service door frame

Service door frame

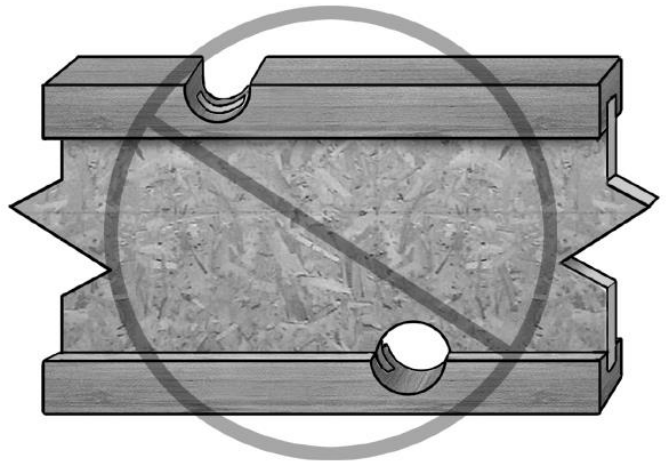
No Notching of Flange

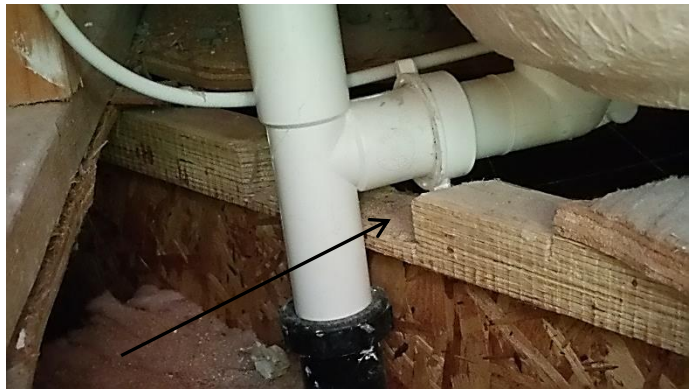
Cut flange

- ✓ Cut I joist top flange supporting master bathtub.
- ✓ There is a probability of moisture intrusion into the wood wall and floor framing; professional testing and certification is required (recommend Allen Powel CMT testing 651-272-5552)

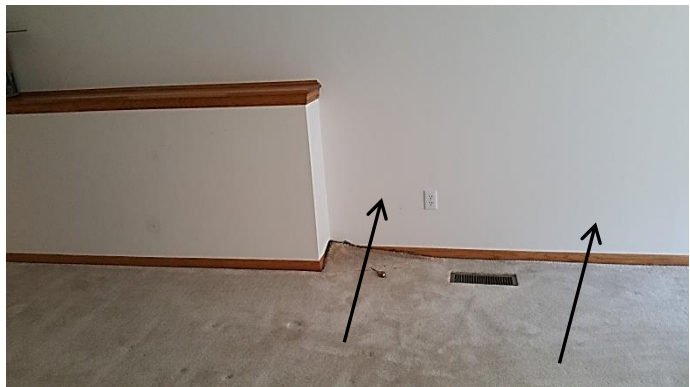
not visible / recommend moisture test / buried wood frame in family room

Buried wall

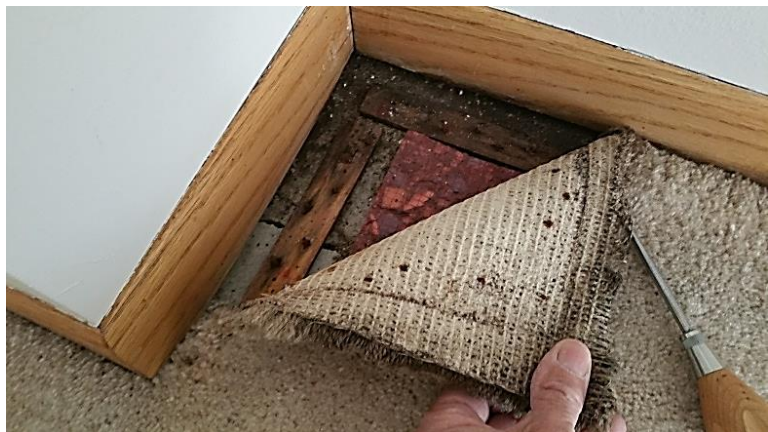
Water damaged floor

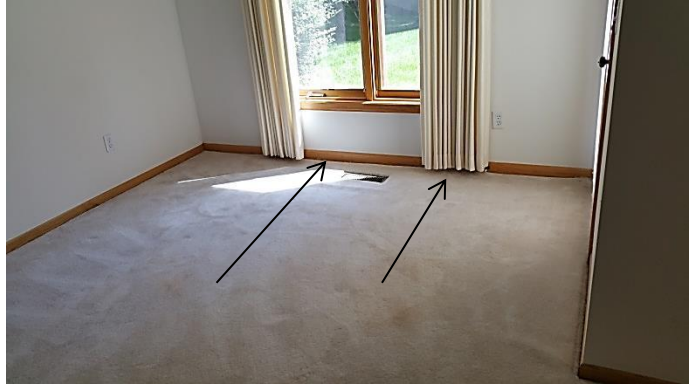
Water stained floor

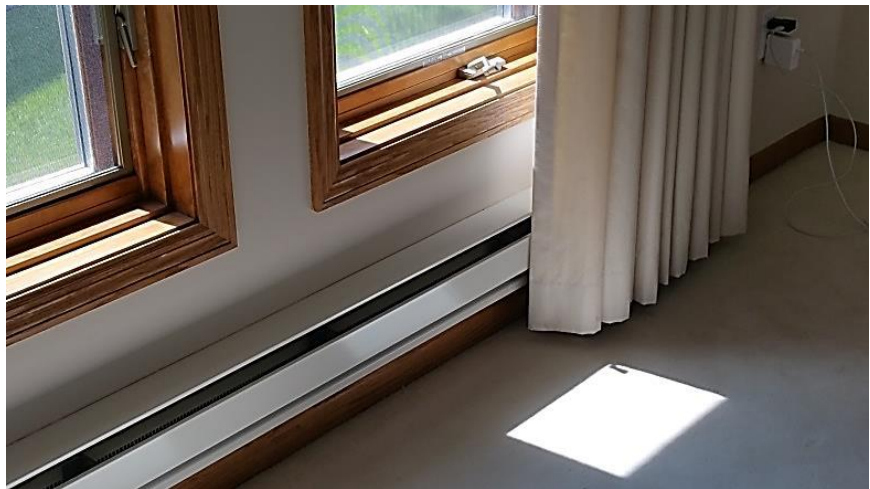
Drapes too close to heater

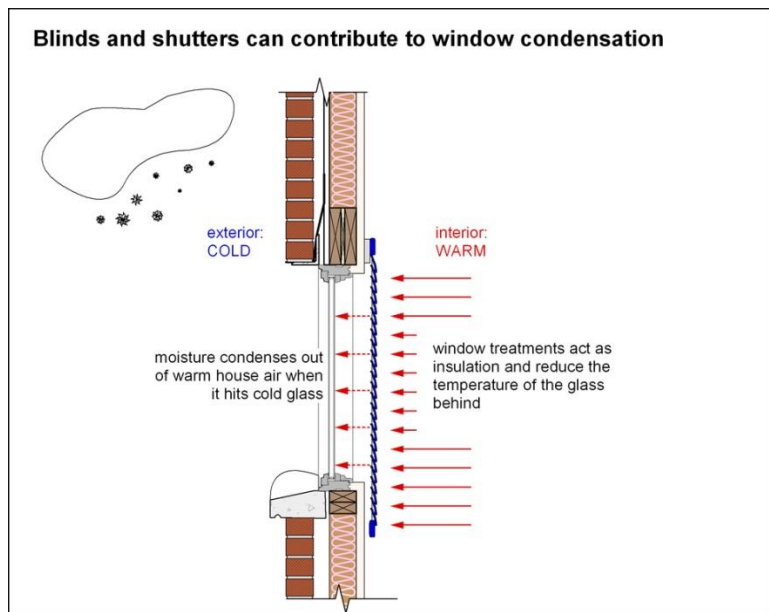
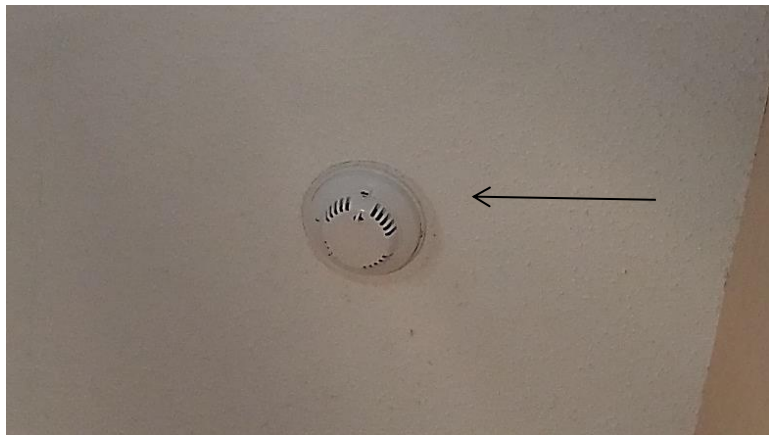
- wall, ceiling, floor ___ ⊗ water stained ceiling (around security system detector)
- door _____ ●
- outlet and fixture ___ ●
- heat _____ ●
