# Lack of Maintenance and Knowledge: *Garbage Disposals Misused and Improperly Installed*

By ROGER HANKEY, ACI

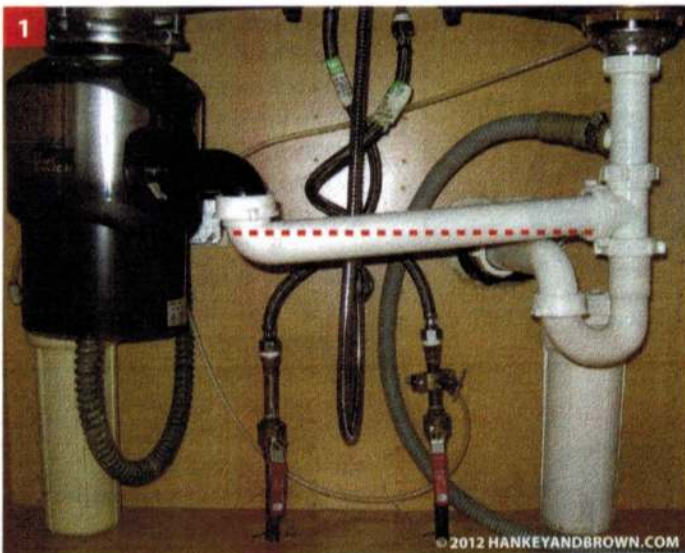
*Photo 1* shows the improper slope of a disposal drain. The reverse slope of this drain will permit water and food waste particles to collect below the dashed red line. This improper slope increases the potential for clogging and foul odors.

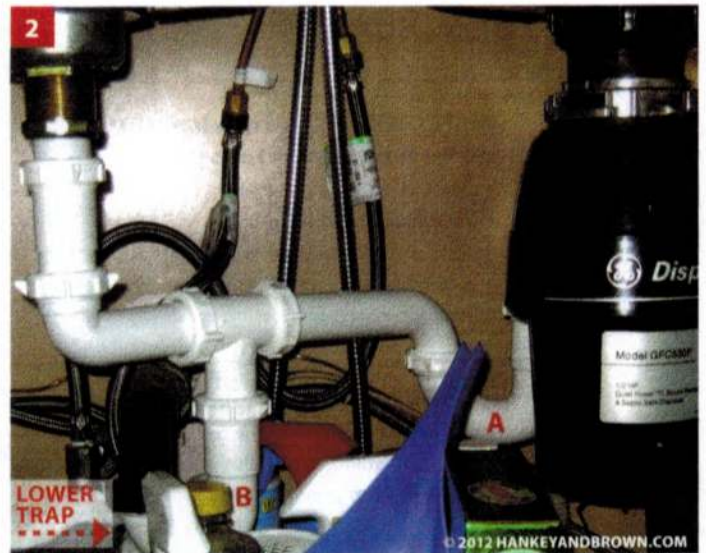
Another similar installation error (*seen above in Photo 2*) is the use of a separate trap "A" in the disposal drain, in SERIES with an existing trap "B." This also increases the potential for clogging since the food waste and water will be slowed as it passes through the complex set of multiple fittings.

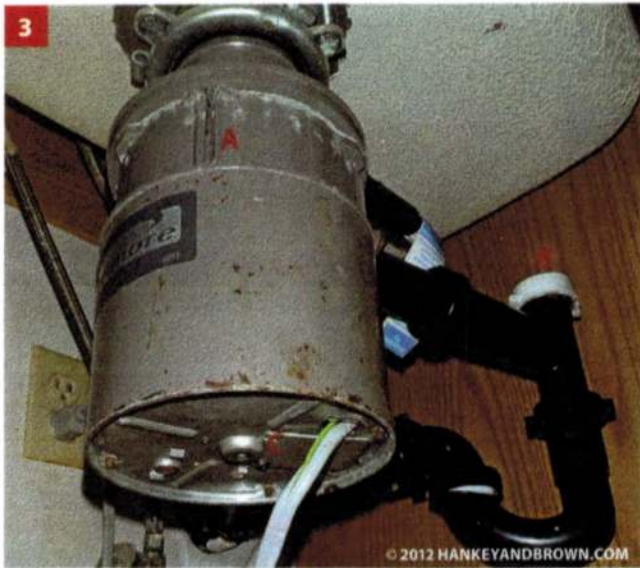
Proper installations often use a “Y” fitting at the sanitary tee in the wall to permit each basin to flow direct to the drain without passing through a second trap. Most disposals are electric powered and must be properly grounded unless they are double insulated. Occasionally, both the plumbing and the wiring on a disposal are incorrect. The unit shown above in *Photo 3* has no clamp or bushing at the cable connection to ensure that the wiring is properly secured to the disposal at “C.” Further, the drain arm from the disposal goes to a tee fitting instead of an elbow at “B.” Finally, the disposal has corrosion on the exterior of the grinding chamber at “A,” which is discussed later in greater detail.

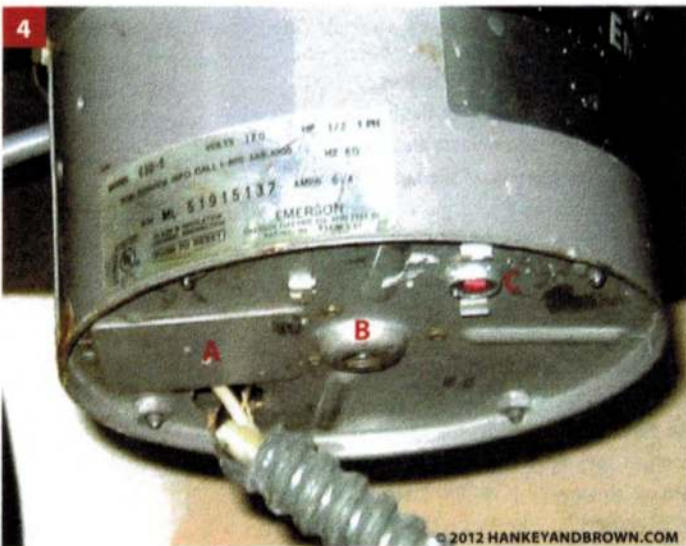
Disposal units, and other devices require a proper clamp and bushing to secure the wiring and to protect the wiring from damage. The disposal shown lacks such a clamp and bushing at “A.” The image also shows the location of the socket in the end of the motor shaft at “B.” This is found on many disposals and permits the use of an Allen wrench to rotate the shaft to free up a jammed disposal. In *Photo 4*, above, the red button shown at “C” on the bottom of the unit is a reset button for the disposal’s internal circuit breaker. Pushing the button in will restore power to the disposal.

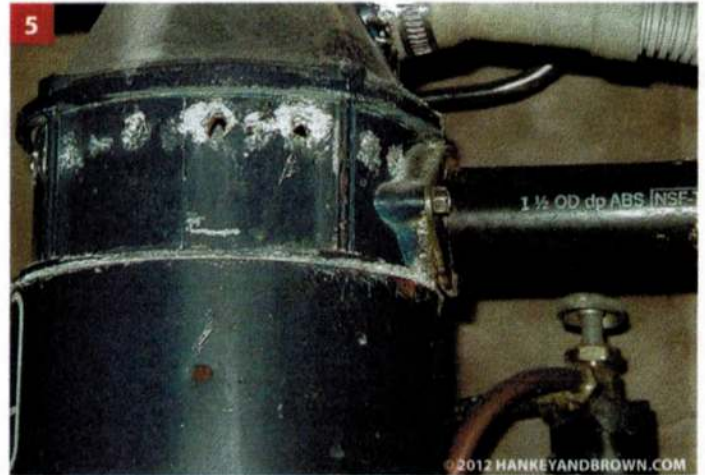
Proper use and maintenance is necessary to reduce the potential for corrosion in the grinding chamber of the disposal. Decaying food particles not flushed from the grinding chamber can form acids that can eat away the die cast “pot” metal found in the case of many lower cost disposals. (Pot metal is a low-cost alloy often high in zinc, sometimes used for inexpensive pots.) It is essential that the disposal’s grinding chamber be flushed with water after each use. Some manufacturers have additional maintenance recommendations including the occasional grinding of ice cubes in the disposal. See the owner’s manual for details.

*Photo 5*, above, shows a typical pattern of corrosion from failure to flush the grinding chamber. The connection nipple for the dishwasher’s gray-waste hose is also vulnerable to corrosion from the strong detergents used in dishwashers.

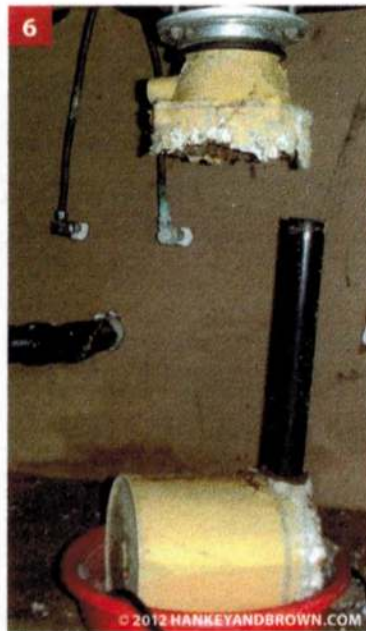
A rare but extreme case of disposal corrosion is shown in *Photo 6*.

Most disposal manufacturers make several models. The more costly models use corrosion-resistant materials, such as stainless steel, in the grinding chamber and have more powerful motors.
