On June 6, 2011, Cities' Inspection Service, Inc. completed a **partial** inspection of the condominium unit located at 123 Oak Street #1, Somewhere, Minnesota for you. Doug Hastings did all the fieldwork relating to this project.

Condo Inspection

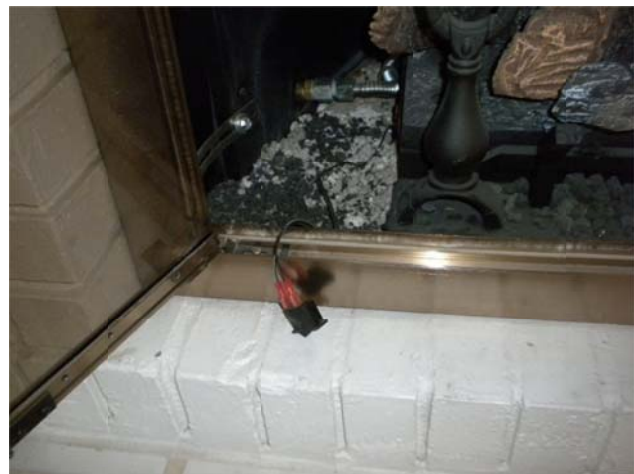
3. Unprotected fireplace wiring

- walls/ceiling_____ ●
- floor_____ ●
- window(s)_____ ⊗out of adjustment (painted shut)
- door_____ ○no patio door screen (with screened in porch not required)
- outlets/fixtures___ ⊗no deck GFCI receptacles
- heating_____ ●
- deck_____ ○over spaced guardrail
- fireplace_____ ⊗oversized gas log / doors must below kept open (flame too hot & too close to glass doors) / unprotected switch & wiring

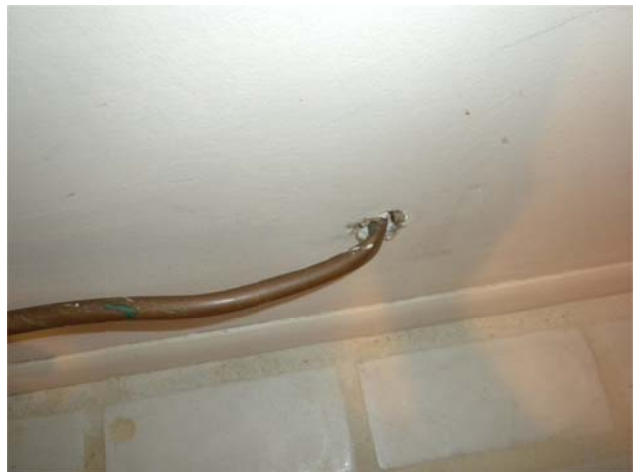
9. Kinked fireplace gas pipe

- gas line_____⊗ kinked & unprotected pipe
10. Other equipment
 - electrical panel___⊗ problematic Federal Pacific panel (fire safety)
 - AC air handler___⊗ low air conditioning supply registers air flow

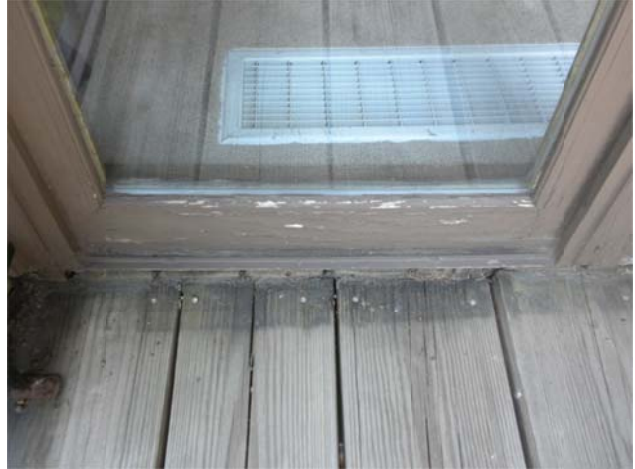
7 & 8. Worn patio doors

7. Bedrooms
 - walls/ceiling_____●
 - floor_____●
 - window(s)_____⊗ undersized window / out of adjustment (painted shut)
 - door_____⊗ worn patio door wood / short useful life (less than 3 years)

- door_____⊗ worn patio door wood / short useful life (less than 3 years)
 - outlets/fixtures___●
 - heating_____⊗ low air flow
 - sink_____⊗ leaking bar sink faucet

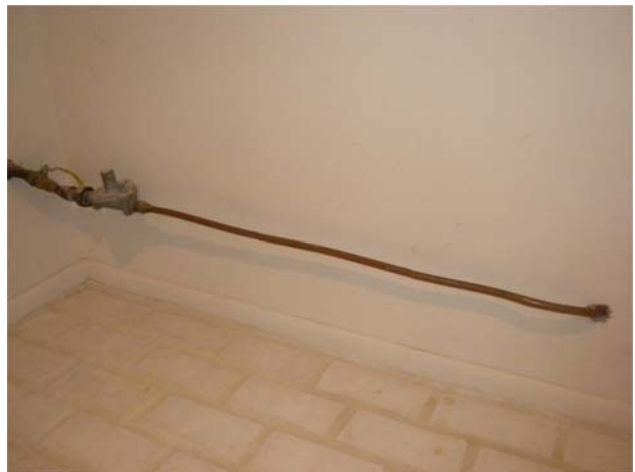
9. Unprotected closet gas pipe
