www.citiesinspection.com

October 5, 2015

On 9/29/2015, Cities' Inspection Service, Inc. completed a home inspection of the property located at 123 Oak Street, Someplace, Minnesota for you. Doug Hastings did all the fieldwork related to this project. Doug used the national home inspection protocol; the American Society of Home Inspectors (ASHI) Standards of Practice.

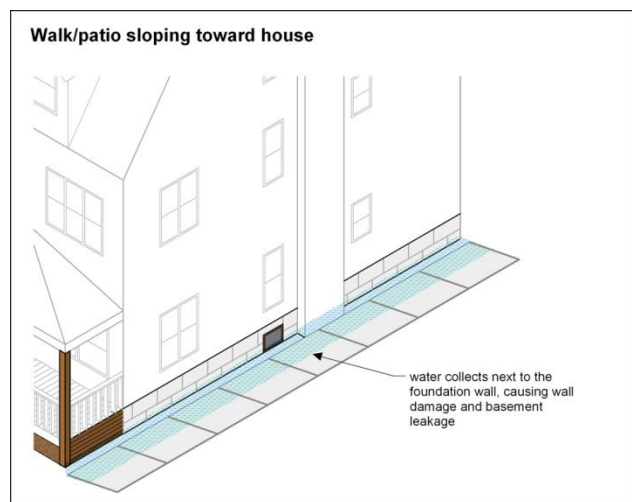
- steps _____ ⊗.... loose patio door blocks / chipped rear steps
- walks _____ ⊗.... cracked & settled concrete / negative slope
- patio _____ ⊗.... deteriorated pavers / flat grade / ponding water on foundation
- fence _____ ⊙.... decayed wood posts on north side
- driveway _____ ⊗.... cracked concrete

Settled front walk

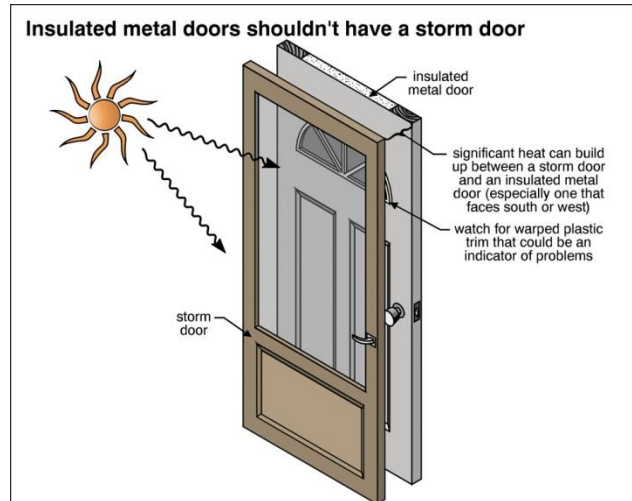
Cracked plastic glass trim

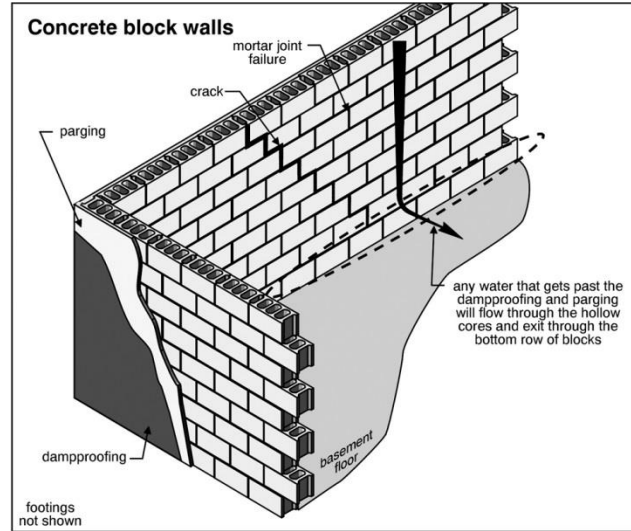
- walls _____ water stained floor east side
- floor slab _____
- drain tiled _____ none

Water stained tiles east side

- ✓ Water stained rec room paneling and floor tiles.
- ✓ Missing basement rim joist insulation.
- ✓ Minimal amount attic insulation and ventilation (ice dams).

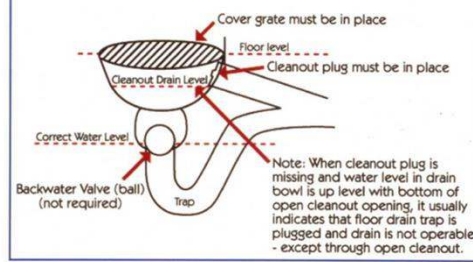
Floor Drain Cleanout

- sewer _____ not visible / camera scoped by Ron the Sewer Rat
- soil stack _____
- drain/vent pipes _____
- bath rough in _____ no water in floor drain trap
- laundry tub _____ cracked & leaking concrete tub / no softener, pump & purifier
air gap (cross connection) / leaking clothes washer shutoff

Sewer concern

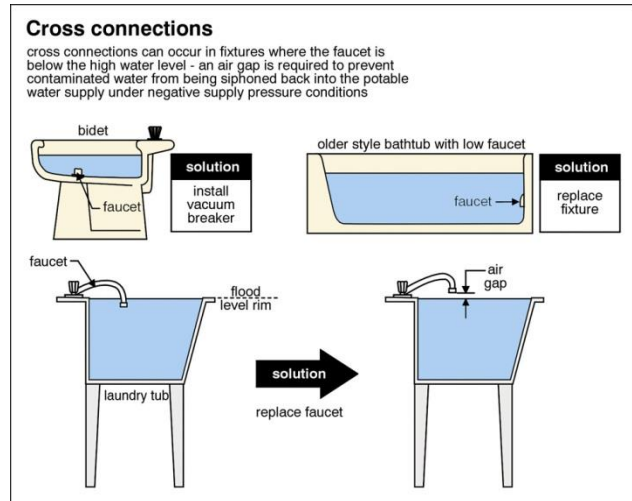
No air gap
