September 1, 2019

On 7/30/2019, Cities' Inspection Service, Inc. completed a home inspection of the property located at XXXXXXXX, XXXXXXXXXXXXX, Minnesota for you. Doug Hastings did all the fieldwork related to this project. Doug used the national home inspection protocol; the American Society of Home Inspectors (ASHI) Standards of Practice.

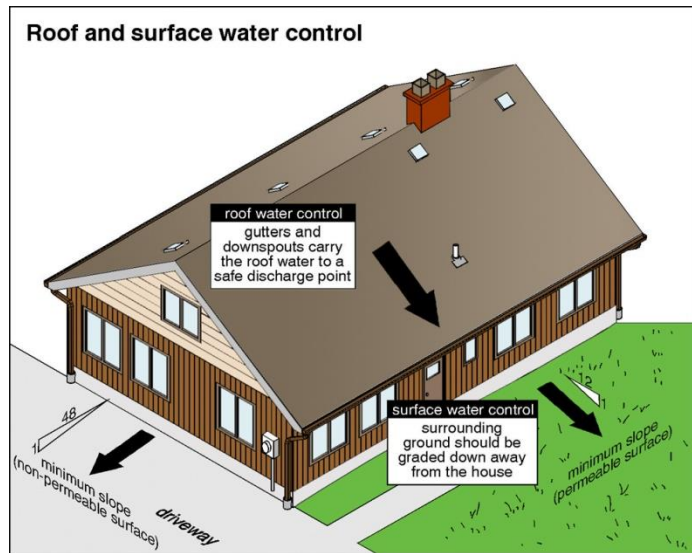
Landscape

- front _____ ⊗.... flat grade (front)
- left side _____ ⊗.... contacting wood framing
- right side _____ ⊗.... settled backfill
- rear _____ ●

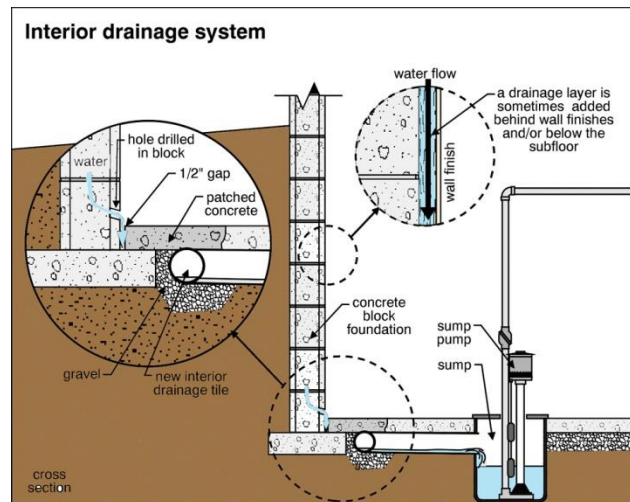
Foundation

- walls _____ ⚠.... not visible
- floor slab _____ ●
- sump/drain tile _____ ⚠.... no pump / no water in sump
- radon mitigation _____ ⚠.... no system / levels not tested
