## *Technical Notes on Brick Construction:*

# **STAINS: Identification & Prevention**

Presented by the Brick Industry Association

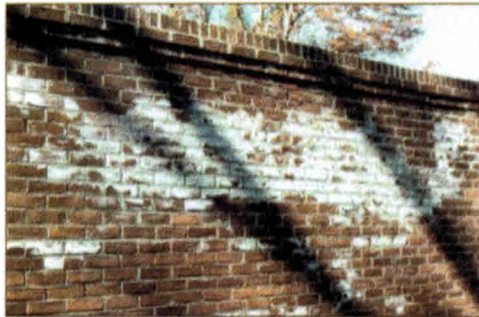
Photo 1, Efflorescence

less deposit of water soluble, white salt crystals, as shown in Photo 1. In some instances, efflorescence may appear on mortar joints as shown in Photo 2. Efflorescence may appear in limited areas on the surface of brickwork as shown in Photo 3 or, in extreme cases, cover the entire brickwork surface.

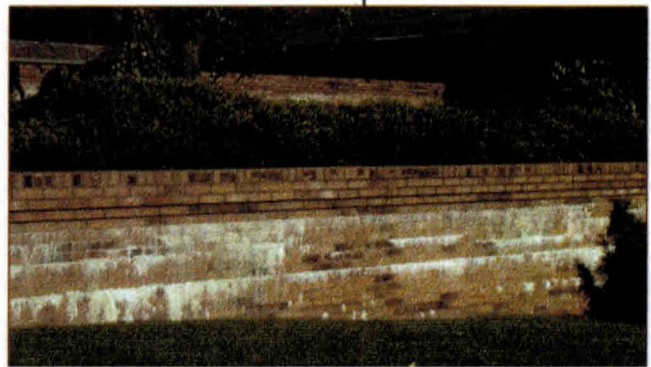
Photo 4, Lime run

Calcium carbonate deposits, sometimes referred to as “lime run,” usually appear as white or gray, crusty formations originating from a spot and running down the face of the wall, as shown in Photo 4. However, the term “lime run” is misleading since the stain is not a direct result of the lime component in the mortar. In fact, hydrated lime actually helps to reduce the risk of lime run. Lime run nearly always occurs at a small hole or opening or hairline crack in the face of the brick masonry, as shown in Photo 5.
