Asphalt Shingle Roof Coverings

BY BRUCE BARKER

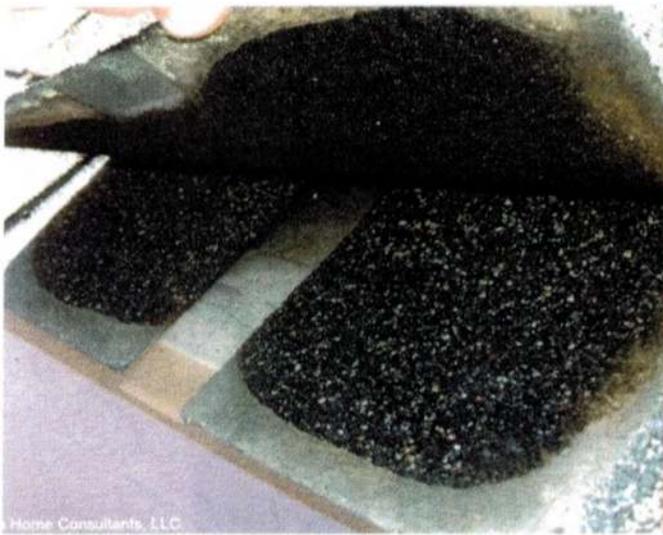
Photo 1

Manufacturers require a starter course at the eaves that extends about 1/4 inch past the drip edge (or sheathing if no drip edge). The starter course is usually shingles with the tabs cut off just under the seal strip. The starter course secures the first shingle course. Without the starter course, wind could get under the unsealed first course and rip the shingles off like opening a zipper. Lift the first shingle course. There should be a seal strip at the starter course and the two courses should be stuck together. The starter course is often installed incorrectly. See *Photo 1*.

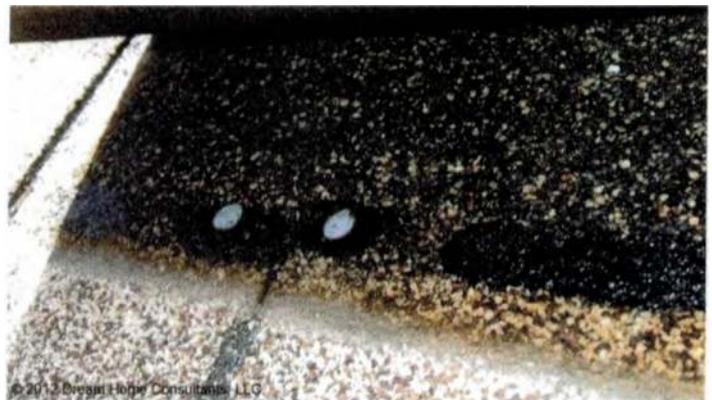
Photo 2

Fastener location depends on the manufacturer and style of shingle. Fasteners should be about 1 inch from the sides of most shingles. Fasteners on many types of shingles should usually be located just below the seal strip. Some manufacturers leave spaces in the seal strip where fasteners should be located. Fasteners should not be located in the sealant material or above it. Improperly located fasteners reduce the wind resistance rating of the shingles. See *Photo 2*.

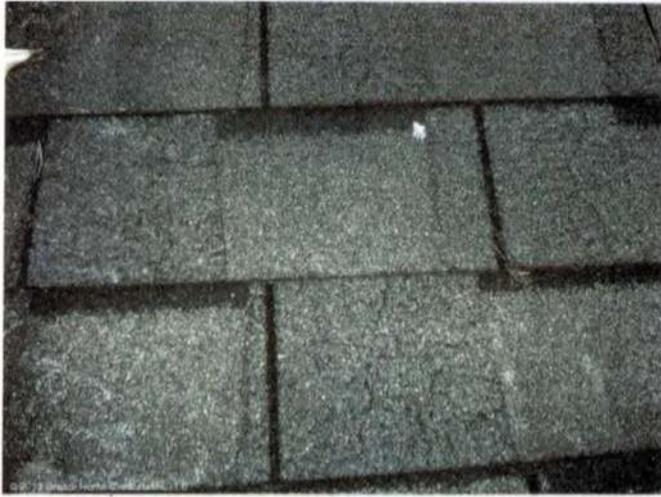
Photo 3 - top left

Look at the shingles to determine their condition. Shingles in poor condition will show evidence of drying and cracking, loss of granules, visible strands of fiberglass (especially at the edges) and curling at the edges. Photo 3 shows cracking shingles. Photo 4 shows significant granule loss. Photo 5 shows typical hail damage.
